**Attachment 1**  
**February 10, 2010**  
**Inspection Findings,**  
**Violations, and**  
**Corrective Actions**

## Industrial Storm Water Inspection Report

Permittee: Lehigh Southwest Cement, Co. (formerly Hanson Permanente Cement)	WDID No. <b>2 43I006267</b>	Date: 2/10/2010
Facility: Lehigh Southwest Cement, Co.	SIC Code: 3241 – Cement, Hydraulic	Receiving Water: Permanente Creek
Facility Address: 24001 Stevens Creek Boulevard; Cupertino (Santa Clara County), California		
Facility Representative(s)/Title(s): Scott Renfrew (Environmental Manager, Lehigh Southwest Cement, Co.), Wilbur Green (Environmental Engineer, Lehigh Southwest Cement, Co.), Henrik Wesseling (Plant Manager, Lehigh Southwest Cement, Co.)		
Additional persons present: None	Inspector(s): Scott Coulson (PG Environmental, LLC)

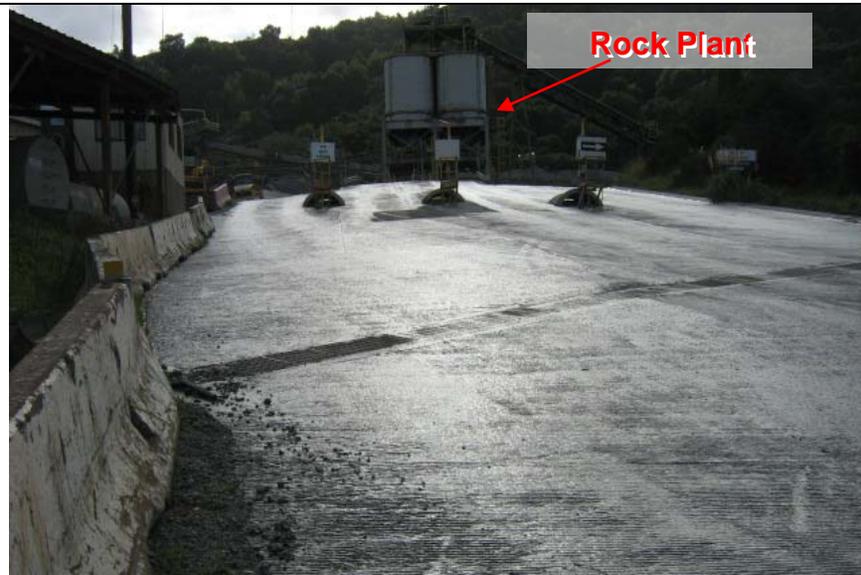
Pollutants were being actively conveyed from the Rock Plant (see attached Photographs 7 and 8) to the Pond 17 inlet. Pollutant accumulation was present along the entire inlet portion of Pond 17, including evidence of a high flow event that had caused the inlet check dams to breach (see attached Photograph 9).

Photograph 7 – View of Rock Plant, contributing area to Pond 17.

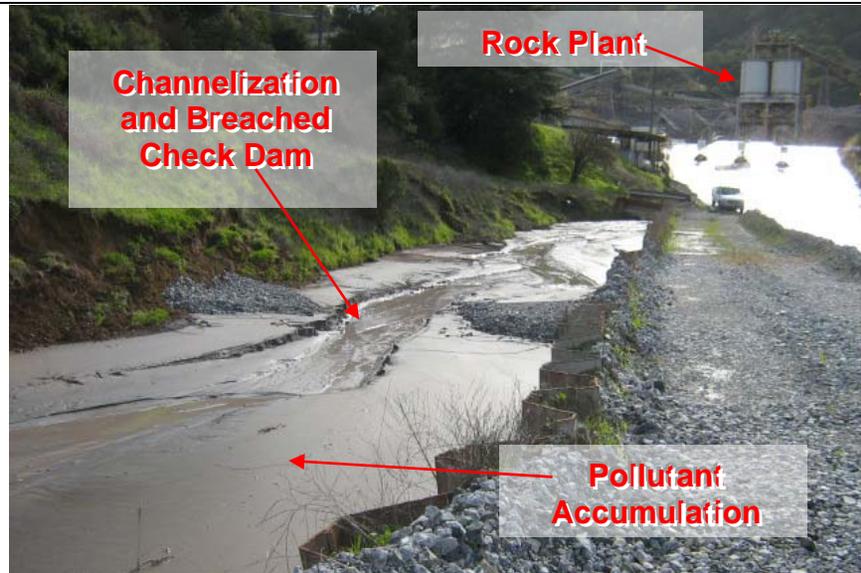
Photograph 9 – Pollutant accumulation along the entire inlet portion of Pond 17.

- Pond 17 - when will repairs be made to limestone barriers - -- initiated on Monday, February 16<sup>th</sup> and completed Thursday, February 18, 2010.

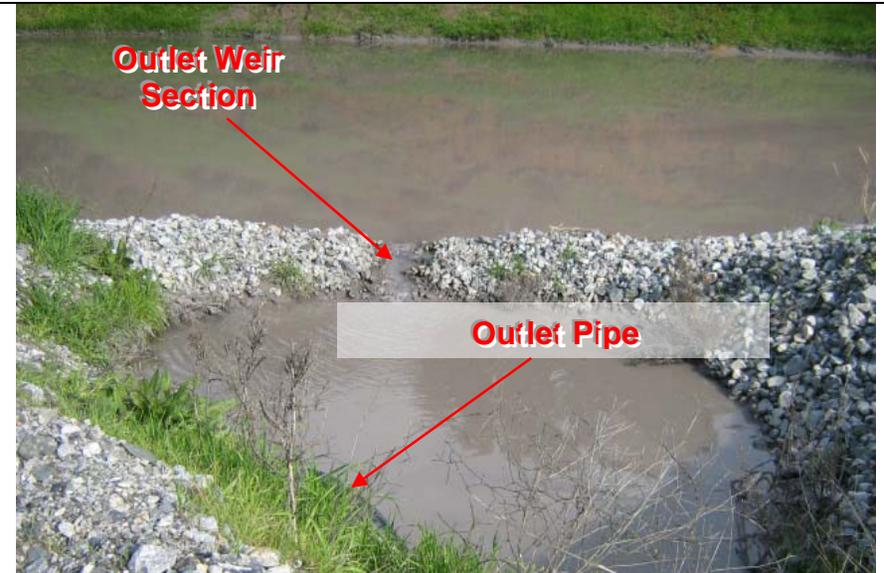
Moreover, pollutant-laden flow was observed passing over the outlet weir section (see attached Photographs 10 and 11) and through

Photograph 10 – Pollutant-laden water in Pond 17.

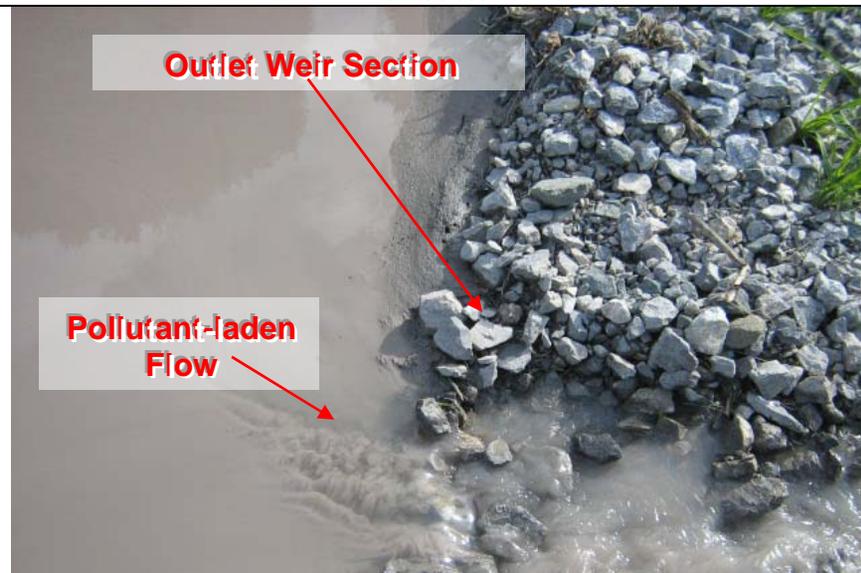
Photograph 11 – Close-up view of pollutant-laden flow passing over the weir.

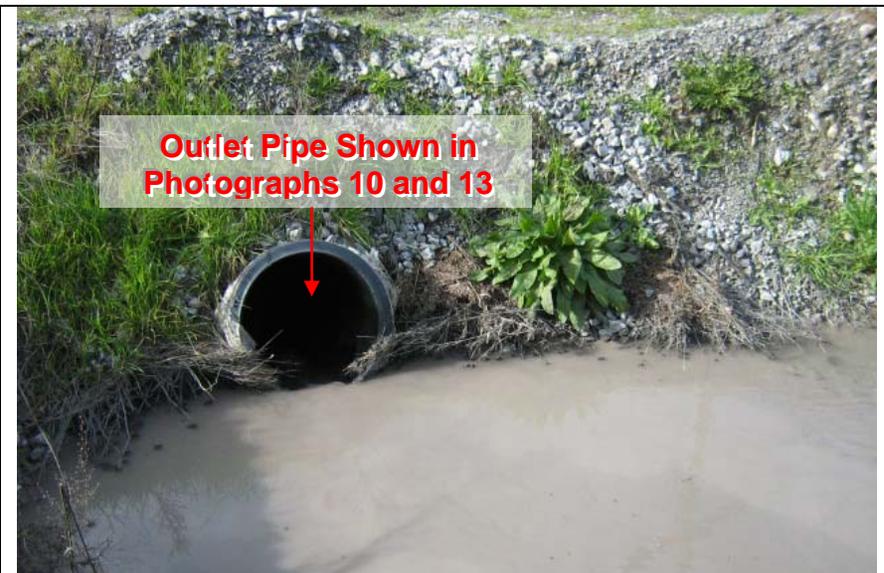
the outlet pipe (see attached Photographs 12 and 13). As specified in Figure 2 of SWPPP 14, the Pond 17 outlet is connected to an outfall to Permanente Creek below Dinky Shed Basin. The Pond 17 outlet flows to a drainage vault (see attached Photographs 14 and 15), which then discharges at the outfall to Permanente Creek. Pollutant-laden flow was observed at the outfall (see attached Photograph 16), and in the Permanente Creek receiving water (see attached Photograph 17 through 19).

Photograph 12 – Pollutant-laden flow passing through the Pond 17 outlet pipe.

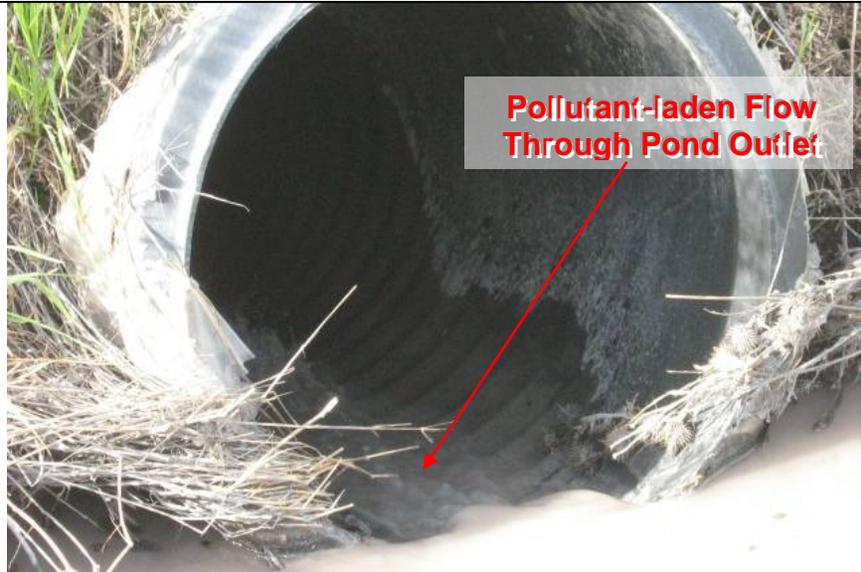
Photograph 13 – Close-up view of pollutant-laden flow passing through the Pond 17 outlet pipe.

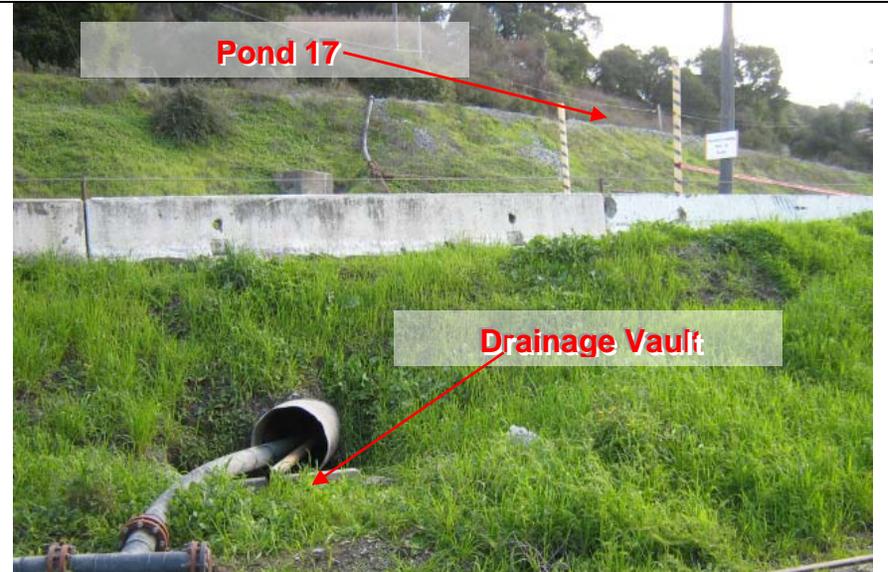
The plumbing configuration down-gradient of the Pond 17 outlet includes an open vault with a sump pump (see attached Photograph 15), and several pipes (see attached Photographs 14 and 16). The Environmental Manager could not explain what the pipes and sump pump are used for. However, the sump pump had the ability to affect the quantity of the facility’s storm water discharges from Pond 17. As

Photograph 14 – The Pond 17 outlet flows to a drainage vault at the toe of the slope.

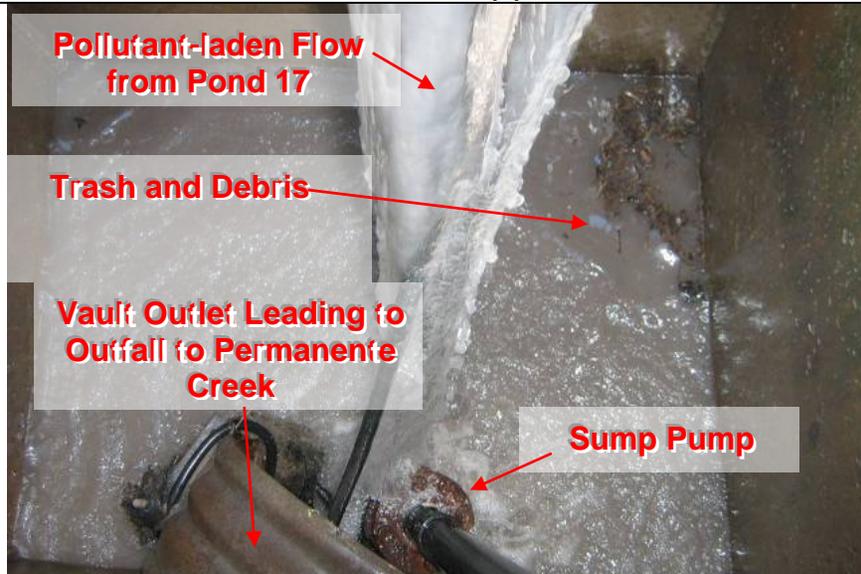
Photograph 15 – Drainage vault at the toe of the slope.

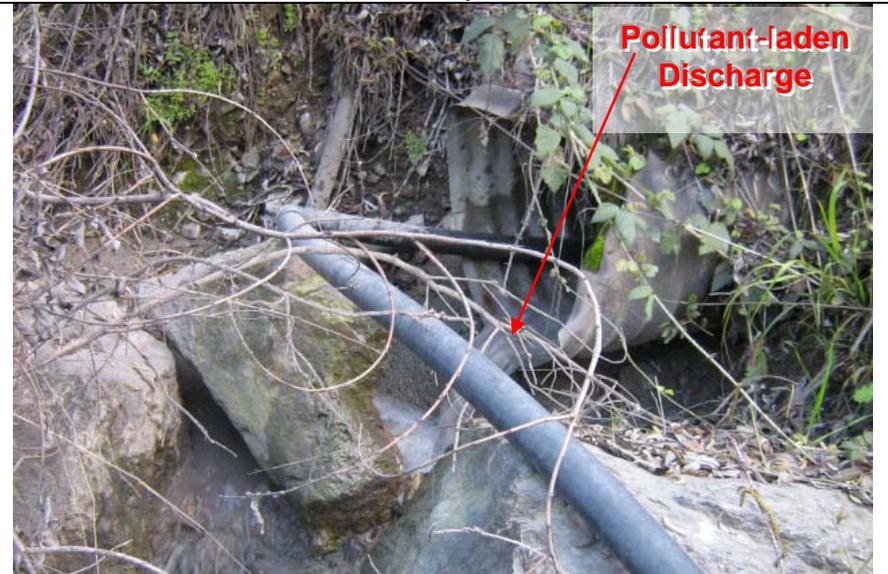
Rather than collecting the sample at the outfall pipe to Permanente Creek (see attached Photograph 16), Figure 4 of SWPPP 14, Storm water Sampling Locations, indicates that the SL-21-PD sample is collected at the outlet of Pond 17 (see attached Photograph 12). Due to the existence of a complex plumbing configuration down-gradient of the Pond 17 outlet, the SL-21-PD sample collection location was not representative of the

Photograph 16 – Outfall to Permanente Creek, down-gradient of vault and Pond 17.

<p><b>VIOLATION</b> Inadequate and non-representative sampling locations</p> <p><b>REQUIRED CORRECTIVE ACTIONS</b> By <b>May 15, 2010</b>, complete a water balance survey of all existing plumbing and drainage flows at the Facility, and update the engineering plans and documents to depict the current plumbing systems and drainage flows on the Facility property. The water balance survey and documentation must address all water onsite, including storm water, process water, and waste water.</p> <p>Provide a paper and electronic copy of the water balance survey to the Regional Water Board.</p> <p>Based on the results of the above-described survey, revise storm water sampling locations, and update Facility maps and monitoring plan accordingly. Provide a paper and electronic copy of all related documents to the Regional Water Board.</p>
---

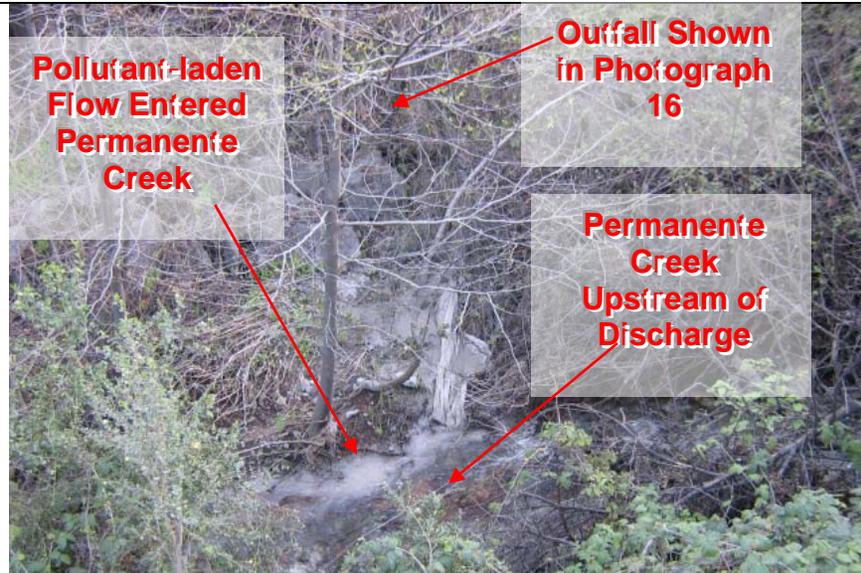
As a result, there was an active pollutant-laden discharge during the inspection. Because Pond 17 was not functioning as an adequate BMP for pollutant removal, either the pond must be modified to provide additional filtering and settling of pollutants, or adequate BMPs must be implemented for the pollutant generating sources at the Rock Plant to reduce pollutant conveyance to the pond, and prevent the subsequent discharge of pollutants to Permanente Creek.

Photograph 17 – Pollutant-laden discharge to Permanente Creek from Pond 17.

<p>VIOLATION Observed discharge of pollutants to waters of the state</p> <p>REQUIRED CORRECTIVE ACTIONS By <b>April 15, 2010</b>, select, install, implement, and maintain BMPs to meet BAT and BCT to eliminate discharge of pollutants from Pond 17 into Permanente Creek.</p> <p>In order to come into compliance, you may need to implement temporary BMPs and later come back in and implement more permanent measures.</p> <p>Revise the Facility's SWPPP to document updates, and submit a paper and electronic copy to the Regional Water Board.</p>
--

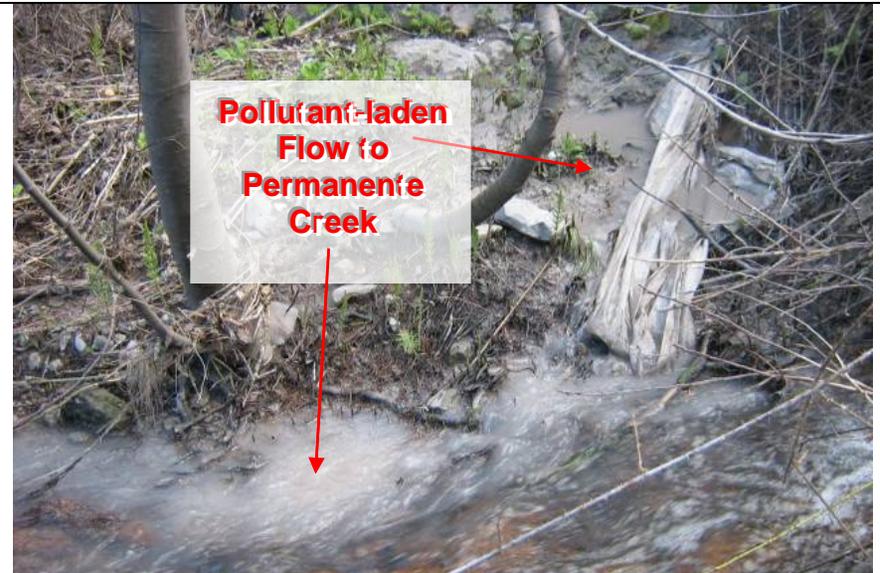
Photograph 18 – Close-up view of pollutant-laden discharge to Permanente Creek from Pond 17.

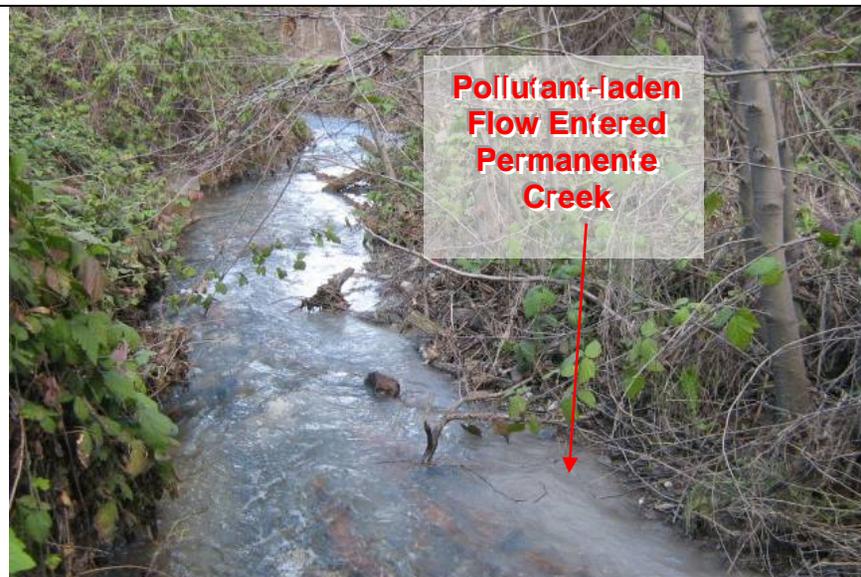
Photograph 19 – View downstream along Permanente Creek.

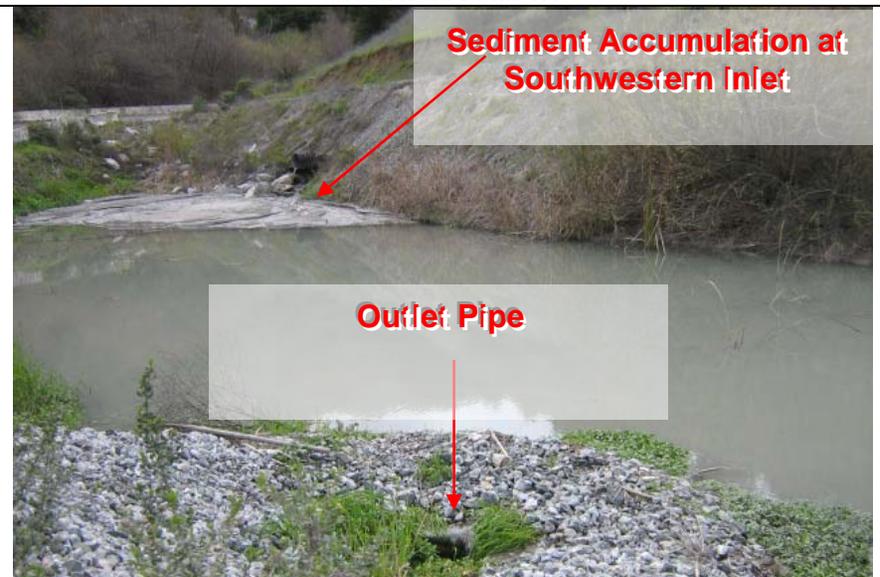
Sediment accumulation was present at the southwestern inlet to Pond 9, and sediment was being actively conveyed from the Rock Plant Road to the southwestern inlet to Pond 9 (see attached Photographs 20 and 21). Sediment-laden water was present in Pond 9, and erosion was observed at the northeastern inlet which lacked flow dissipation BMPs (see attached Photograph 22). As specified in Figure 2 of SWPPP 14, the Pond 9 outlet is connected to an outfall to Permanente Creek, denoted as the SL-17 PD sample collection location (see attached Photographs 23 and 24).

Photograph 20 – Sediment conveyed from the Rock Plant Road to the southwestern inlet to Pond 9.

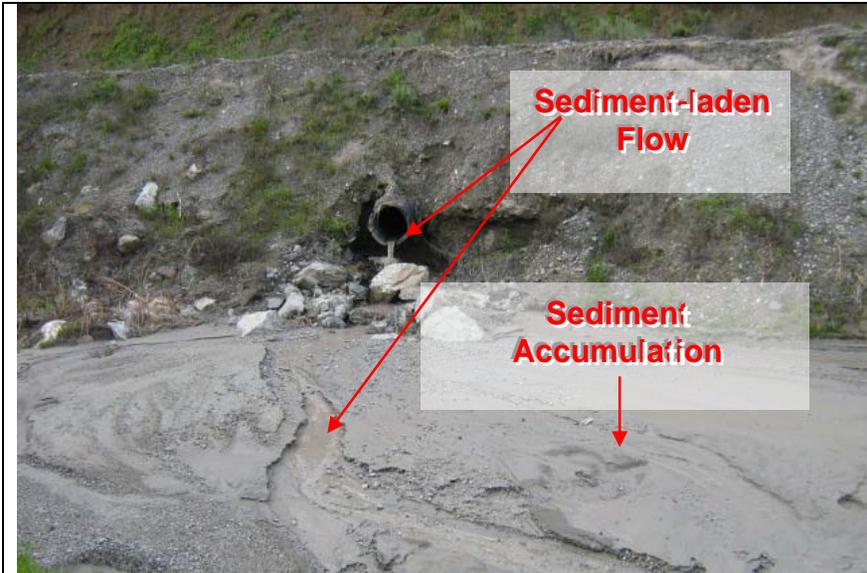
Photograph 21 – Close-up view of sediment conveyed from the Rock Plant Road to the southwestern inlet to Pond 9.

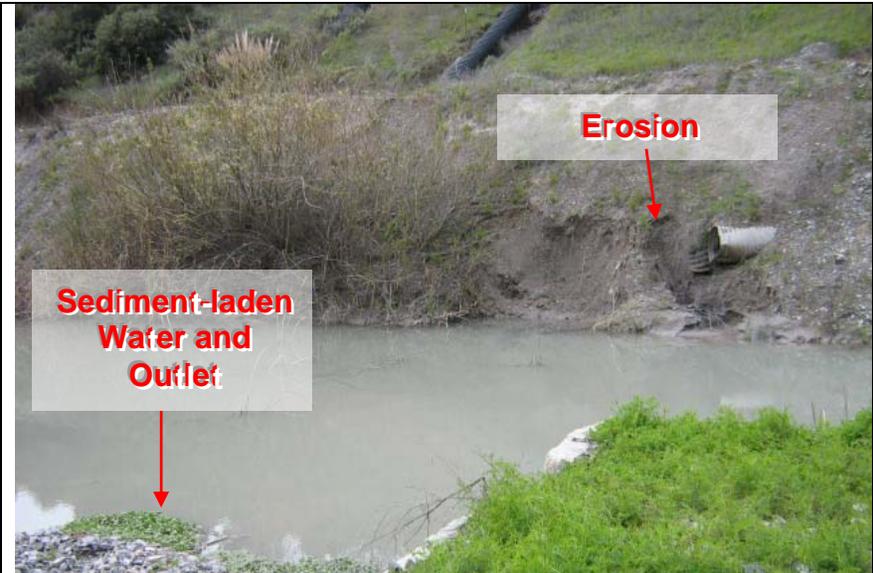
Photograph 22 – Erosion at the northeastern inlet which lacked flow dissipation BMPs.

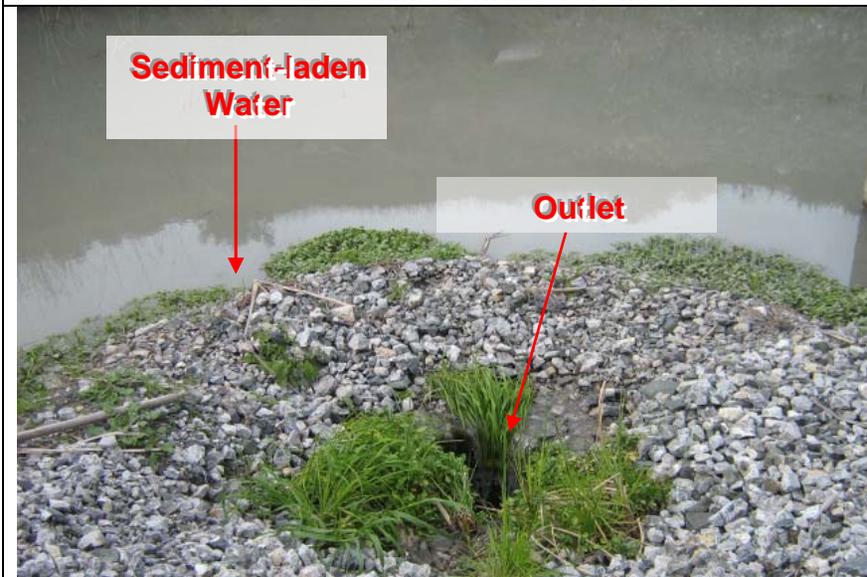
Photograph 23 – Close-up view of Pond 9 outlet.

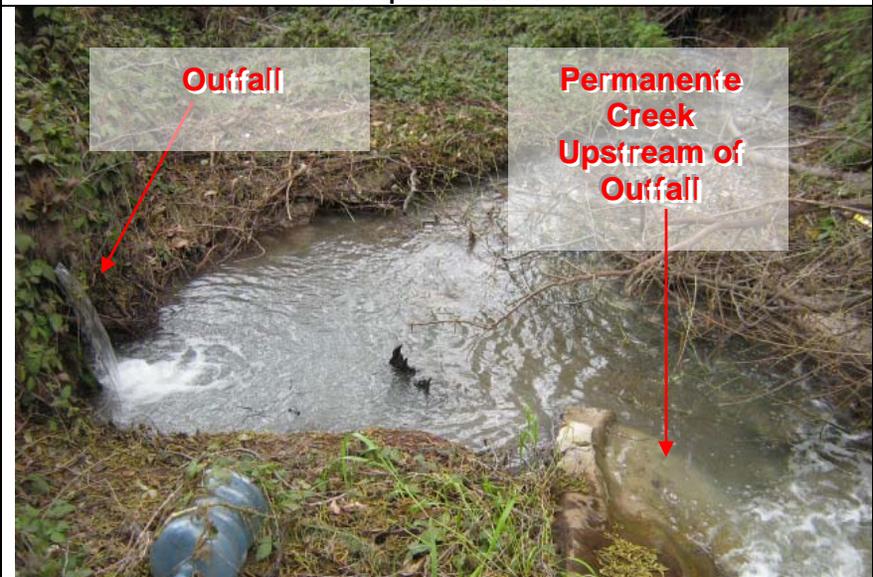
Photograph 24 – Outfall to Permanente Creek from Pond 9, denoted as the SL-17 PD sample collection location.

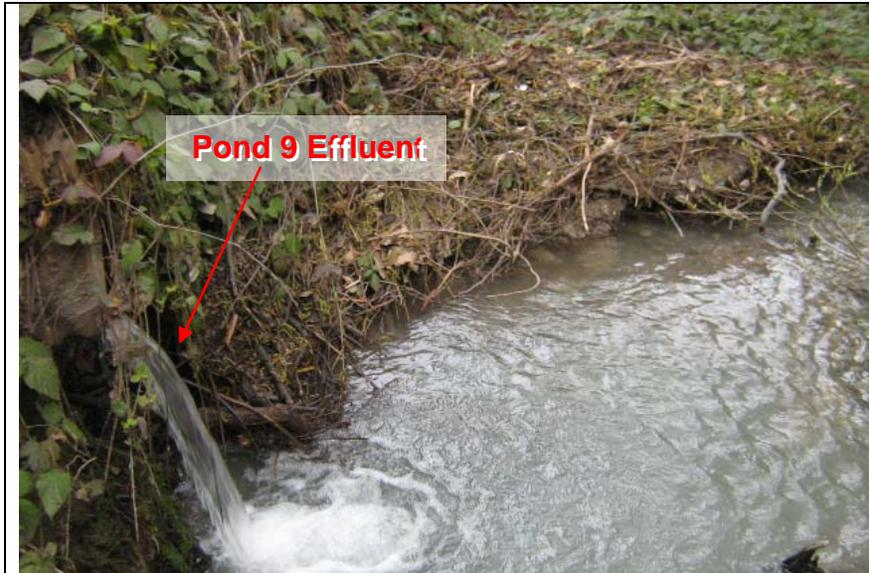
Photograph 25 – Close-up view of outfall from Pond 9.

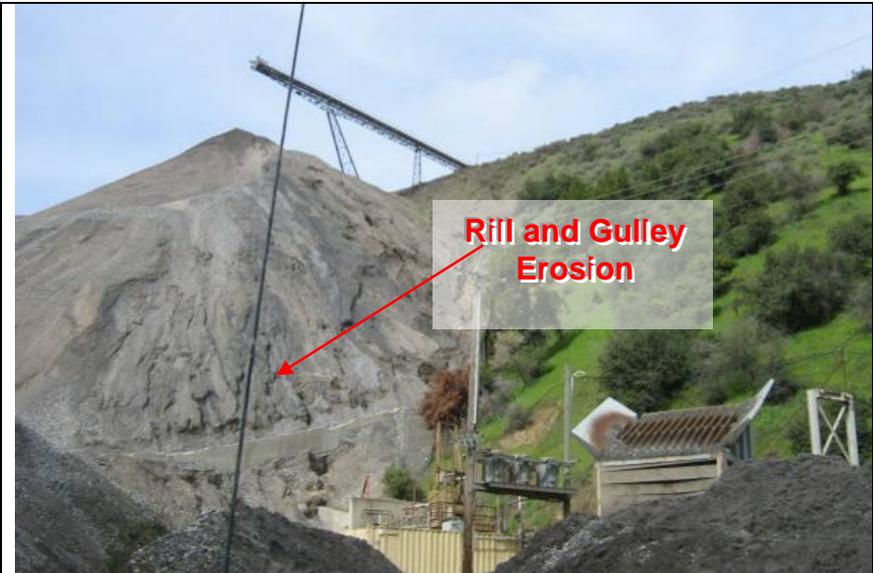
Evidence of slope erosion was observed at an area known as the Rock Pile, including gully formation on the Rock Pile slope (see attached Photograph 26). Sediment accumulation in the sediment trap at the

**Rill and Gully Erosion**

Photograph 26 – Area known as the Rock Pile along Rock Plant Road.

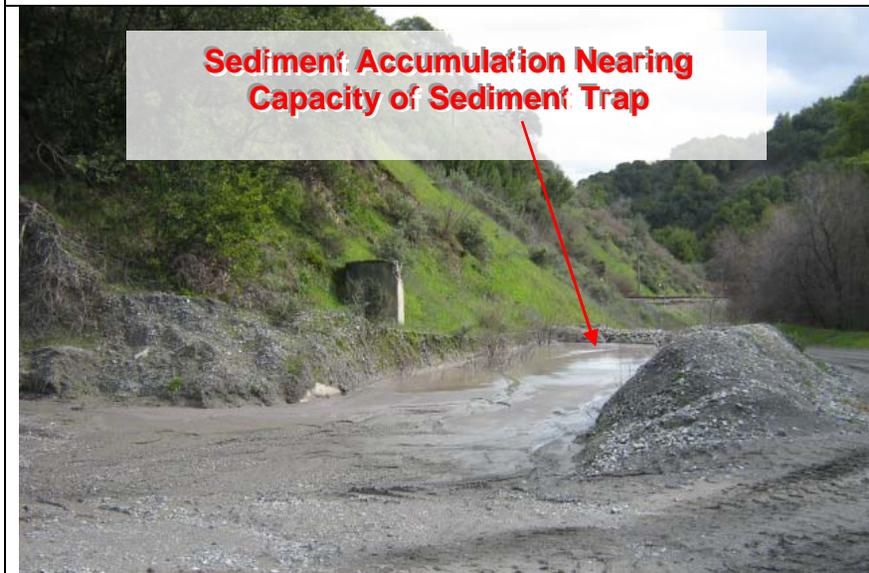
base of the Rock Pile was nearing the capacity of the BMP (see attached Photograph 27). Subsequent down-gradient sediment traps along Rock Plant Road were also nearing capacity due to sediment accumulation (see attached Photographs 28 and 29). Sediment-laden flow was observed bypassing the sediment trap BMPs and flowing down the roadway (see attached Photograph 29), potentially contributing to the sediment loading in Pond 9 (as described in Finding 4, above).

**Sediment Accumulation Nearing Capacity of Sediment Trap**

Photograph 27 – Sediment trap BMP at the base of the Rock Pile along Rock Plant Road.

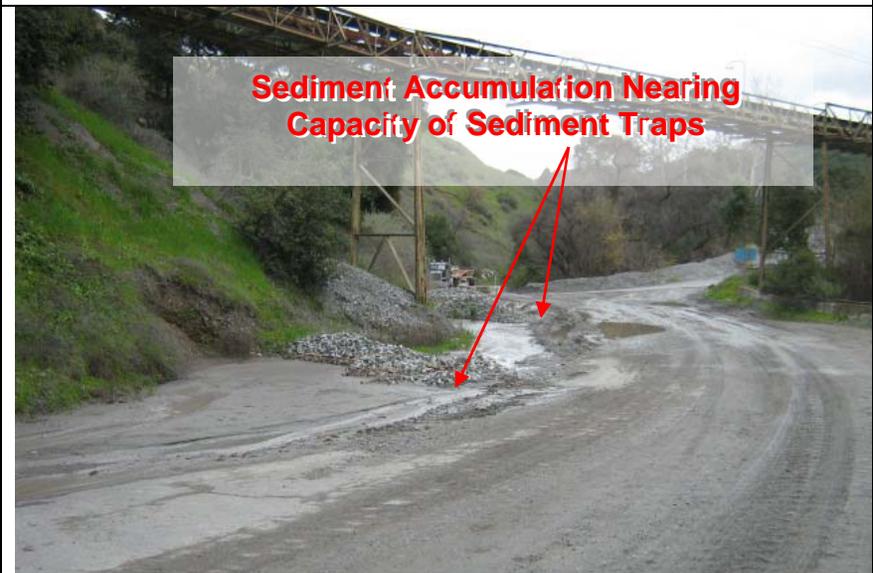
**Sediment Accumulation Nearing Capacity of Sediment Traps**

Photograph 28 – Subsequent down-gradient sediment traps along Rock Plant Road, nearing capacity due to sediment accumulation.

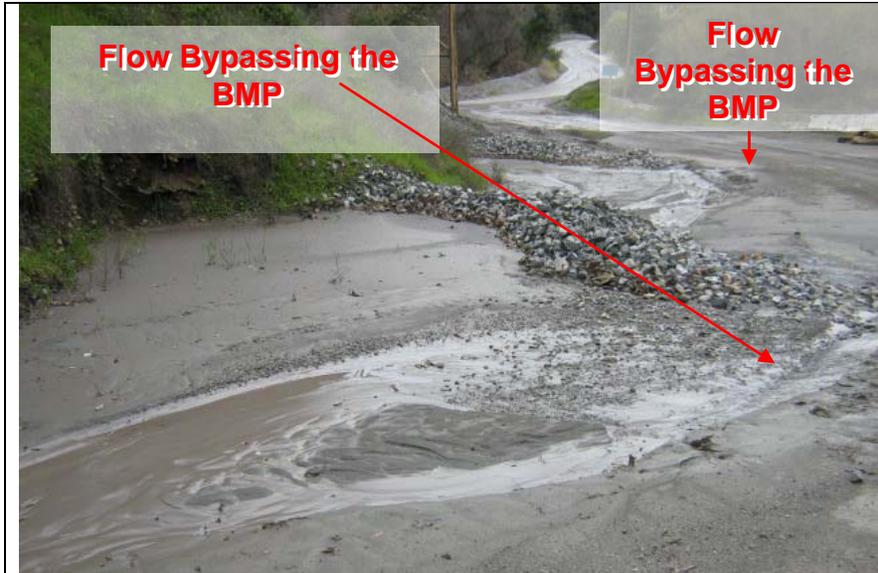
Photograph 29 – Close-up view of sediment traps shown in Photograph 28.

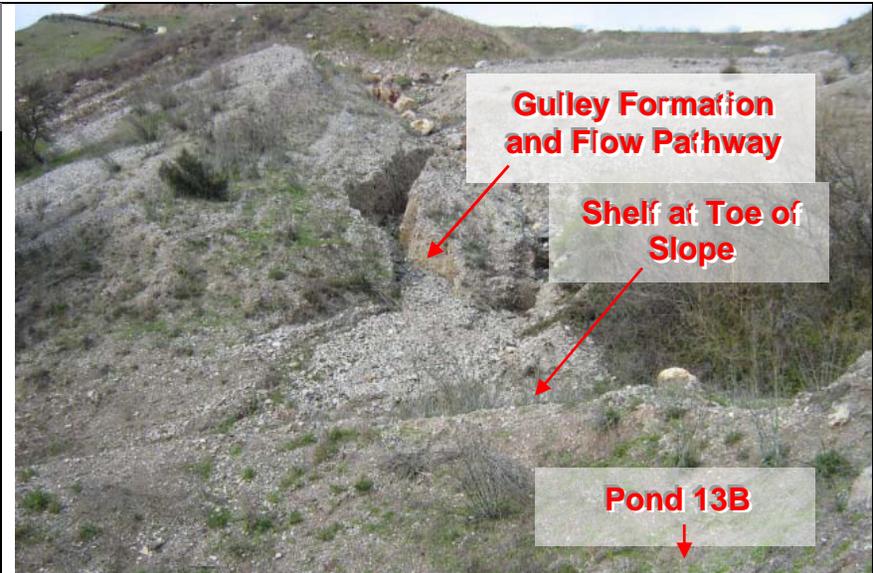
6. The EPA Contract Inspector observed, during the inspection, that adequate BMPs were not implemented to prevent the discharge of sediment from a disturbed slope located northwest of Pond 13B. Evidence of slope erosion and concentrated flow was observed northwest of Pond 13B, including gully formation (see attached Photographs 30 and 31). A shelf at the toe of the slope would prevent flow from entering Pond 13B; instead directing flow events toward Pond 13, an instream sediment control pond (see attached Photographs 30 through 33).

Photograph 30 – Slope erosion northwest of Pond 13B.

- Hillside above ponds 13A and 13B - provide information on when the half culvert running from top of the hillside will be repaired – scheduled dry season 2010.

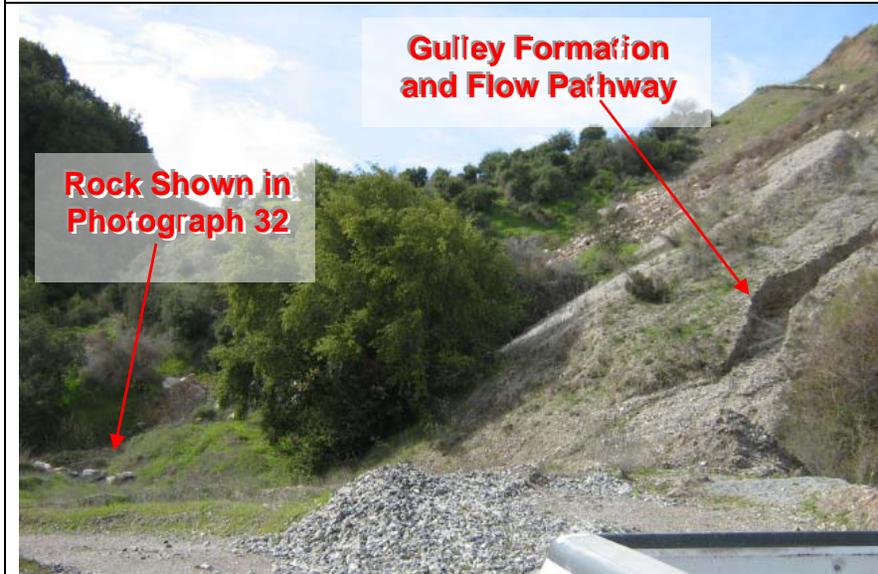
Photograph 31 – Slope erosion northwest of Pond 13B.

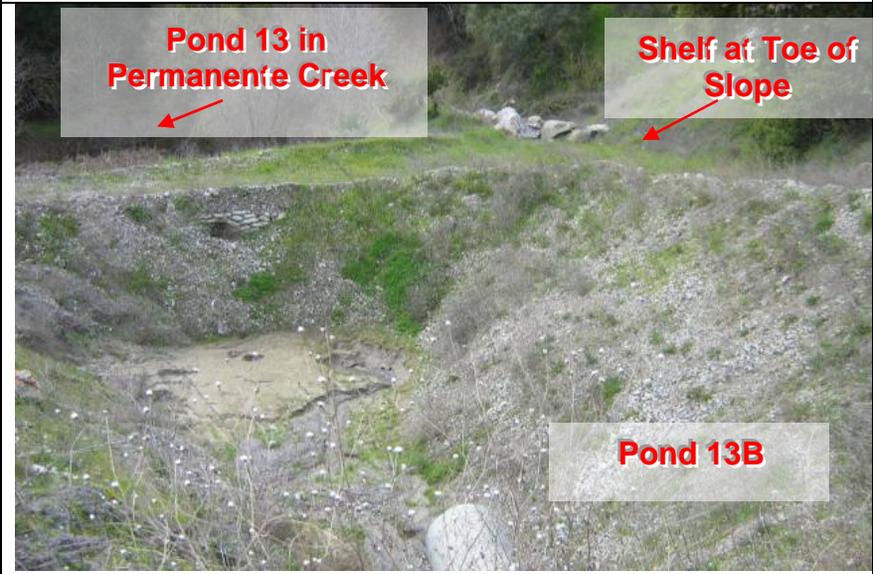
Photograph 32 – View down-gradient of slope erosion.

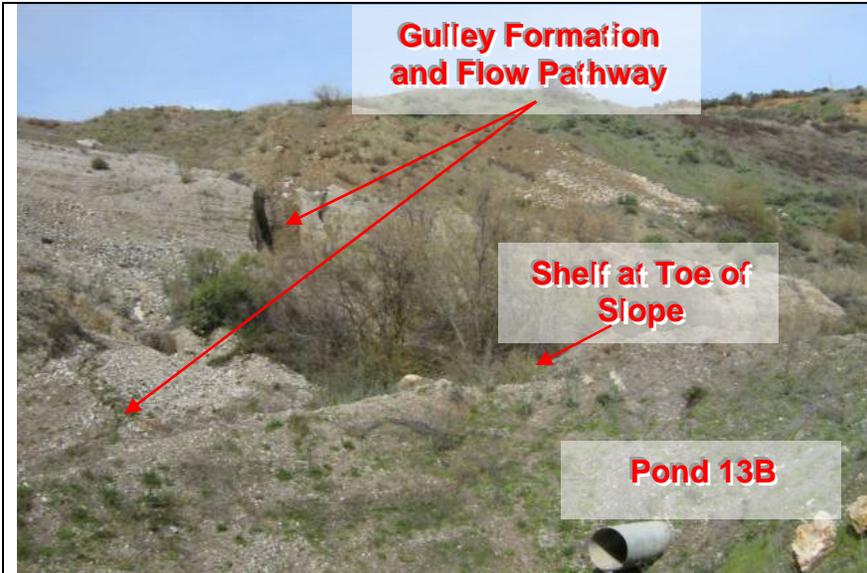
Photograph 33 – Different view of slope erosion northwest of Pond 13B.

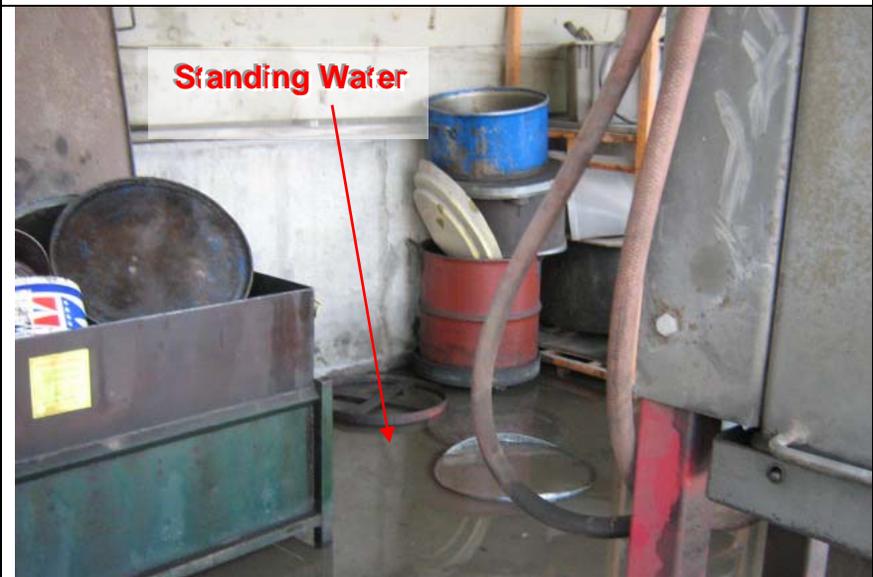
7. The EPA Contract Inspector observed, during the inspection, that adequate Material Handling and Storage BMPs were not implemented to minimize exposure of significant materials to storm water at the vehicle and equipment maintenance shop located in the northeast corner of the Rock Plant (see attached Photograph 35). Automotive lubricants and other chemicals were stored in standing water at the chemical storage area (see attached Photographs 36 through 39).

Photograph 36 – View of standing water present in chemical storage area.

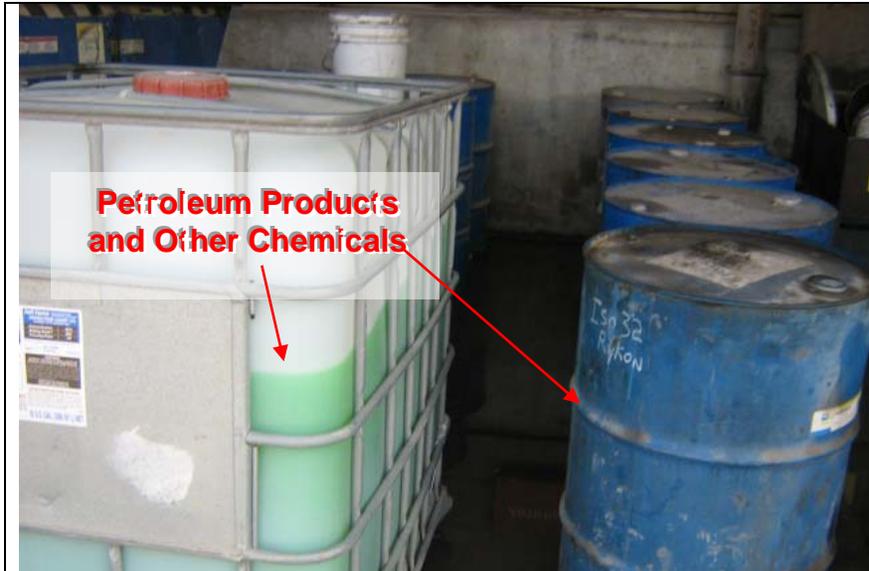
**Petroleum Products  
and Other Chemicals**

**Standing Water**

Photograph 37 – Automotive lubricants and other chemicals stored in standing water.

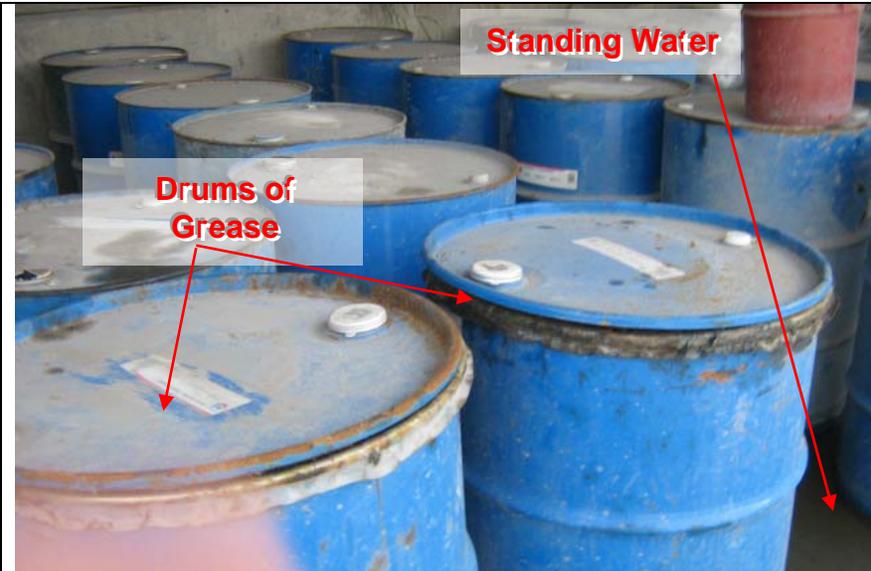
**Drums of  
Grease**

**Standing Water**

Photograph 38 – Automotive lubricants and other chemicals stored in standing water.

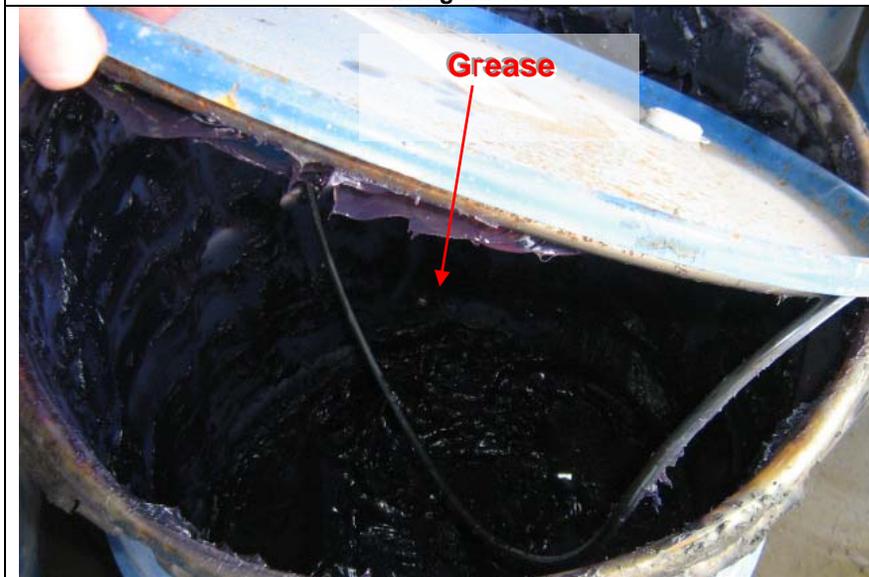
**Grease**

Photograph 39 – View of drum contents shown in Photograph 38.

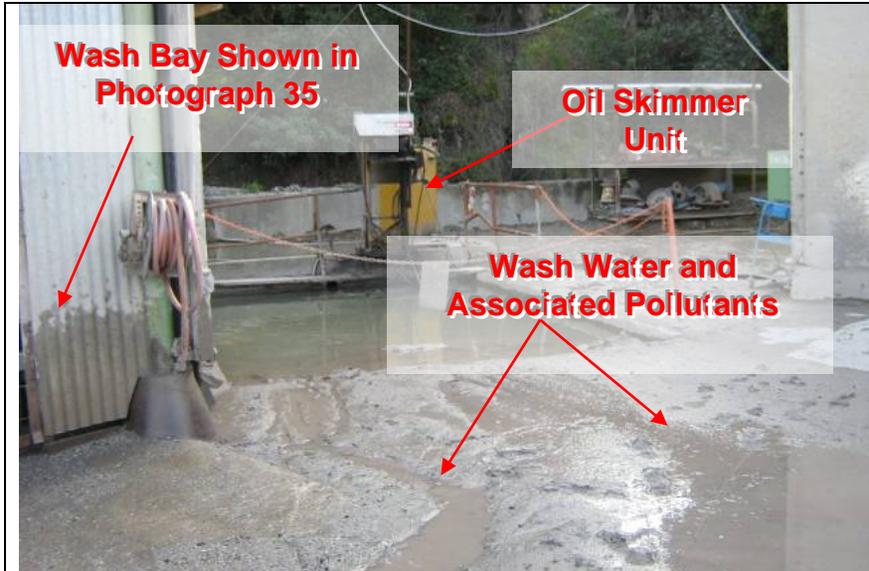
8. The EPA Contract Inspector observed, during the inspection, that adequate Material Handling and Storage BMPs were not implemented to minimize exposure of significant materials to storm water and non-storm water sources at the vehicle and equipment wash bay located in the northeast corner of the Rock Plant. Vehicle and equipment wash water and associated pollutants were actively flowing into an oil skimmer unit located outside the wash bay (see attached Photographs 35 and 41).

As a result of the Permittee’s SOP described in an e-mail dated February 24, 2010, there was a potential for wash water and associated pollutants “to be discharged after inspection for oil sheen or other contaminants.” The SWPPP must be updated to identify the wash bay as a potential non-storm water pollutant source. Moreover, non-storm water discharges that do not meet the conditions provided in Special Conditions D are prohibited under Section A.6.a.v of the Permit. If the discharge of wash water occurs as indicated in the Permittee’s SOP (described in the e-mail dated February 24, 2010), the unauthorized non-storm water discharge must either be eliminated or a separate permit must be obtained.

Photograph 41 – Vehicle and equipment wash water was actively flowing into an oil skimmer unit located outside the wash bay.

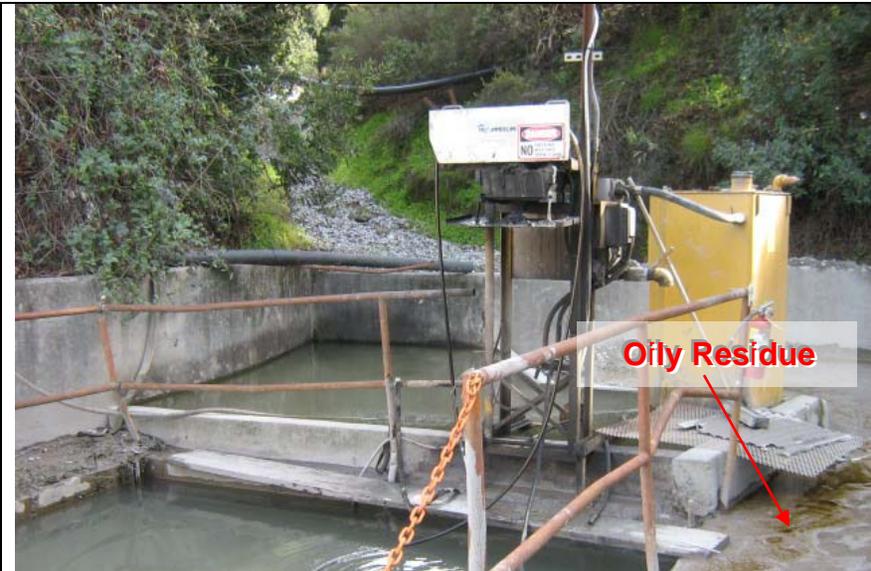
Photograph 42 – View of oily residues near the skimmer unit.

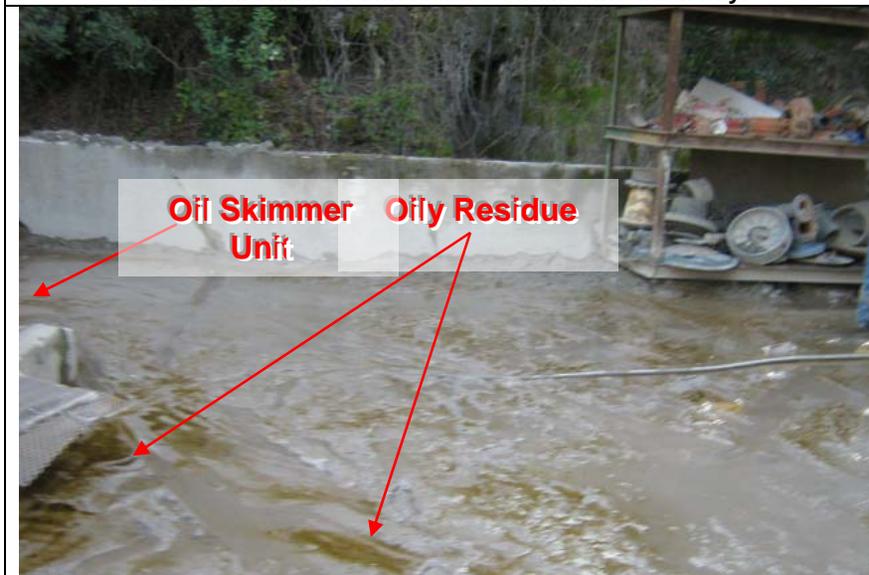
Photograph 43 – View of oily residues near the skimmer unit.

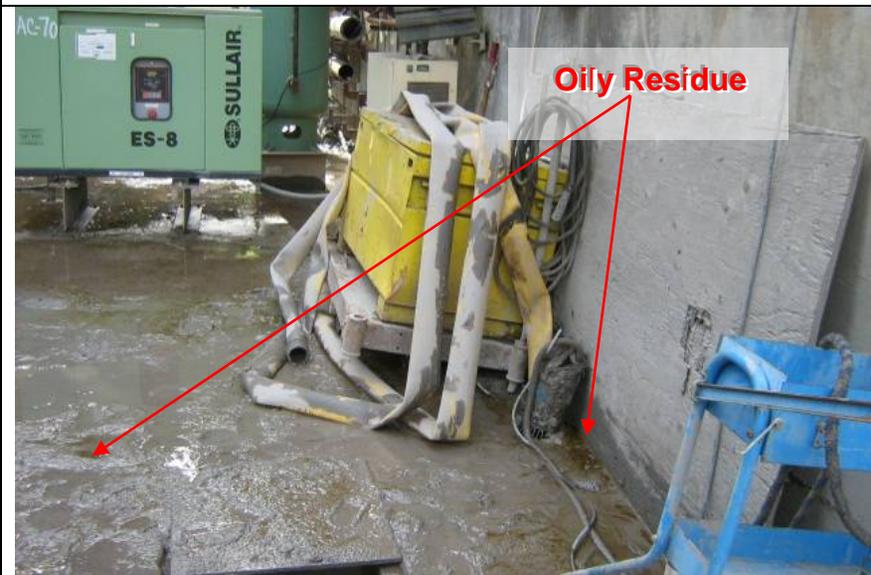
Photograph 44 – View of oily residues near the skimmer unit.

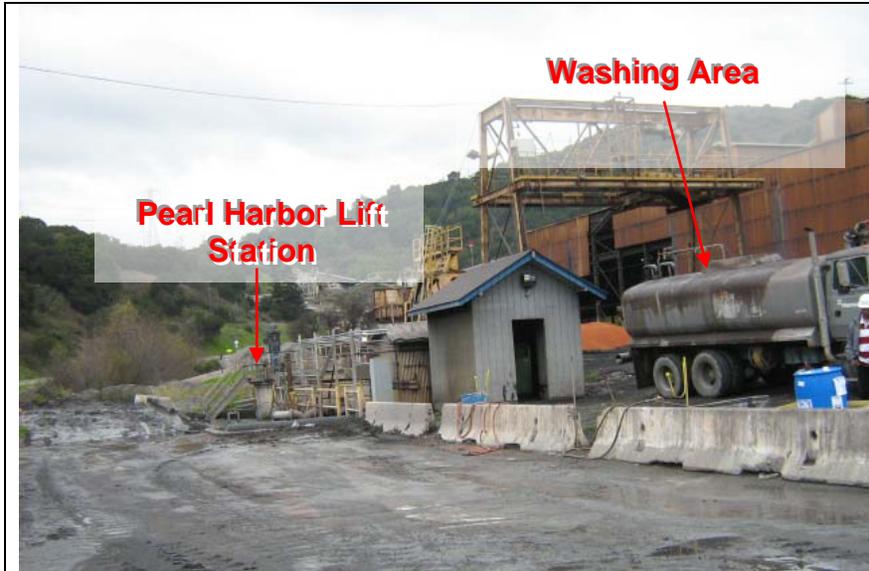
9. The EPA Contract Inspector observed, during the inspection, that adequate Material Handling and Storage BMPs were not implemented to minimize exposure of cleaning materials to storm water and non-storm water sources at the vehicle and equipment washing area located near the Pearl Harbor lift station in the eastern portion of the cement plant (see attached Photograph 45).

Photograph 45 – Vehicle and equipment washing area located near the Pearl Harbor lift station in the eastern portion of the cement plant.

- Pearl Harbor/equipment wash area - why were empty poly drums being stored there and why was the housekeeping in the area deficient – The operator who delivered the new wash aid did not immediately and properly dispose of empty container.

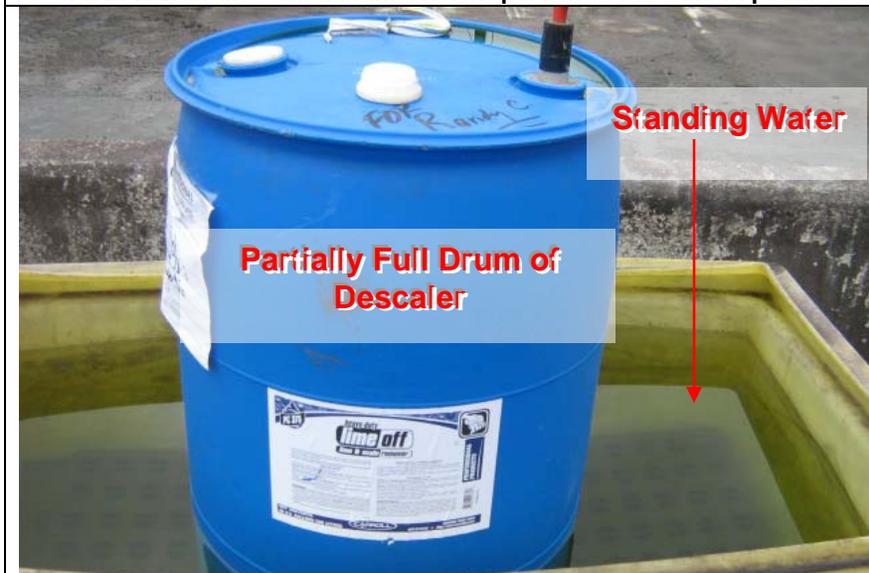
Photograph 47 – Drum of acidic descaler stored in standing water.

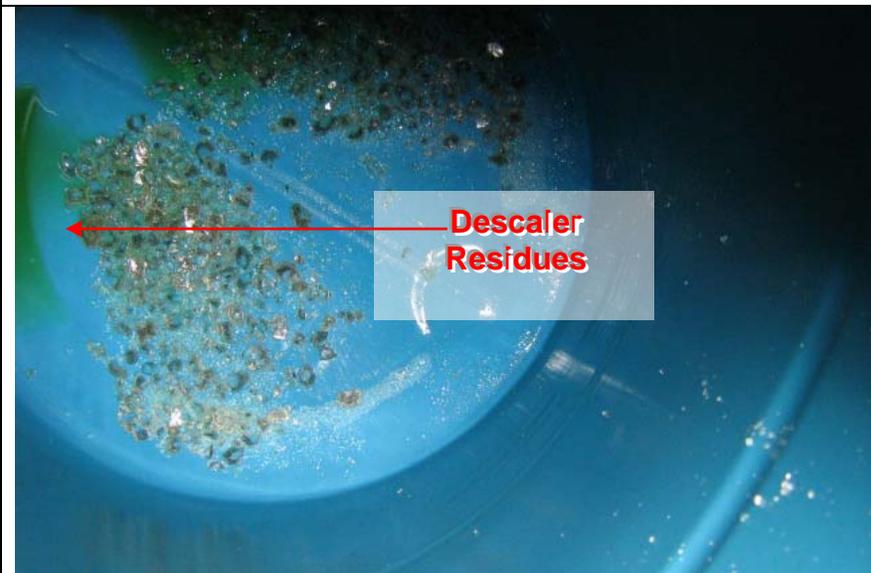
Photograph 48 – Drum containing acidic descaler residues was stored without the drum bung intact.

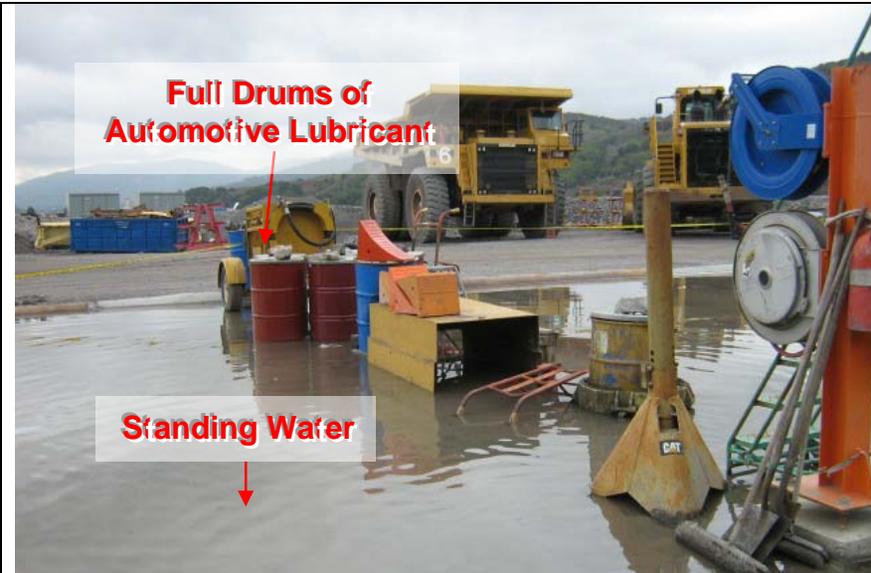
Full drums of petroleum-based automotive lubricants were stored in standing water at the concrete pad (see attached Photographs 50 through 52). In addition, an open waste container used for hazardous wastes (e.g., oil soaked rags, etc.) had accumulated standing water inside (see attached Photographs 53 and 54). As a result of these material storage practices and the standing water near the capacity of the concrete pad (see attached Photographs 49 and 55), there was a potential for the contribution of pollutants to storm water and the subsequent release of pollutants from the concrete pad.

Photograph 50 – Petroleum-based automotive lubricants and other chemicals stored in standing water.
