**Attachment 1**  
**February 10, 2010**  
**Inspection Findings,**  
**Violations, and**  
**Corrective Actions**

## Industrial Storm Water Inspection Report

Permittee: Lehigh Southwest Cement, Co. (formerly Hanson Permanente Cement)	WDID No. <b>2 43I006267</b>	Date: 2/10/2010
Facility: Lehigh Southwest Cement, Co.	SIC Code: 3241 – Cement, Hydraulic	Receiving Water: Permanente Creek
Facility Address: 24001 Stevens Creek Boulevard; Cupertino (Santa Clara County), California		
Facility Representative(s)/Title(s): Scott Renfrew (Environmental Manager, Lehigh Southwest Cement, Co.), Wilbur Green (Environmental Engineer, Lehigh Southwest Cement, Co.), Henrik Wesseling (Plant Manager, Lehigh Southwest Cement, Co.)		
Additional persons present: None	Inspector(s): Scott Coulson (PG Environmental, LLC)

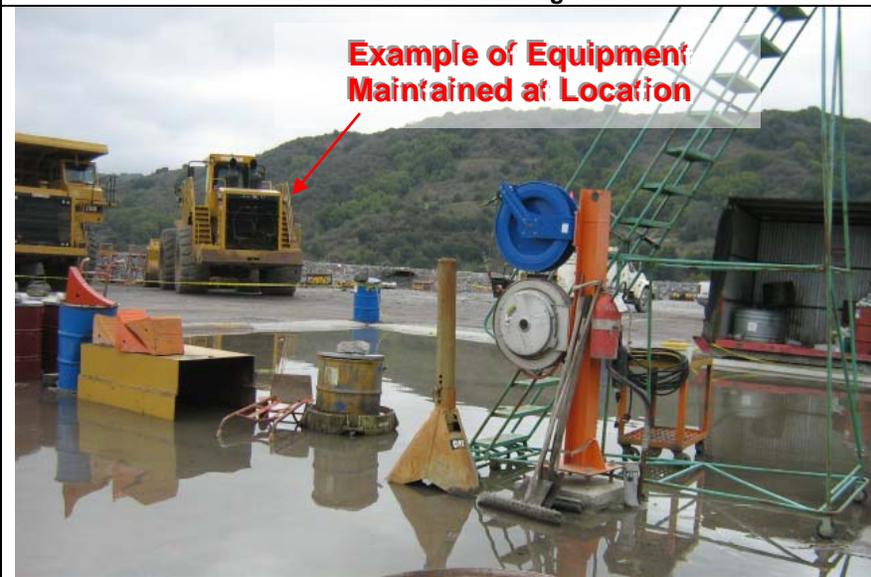
Full drums of petroleum-based automotive lubricants were stored in standing water at the concrete pad (see attached Photographs 50 through 52). In addition, an open waste container used for hazardous wastes (e.g., oil soaked rags, etc.) had accumulated standing water inside (see attached Photographs 53 and 54). As a result of these material storage practices and the standing water near the capacity of the concrete pad (see attached Photographs 49 and 55), there was a potential for the contribution of pollutants to storm water and the subsequent release of pollutants from the concrete pad.

Photograph 52 – Standing water on heavy equipment maintenance pad.

- Quarry shallow secondary containment area of equipment repair area - provide information on where this water will be pumped – This water will be transferred to a separator tank, the separated hydrocarbon will be sent offsite for disposal as a non-RCRA California Haz Waste. The SOP to keep the area free of oily residue will allow for water to be discharged after inspection for oil sheen or other contaminants. Water will be filtered prior to discharge.

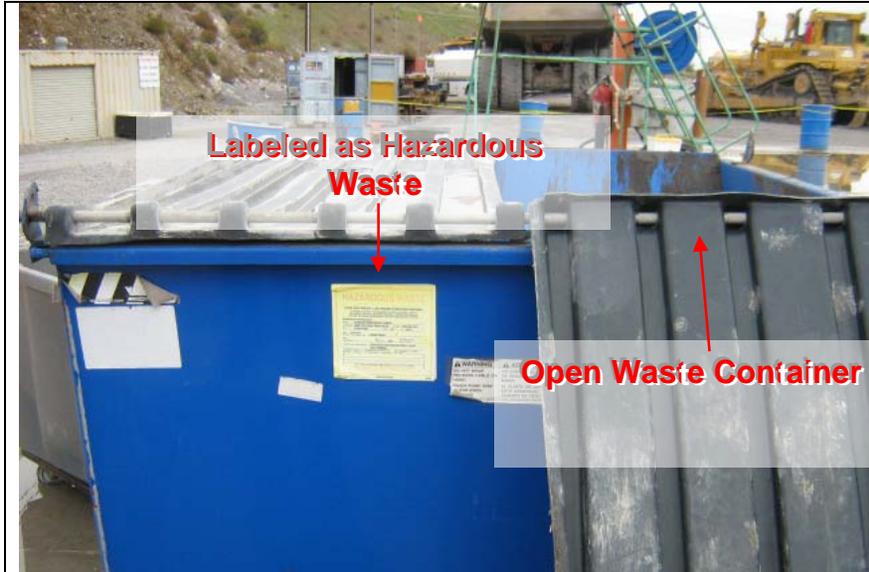
Photograph 53 – Open waste container for hazardous wastes (e.g., oil soaked rags).

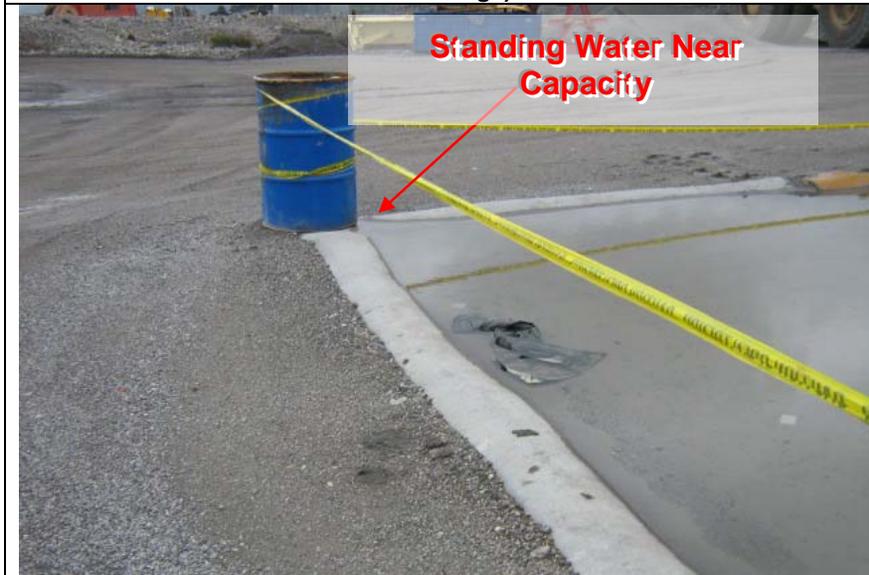
Photograph 55 – Standing water near the capacity of the concrete pad.

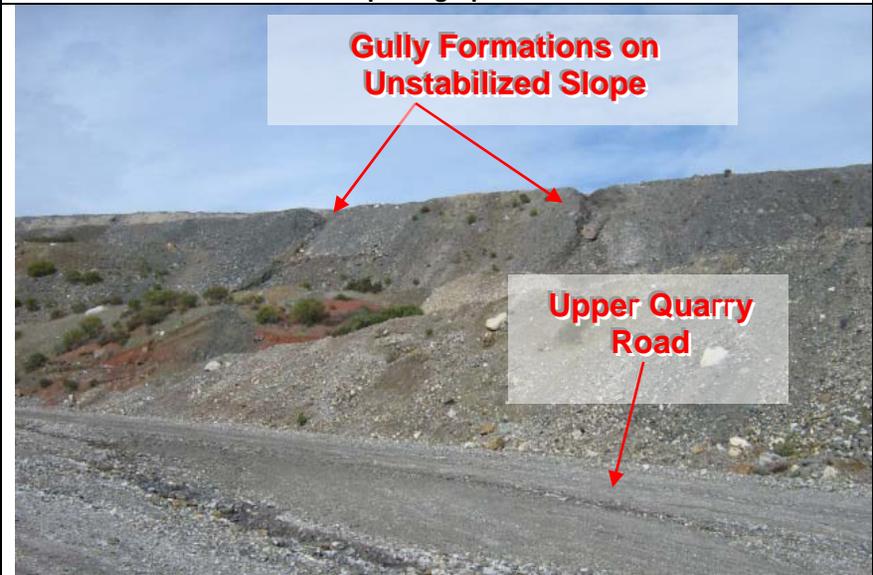
11. The EPA Contract Inspector observed, during the inspection, that adequate BMPs were not implemented to prevent the discharge of sediment from the unstabilized Upper Quarry Road, roadway shoulder, and associated cut and fill slopes located approximately 0.5 miles southeast of the West Material Storage Area (see attached Photograph 56).

The slope near the intersection of Upper Quarry Road and an access road leading northeast, showed erosion, including gully formation (see attached Photographs 56 and 57), fine sediment accumulation at the toe of the slope (see attached Photograph 58), and slope failure (see attached Photograph 59).

Photograph 56 – Unstabilized areas along the Upper Quarry Road approximately 0.5 miles southeast of the West Material Storage Area.

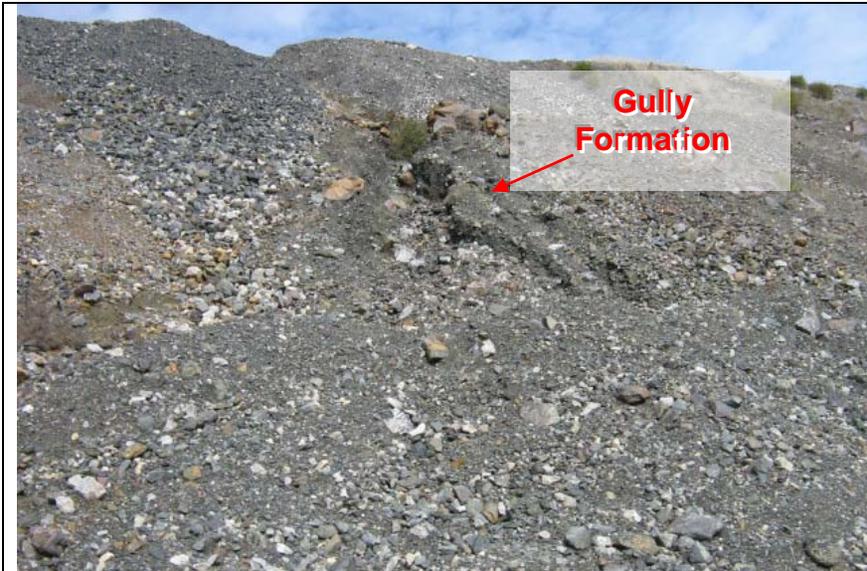
**Gully Formation**

Photograph 57 – Close-up view of a gully formation on unstabilized slope shown in Photograph 56.

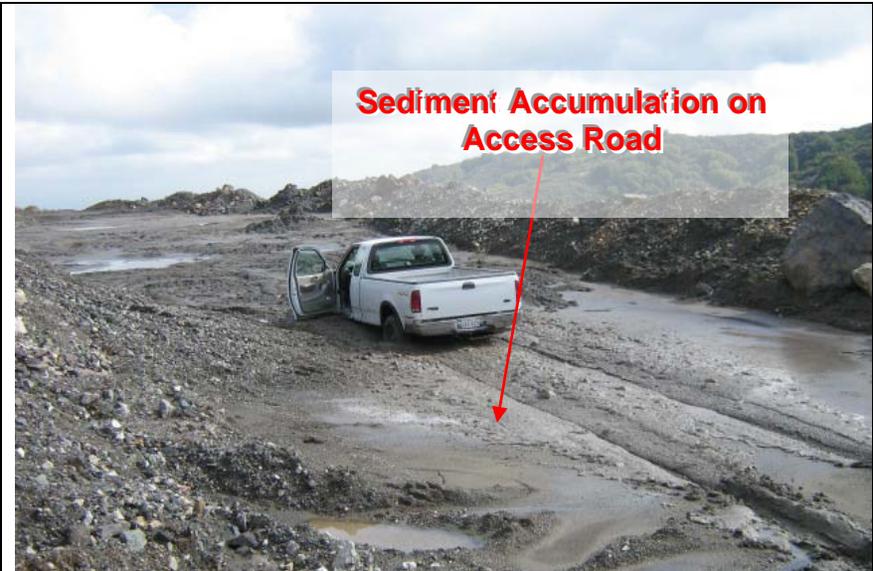
**Sediment Accumulation on Access Road**

Photograph 58 – View of fine sediment accumulation at toe of unstabilized slope shown in Photographs 56 and 57.

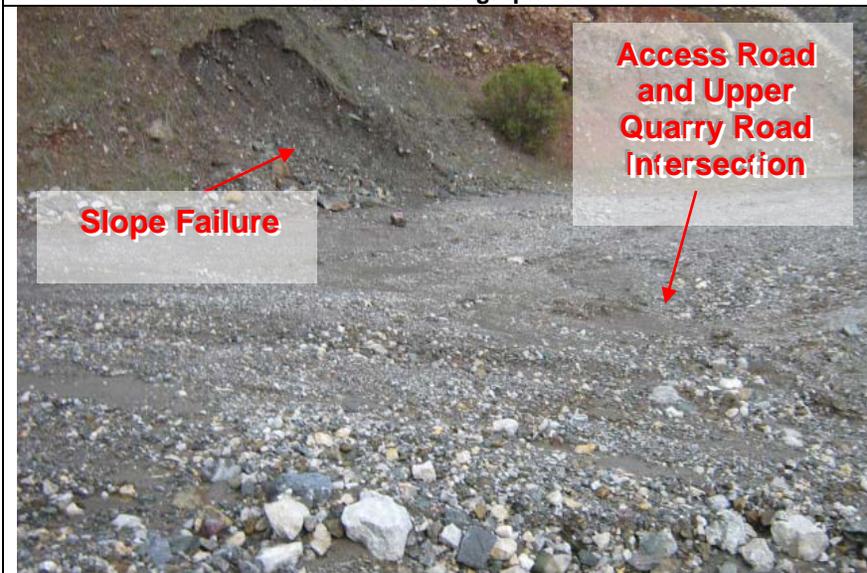
**Slope Failure**

Photograph 59 – View of slope failure at intersection of access road and Upper Quarry Road.

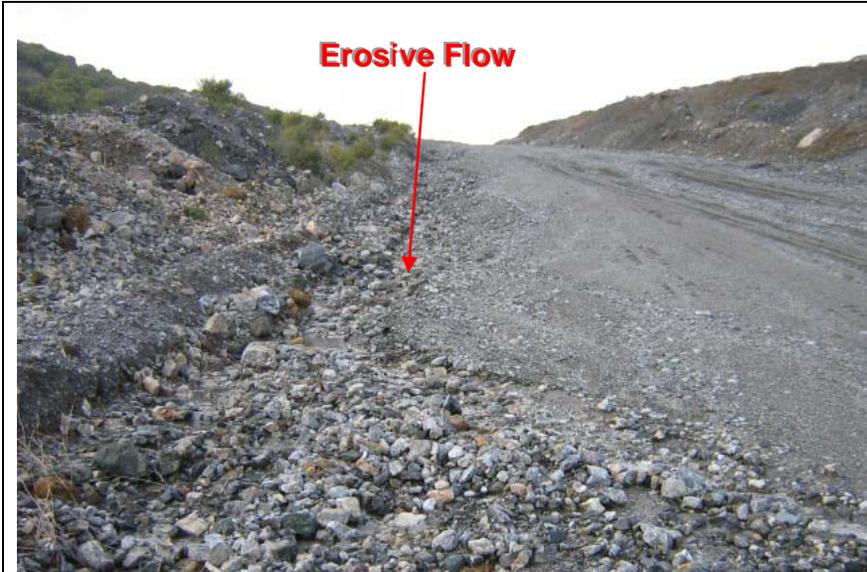
In addition, flow dissipation BMPs had not been implemented in the roadway drainage ditches, and erosive flow was observed running down the surface of Upper Quarry Road without proper grade to direct flows into the drainage ditches (see attached Photographs 60 through 62). As a result, there was a potential for the discharge of sediment to the active Quarry Pit. Furthermore, the unstabilized Upper Quarry Road, roadway shoulder, and associated cut and fill slopes are a potential source of the elevated total suspended solids results (47,200 mg/L) at the SL-6-RD sample location on January 18, 2010. Adequate BMPs must be implemented to prevent the discharge of sediment from the unstabilized Upper Quarry Road, roadway shoulder, and associated cut and fill slopes to the active Quarry Pit.

Photograph 61 – Erosive flow in drainage ditch lacking flow dissipation BMPs.

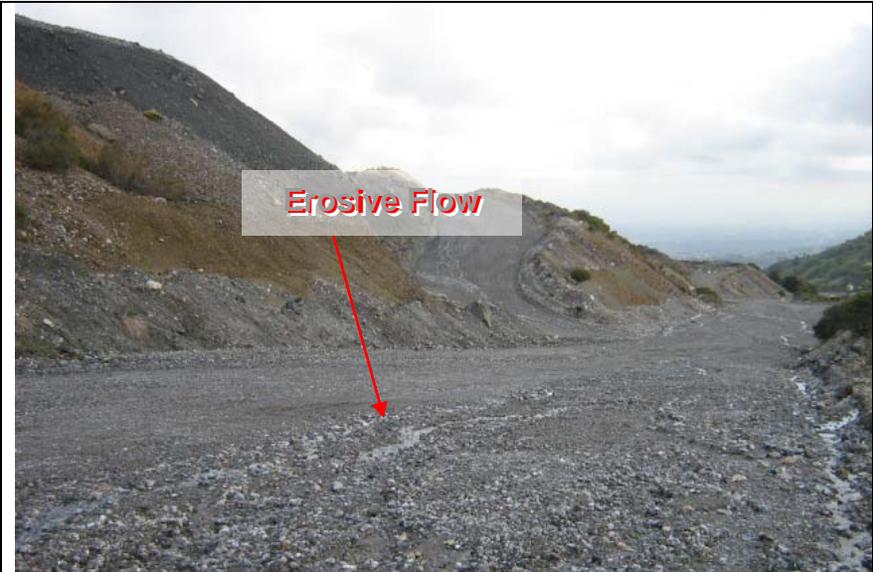
Photograph 62 – Erosive flow not directed to drainage ditch.
