Lehigh Southwest Cement Company

Subject: Re: NOTICE OF VIOLATION and required corrective action for failure to protect stormwater at industrial facility

Facility: Lehigh Southwest Cement Co. (formerly Hanson Permanente Cement) Industrial facility, located at 24001 Stevens Creek Boulevard, Cupertino, Santa Clara County
WDID No. 2 4310062677

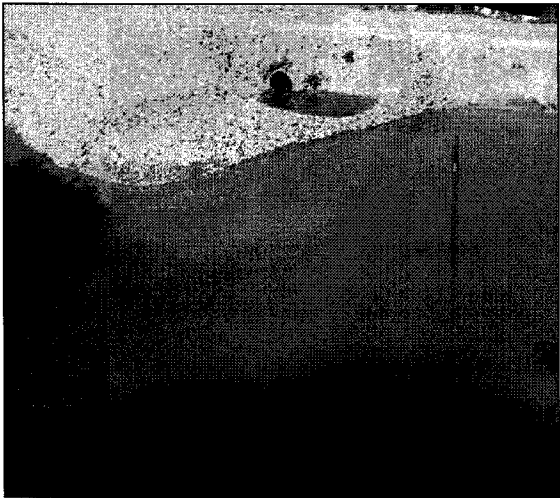
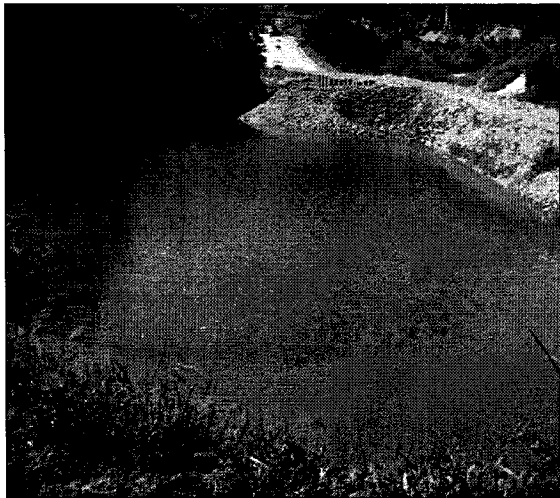
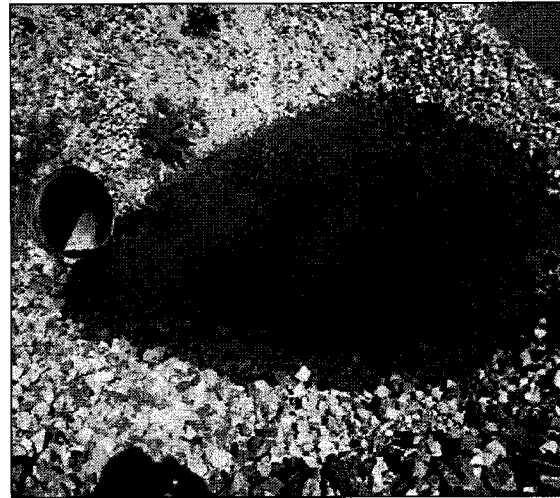
Pond 17 was cleaned out in the 2009 dry season, consistent with past practice. The frequency and intensity of the storms in late January/early February 2010 led Pond 17 to be completely filled with sediment just prior to the February inspection. The February 10th, 2010 inspection occurred before any pond sediment removal activities could be completed after conditions allowed following the most recent storm. However, these pond sediment removal activities were initiated on February 16th and completed on February 19th, 2010. As is consistent with all pond sediment

Pond 17 was completely cleaned out with the sediment removed and, as a function of stormwater quality, currently produces a very clean discharge. Please see the pictures below, reflecting post-cleanout Pond 17 water quality.

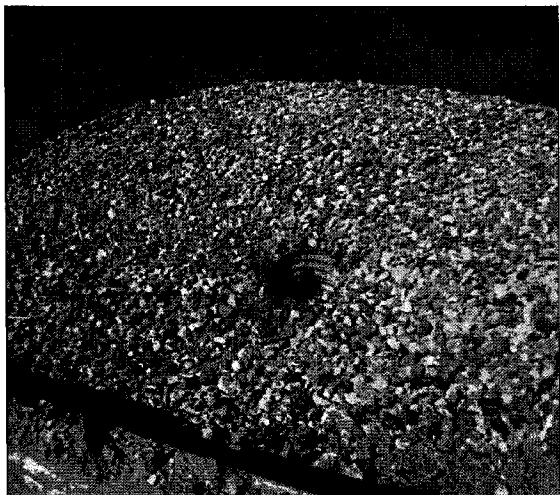
Lehigh Response: Pond 9 receives stormwater that come into contact with aggregate customer bulk trucks and plant mobile equipment. The pond is designed to retain this storm water allowing potential sediment to dropout before moving to the discharge standpipe. Additionally, the pond structures a limestone material around the discharge standpipe for further sediment control and water "polishing" prior to discharge. The recent frequency and intensity of the storms in late January / early February 2010 resulted in the inlet of Pond 9, only one of the five roadway inlets, to be filled with sediment. Pond 9 was inspected late in January and, at that time, was holding up well. At the time of the inspection the pond still retained retention capacity to allow for sediment dropout. However, it was noted that the limestone filter material had fallen away during the most recent storms prior to the February 10th, 2010 inspection.

Because of contractor scheduling delays and storm events the scheduled Pond 9 clean out will be carried out the week of April 19, 2010.
