SURFACE MINING INSPECTION REPORT

I. Mine Name as reported by Operator on Mining Operation Annual Report Permanente Quarry	Inspection Date: August 25, 2011	CA MINE ID#: 91 - 43 - 0004
---	-------------------------------------	--------------------------------

Re: 2011 SMARA Mine Inspection
CPO File 2250-13-66-09PAM (Permanente Road)
Permanente Quarry, 91-43-0004
Cupertino, California

2011 SMARA Inspection Photos

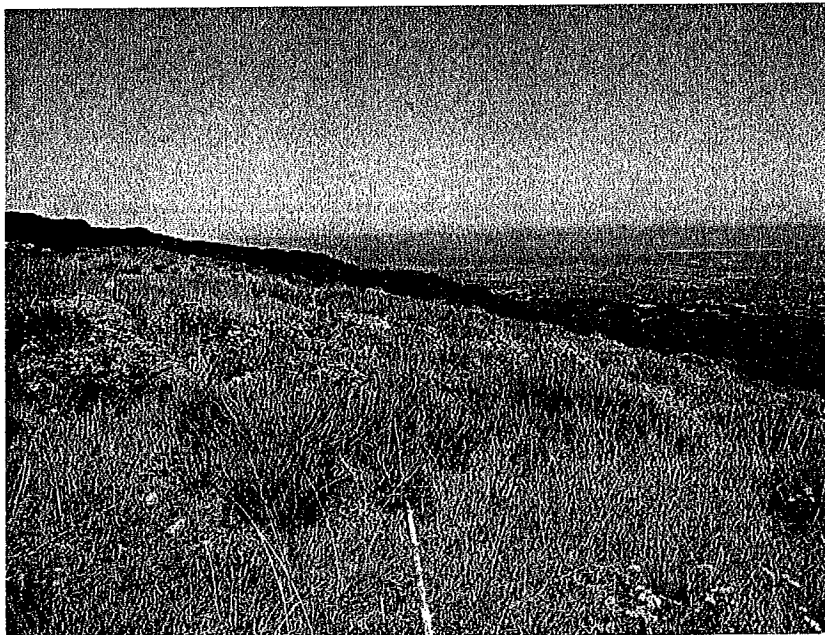
Photo 1: Re-vegetated north slope of West Material Storage Area (WMSA) at Permanente Quarry, looking northwest. Dated August 25, 2011. Compare to photo 1 in 2008, 2009 and 2010 inspection reports.

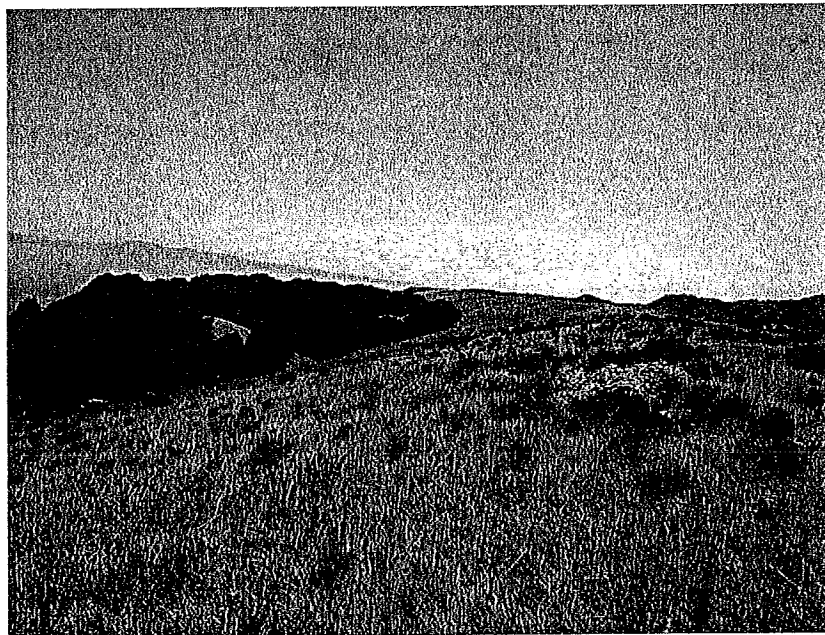
Photo 2: Looking east at re-graded and re-vegetated north slope of the WMSA. Dated August 25, 2011. Compare to photo 2 in 2008, 2009 and 2010 inspection reports.

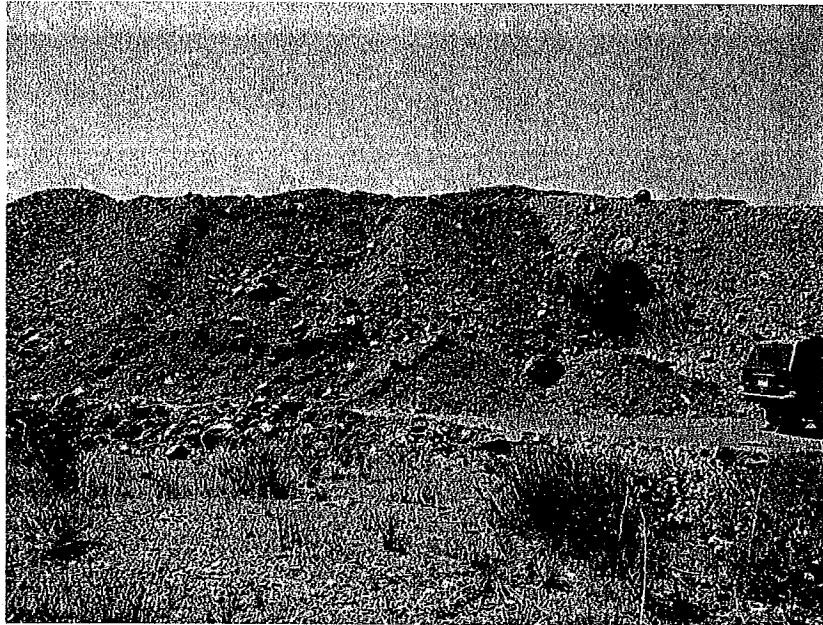
Photo 3: Repair of eroded slope of northern upper waste rock pile. Upper portion of waste rock piles will be re-graded to drain runoff to the haul road along south side of WMSA and re-vegetated for erosion control. Dated August 25, 2011. Compare to photo 5 in 2010 inspection report.

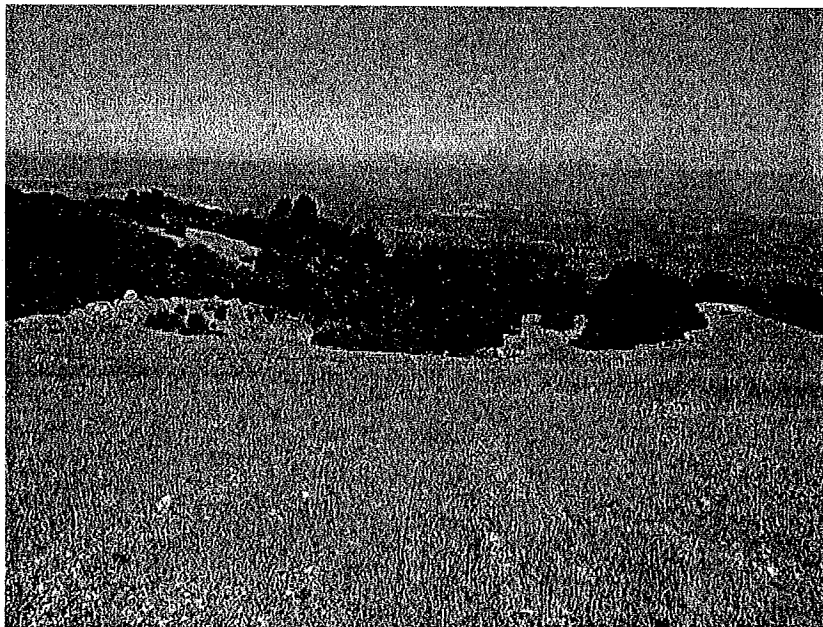
Photo 4: Looking north at eastern portion of north slope of WMSA. Running across center of image is recommended drainage swale recently constructed to direct runoff away from closed depression at toe of slope. Date August 25, 2011. Compare to inspection report photo 5-2008, photo 4-2009 and photo 6-2010.

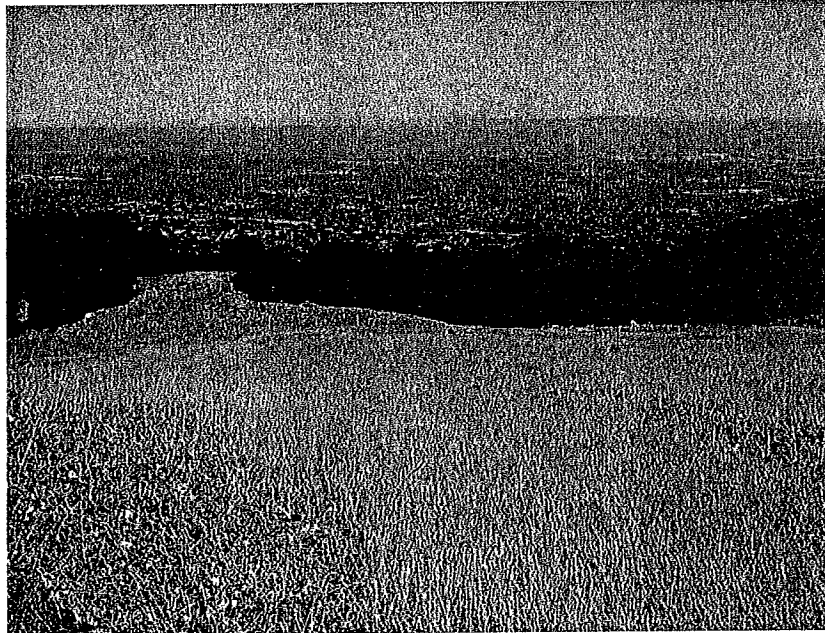
The easternmost portion of the northern slope of the WMSA was re-graded and hydroseeded in 2008, and re-vegetation appears to be succeeding. At the toe of the area worked in 2008, there appears to be a small closed depression that may trap runoff (Photo 4). During the 2010 inspection, a small diversion swale was being constructed across the slope to re-direct sheet flow away from this depression and into the natural drainage to the east. This drainage swale has been completed and re-vegetated for erosion control (Photos 5).

Photo 5: Looking north from eastern end of mid-slope drainage swale where runoff flows into the natural ravine. Date August 25, 2011. Compare to 2010 inspection report photo 5.

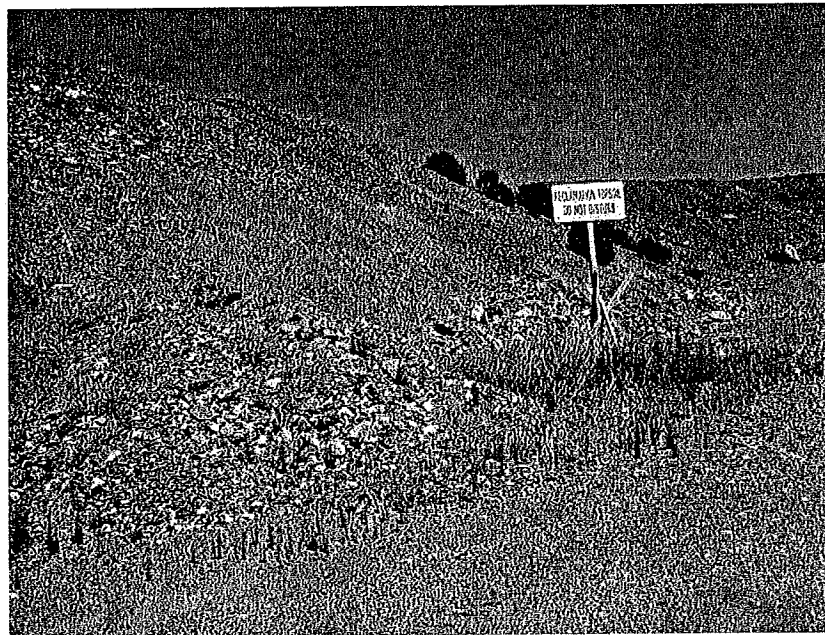
The portion of the WMSA overburden in the designated topsoil storage area continues to be signed to warn drivers not to disturb the area, which corrects a previous violation (Photo 6).

Photo 6: Topsoil storage area in WMSA, looking north; note sign. Dated August 25, 2011.

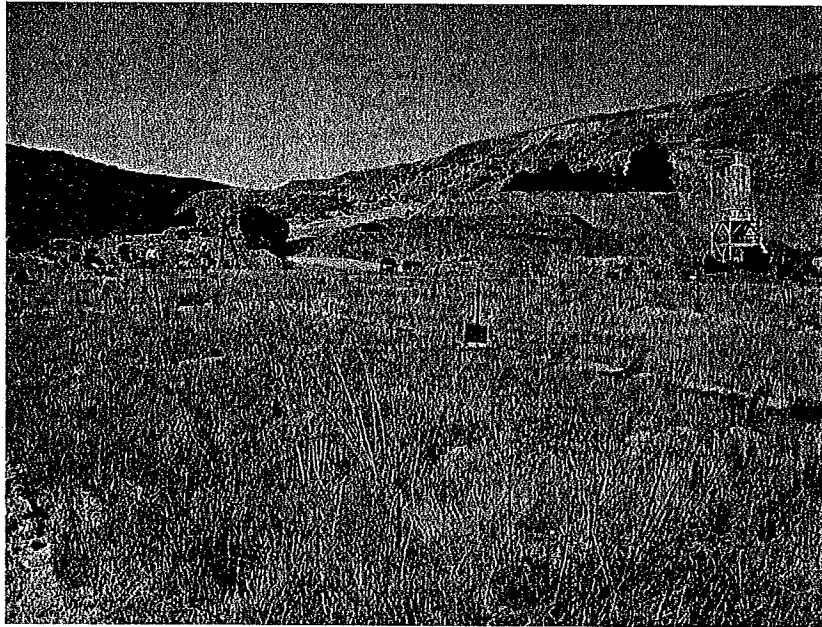
Photo 7: Flat lying test plots at the Yeager Site, southeast of WMSA, looking northwest. Plots planted in 2008. Dated August 25, 2011. Compare to inspection report photo 8-2008, photo 11-2009, 12-2009, and photo 10-1210.

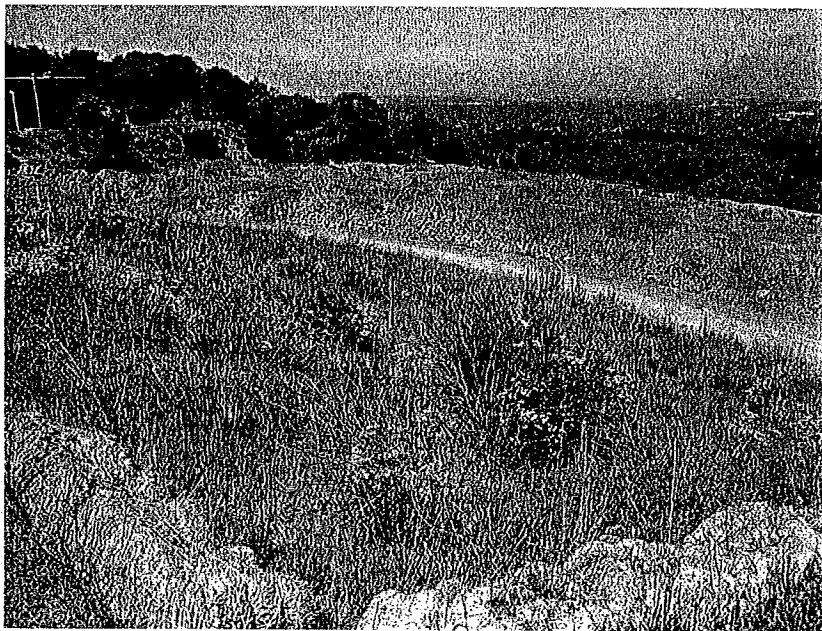
In order to address the issue of the lack of topsoil for re-vegetation of the site, the operator established a topsoil storage area within the WMSA and began a series of re-vegetation test plots to evaluate various soil treatments and to determine what soil and seed combinations will be best for successful re-vegetation. One of these test plots is located in a flat area southeast of the WMSA, called the Yeager Site. Test plots of various re-vegetation treatments at the Yeager Site appear to be yielding good results (Photo 7). A second re-vegetation test plot has been established on the north-facing slope in what is being called the East Material Storage Area (EMSA) to evaluate various soil treatments necessary for re-vegetation of slopes of this area. Test plots of different re-vegetation treatments in the EMSA Site also appear to be yielding good results (Photos 8).

Photo 8: Test plots at the EMSA Site, on north-facing slope, looking northwest. Plots planted in 2008. Dated August 25, 2011. Compare to inspection report photo 16-2008, photo 13-2009, photo 14-2009 and photo 11-2010.

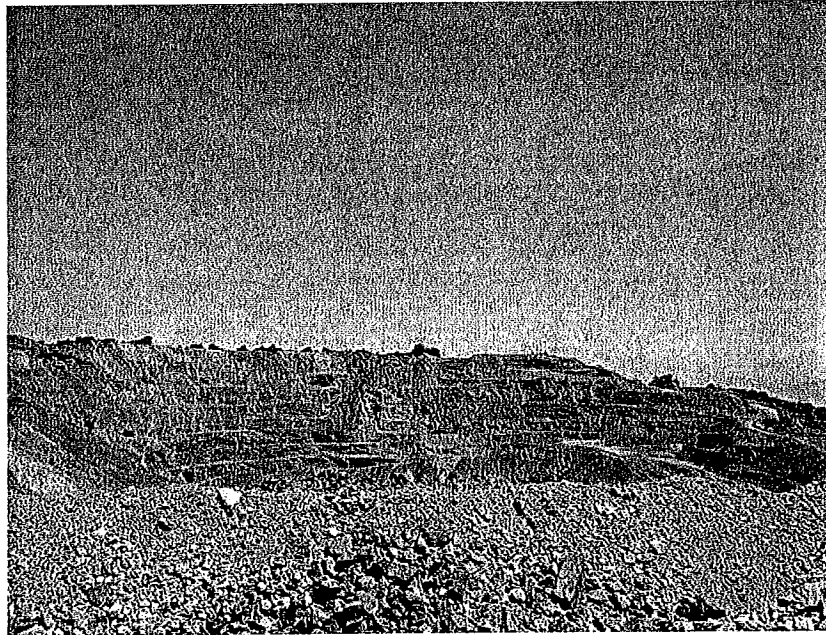
Photo 9: Northeast portion of pit with Mid-Pen Rockslide in center, looking northeast. Dated August 25, 2011. Compare to inspection report photo 11-2008, photo 15-2009, and photo 12-2010.

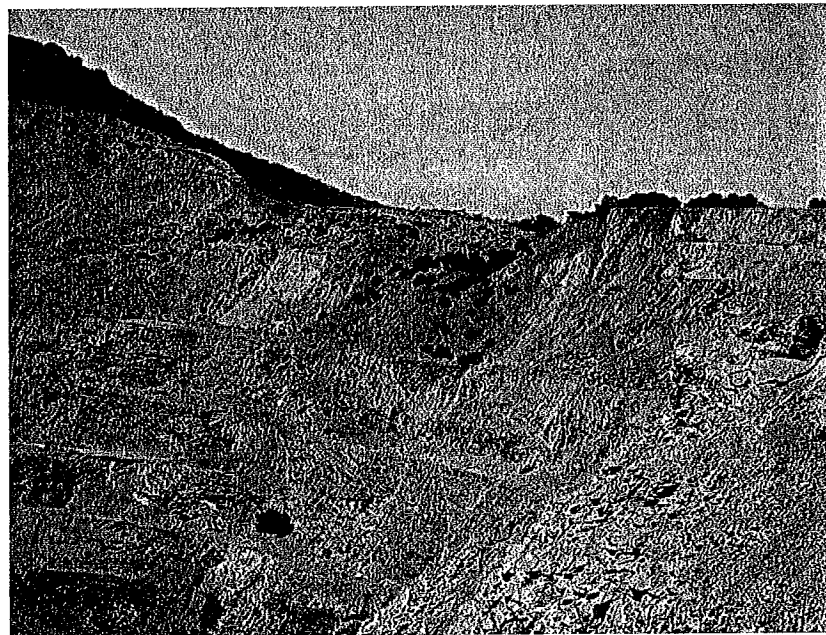
Photo 10: Northern portion of pit with Scenic Easement Rockslide in center, looking northwest. Dated August 25, 2011. Compare to inspection report photo 12-2008, photo 16-2009, and photo 13-2010.

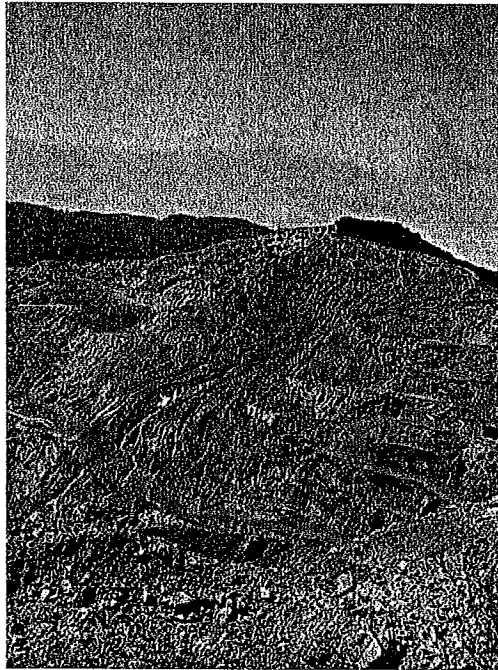
As discussed above, the northern highwall of the pit has had three large rockslides. No major new movement on these rockslides was observed during the 2011 inspection. The Mid-Pen Rockslide, extends approximately half-way down the highwall (Photo 9). The Scenic Easement Rockslide has a slope failure that extends down slope approximately as far as the Mid-Pen Rockslide (Photo 10). This rockslide lowered the ridgeline contrary to the 1972 RPE. The largest slide, the Main Rockslide, appears to extend across most of the current height of the northwestern highwall (Photo 11).

Photo 11: Northwest portion of pit with Main Rockslide in center, looking west. Dated August 25, 2011. Compare to inspection report photo 12-2008, photo 17-2009, and photo 14-2010.

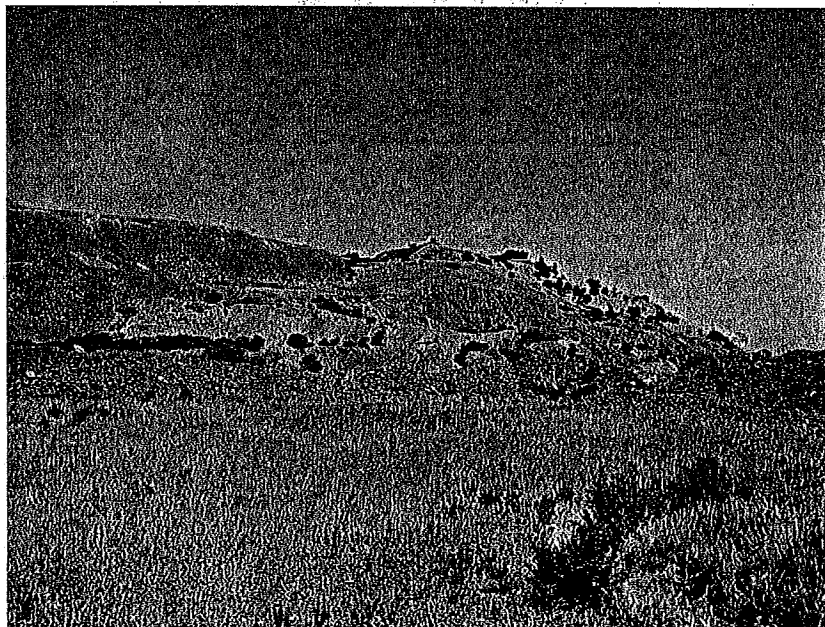
Photo 12: Western portion of pit and eastern portion of WMSA looking at head scarp area of Haul Road Slide, looking north. Dated August 25, 2011. Compare to inspection report photo 18-2009 and photo 15-2010.

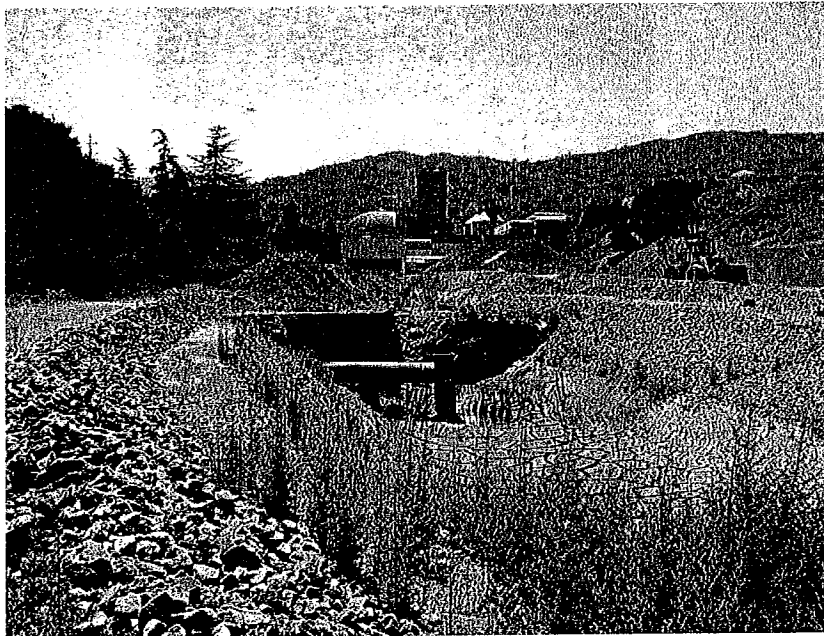
Photo 13: Point 30 stormwater pond, looking south at plant site. Outfall discharges to Permanente Creek. Rock armoring of outfall done to mitigate potential erosion. Dated August 25, 2011. Compare to 2010 inspection photo 16.

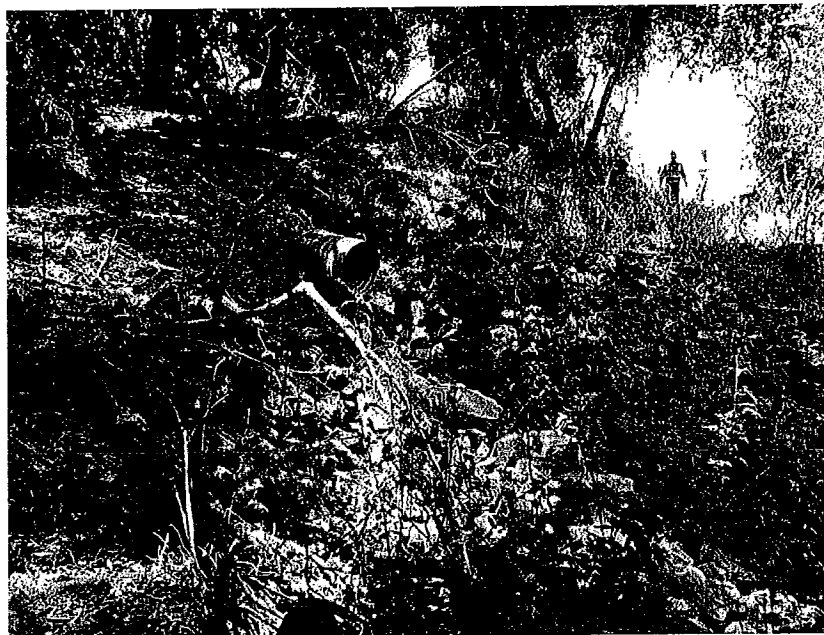
Photo 14: Looking west at rocky outfall for discharge to Permanente Creek from point 30 pond. Dated August 25, 2011.

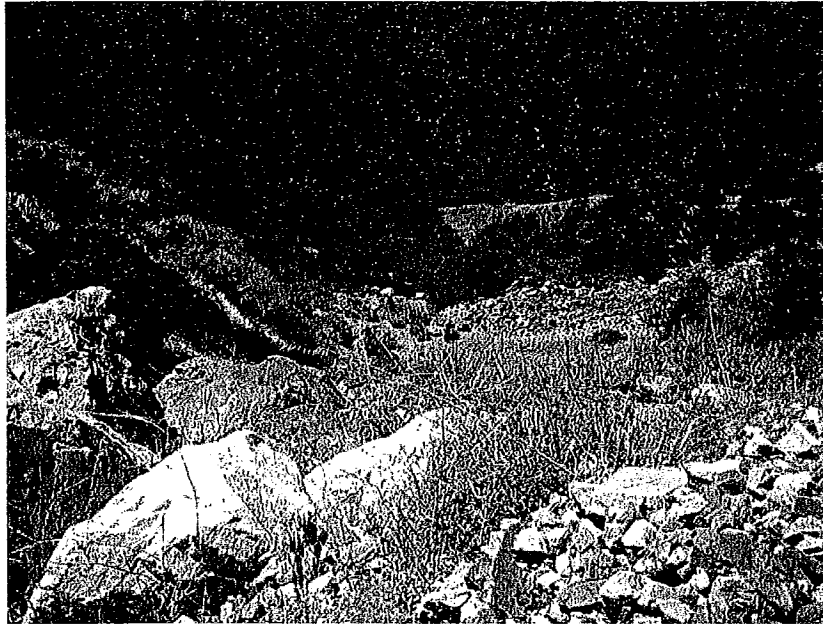
been placed in this outfall with the intention of mitigating the potential erosion and instability. This drainage outfall was observed during our inspection and appears to be performing as intended (Photo 15). The drainage outfalls along this roadway should continue to be monitored as part of the site's stormwater management plan. County staff will inspect the site before the end of November to document completion of that work.

Photo 15: Rock outfall from pre-SMARA road running along southern edge of WMSA, looking south at Permanent Creek. Dated August 25, 2011. Compare to inspection report photo 7-2008 and photo 9-2009.

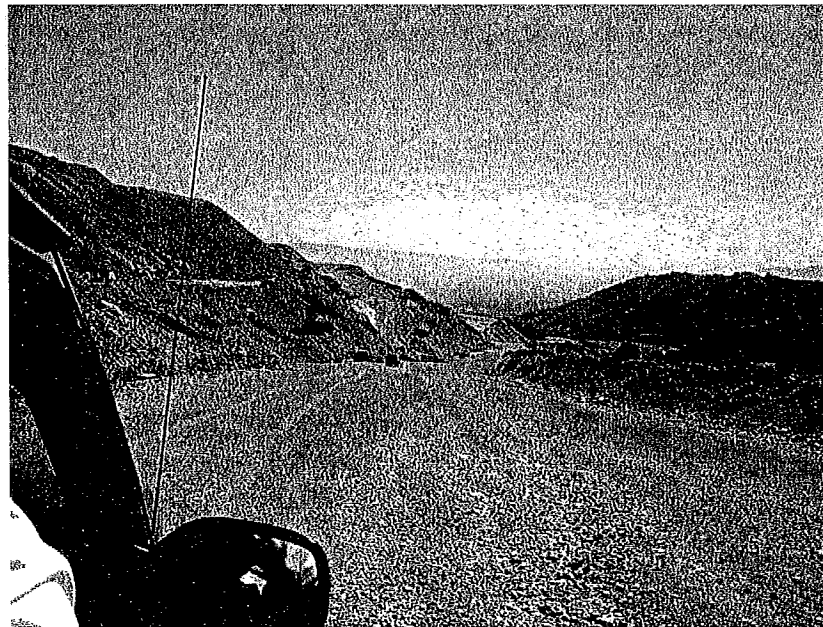
The operator has installed a number of rock check dams along the inside ditch of the main haul road as an erosion control measure (Photo 16).

Photo 16: Rock check dams along main haul road on south side of WMSA to help control erosion, looking east. Dated August 25, 2011. Compare to 2010 inspection report photo 18.
