Sedimentation Basin/Pond Description Report

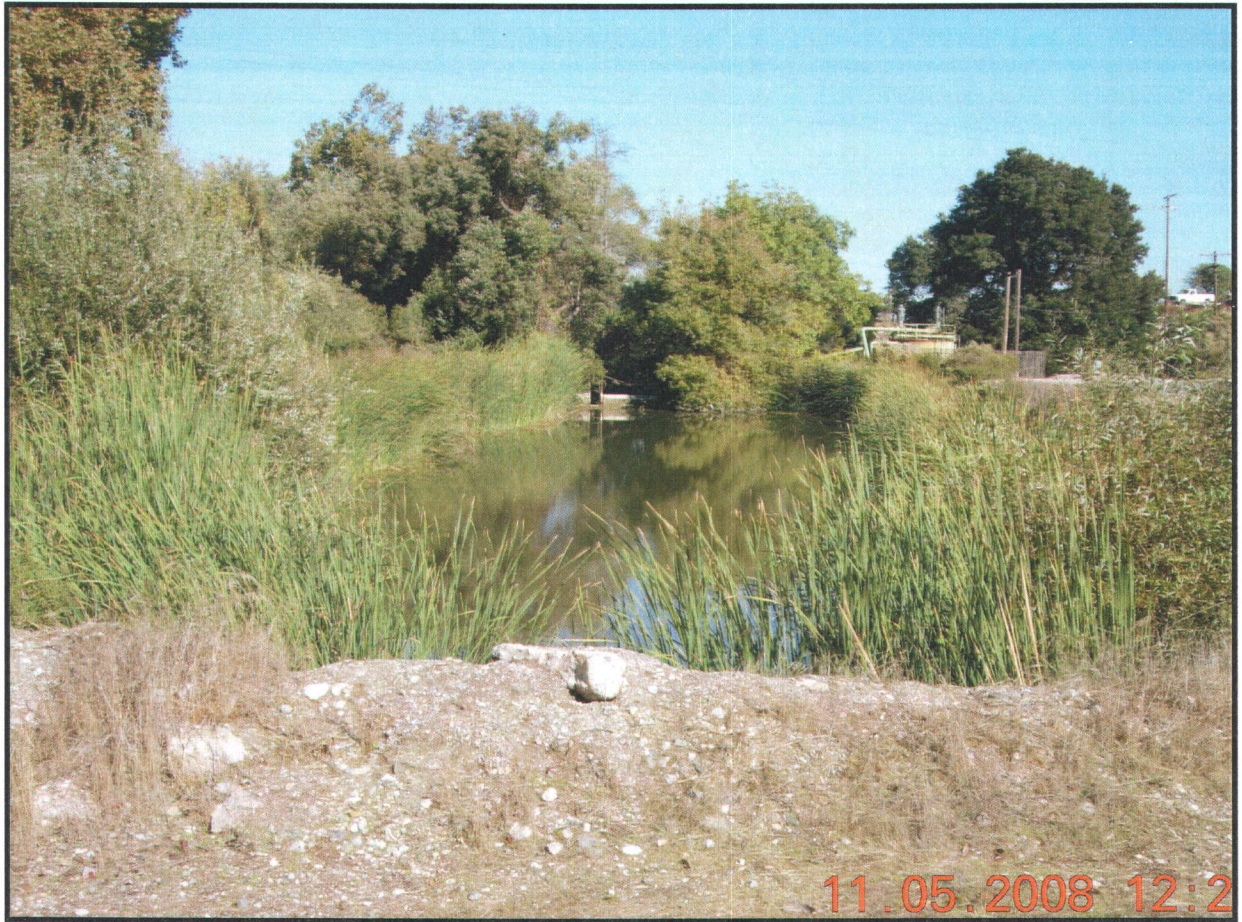
Permanente Creek:

CRLF Status: Permanente Creek, from Pond 14 to Pond 13, is considered suitable habitat and provides a movement corridor for CRLF:

- During a 1997 survey by Radian International, CRLFs were consistently observed at a single location approximately 30 yards downstream of Pond 14 in a small pool (10x5 feet) located outside and downstream of the Study Area.

- Rana Resources conducted a site assessment in 2008 and concluded that Permanente Creek likely serves as a movement corridor between known breeding populations.

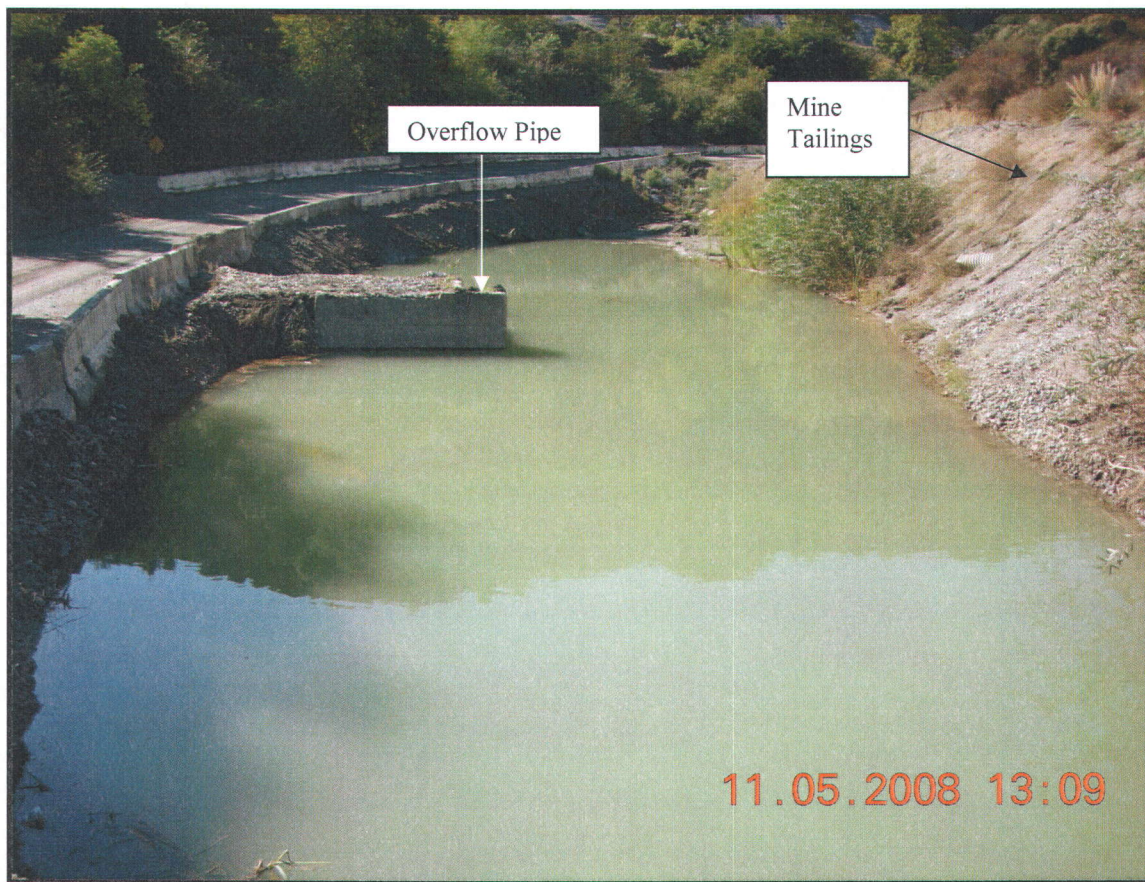
Pond 16 (1,059 sq ft; 0.024 acre):

Current Condition: Pond 16 does not support vegetative growth. It typically has a few inches of sediment on the bottom along with approximately 12 inches of water during the winter. During the summer months the water evaporates and the pond becomes dry. During winter storm events the water level activates the water pump several times each day.

CRLF Status: Based on surveys conducted by CRLF experts, the absence of vegetation or cover from predators, the shallow nature of the pond, and the continual operation of the water pump during storm events, HBG determined Pond 16 does not support suitable habitat for CRLF.

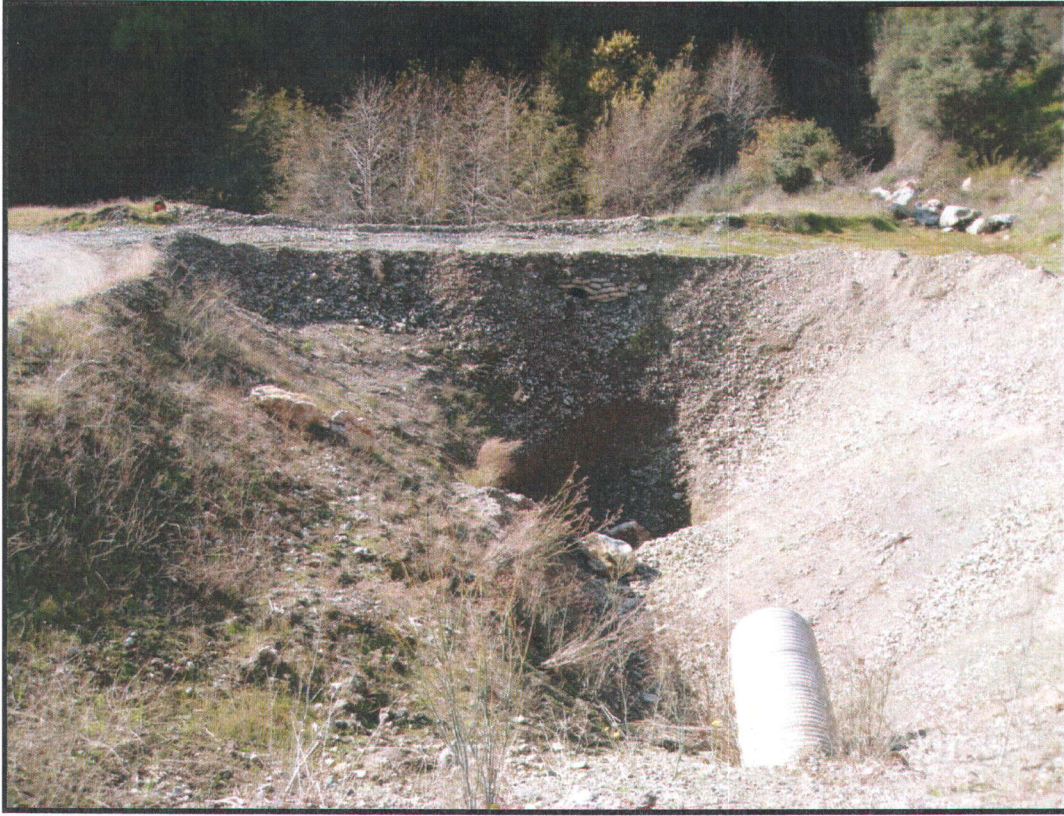
Pond 13A (2,398 sq ft; 0.055 acre):

Current Condition: Pond 13A is unvegetated except for a small 15 square foot patch of tules and willows in the southwestern most corner of the pond. The banks are steep (2:1 slope) and are comprised of sandy/gravel soils. Pond 13A does retain water for long periods after rain events but typically will dry out during the summer. Large piles of mine tailings directly adjacent to the pond deposit rock, gravel and sand into the pond each winter. Additionally, a large culvert discharges stormwater into Pond 13A generated from mining operations above the pond. Barriers to migration include trucks and large earth-moving equipment which travel along the road between Pond 13A and Pond 13 on a daily basis. In addition, a 100 foot pile of sparsely vegetated mine tailings creates a migration barrier between the Pond 13A and Pond 13.

CRLF Status: Surveys conducted by CRLF experts have never observed a CRLF in Pond 13A. We also note the following conditions that tend to make Pond 13A poorly

suitable for CRLF: (1) the rapid accumulation sediment each year; (2) the lack of vegetative cover from predators; (3) the short duration of ponding; (4) steep un-vegetated slopes between Pond 13A and Pond 13 and (5) vehicle traffic along the road between Pond 9 and Permanente Creek. These factors produce unsuitable habitat and inhibit the movement of frogs from suitable habitat to Pond 13A.

Based on the survey results from CRLF experts, lack of ponding for long durations, rapid accumulation of sediment each year, lack of vegetation for foraging, resting, and protection from predators, and barriers to migration from suitable habitat, HBG has determined that Pond 13A does not provide suitable habitat for CRLF.

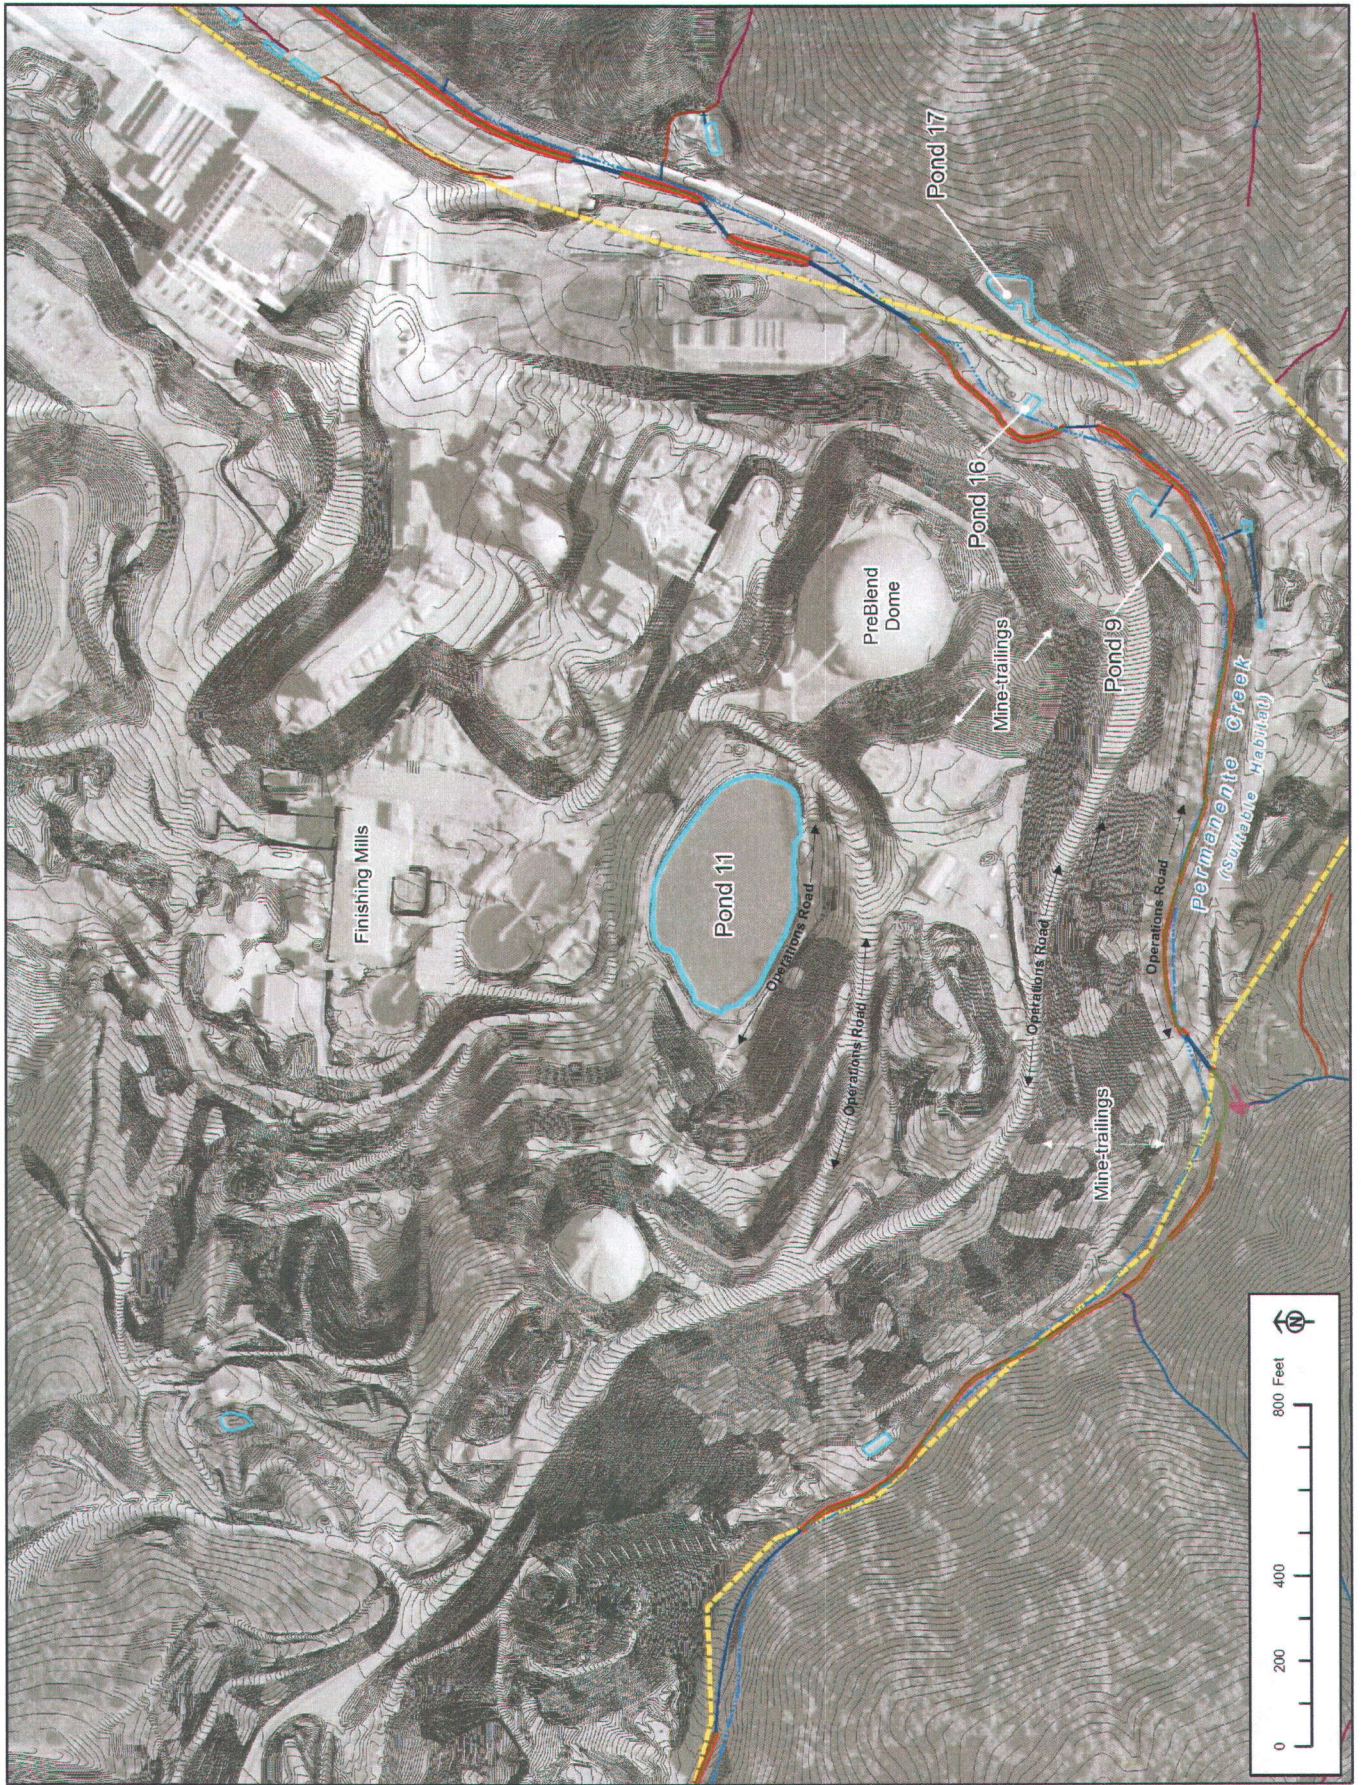
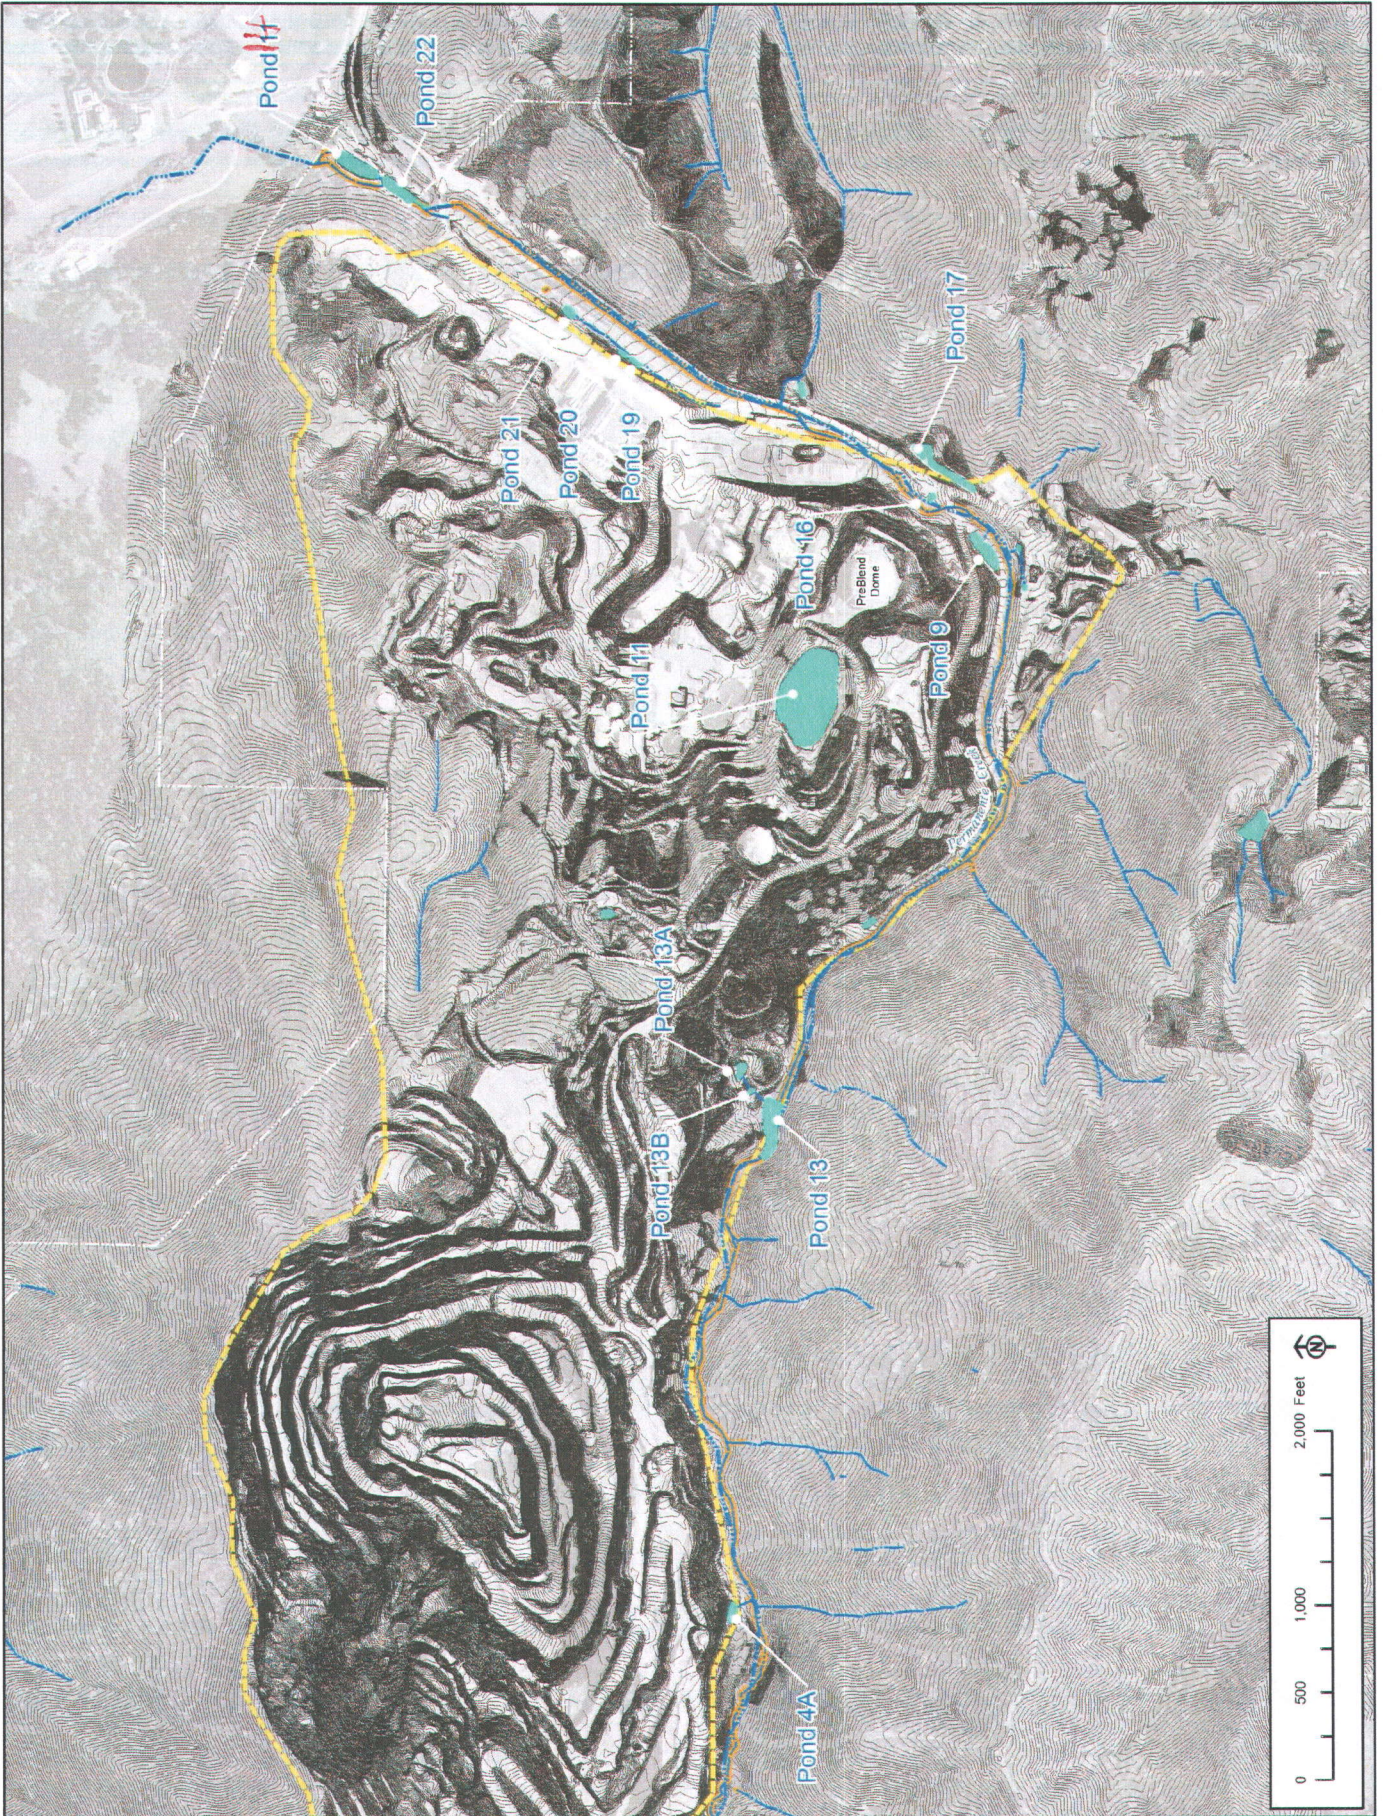
Pond 11/Lake (134,841 sq ft; 3.1 acre):

Current Condition: Pond 11 is a deep water pond. The northern and eastern banks are lined with concrete with no vegetation. The southern and western banks are not entirely lined with concrete and have established vegetation along the top of the bank and slope of the bank where sedimentation has accumulated. Its primary purpose is to provide and retain water for use in the Finishing Mills process. It does not accumulate large amounts of sedimentation during a normal year. Barriers to migration between Pond 11 and the nearest suitable habitat are significant and include heavily used roadways, numerous structures, and large piles of sparsely vegetative mine-tailings. The large piles of mine-tailings are steep (2:1 slope in many areas) and rise in elevation of upward of 200 feet relative to the nearest suitable habitat.

The aerial photograph provided in this report illustrates the significant barriers (topographic barriers, roads/industrial operations, mine tailings) between suitable habitats and Pond 11.

CRLF Status: Surveys conducted by CRLF experts have never observed a CRLF in Pond 11. This may be the result of several factors including (1) significant barriers to migration from the nearest suitable habitat; (2) marginal emergent vegetation habitat along banks; and (3) water quality as a result of operational process (possible PH not suitable for CRLF). These factors produce unsuitable habitat and inhibit the movement of frogs to the pond from suitable habitat locations.

Based on the survey results from CRLF experts, the design and operational use of the pond, and significant barriers to migration, HBG has determined that Pond 11 does not provide suitable habitat for CRLF and that it is unlikely that CRLF could access the pond from adjacent suitable habitats.
