PERMANENTE CREEK LONG-TERM RESTORATION PLAN

Prepared for
Lehigh Southwest Cement Company
24001 Stevens Creek Boulevard
Cupertino, CA 95014

March 10, 2010

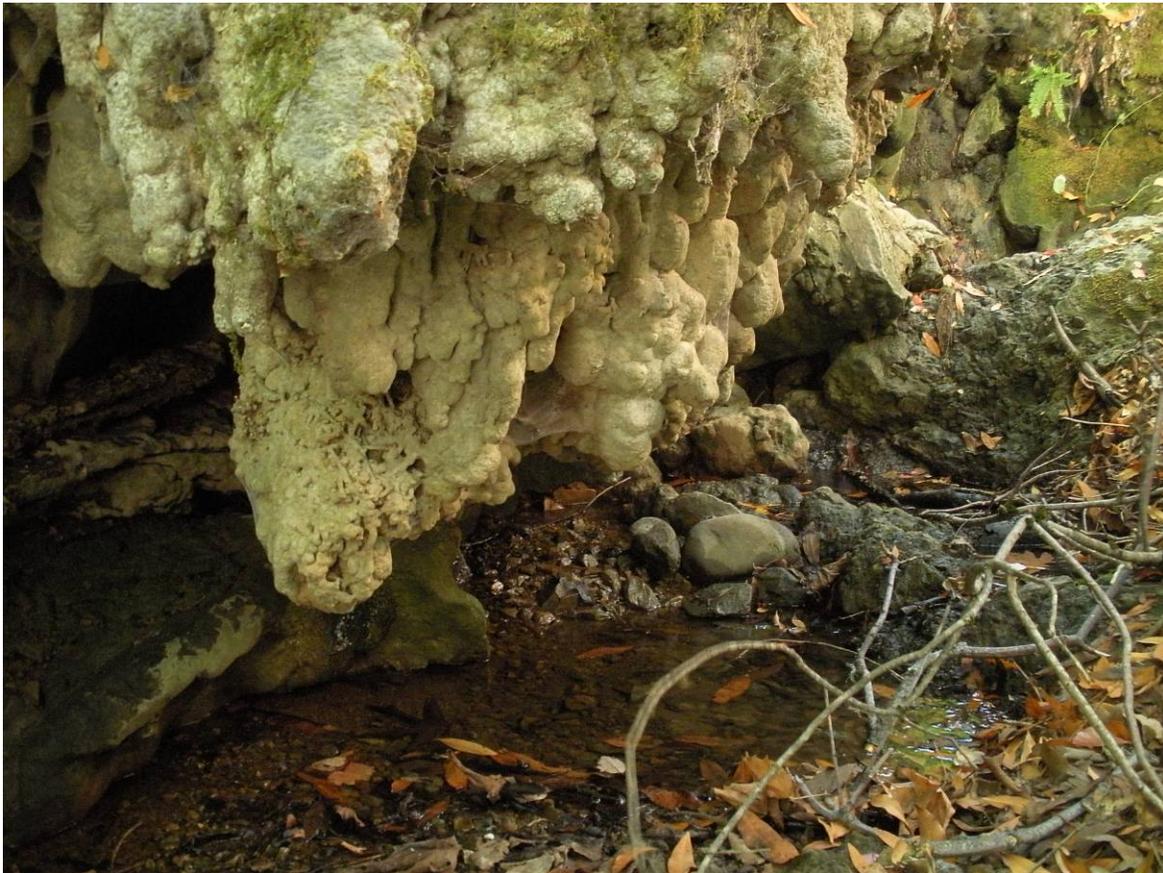
Figure 2-1 Calcium carbonate-encrusted roots and rock steps (right) within the ordinary high water elevation of the Creek

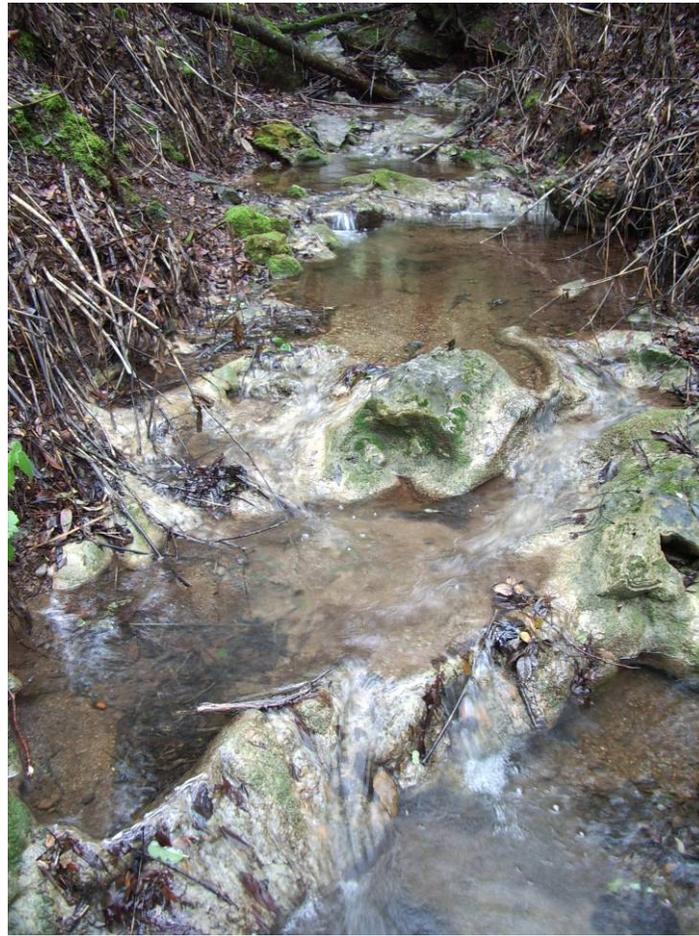
Figure 2-2 Precipitate rock forming step pools

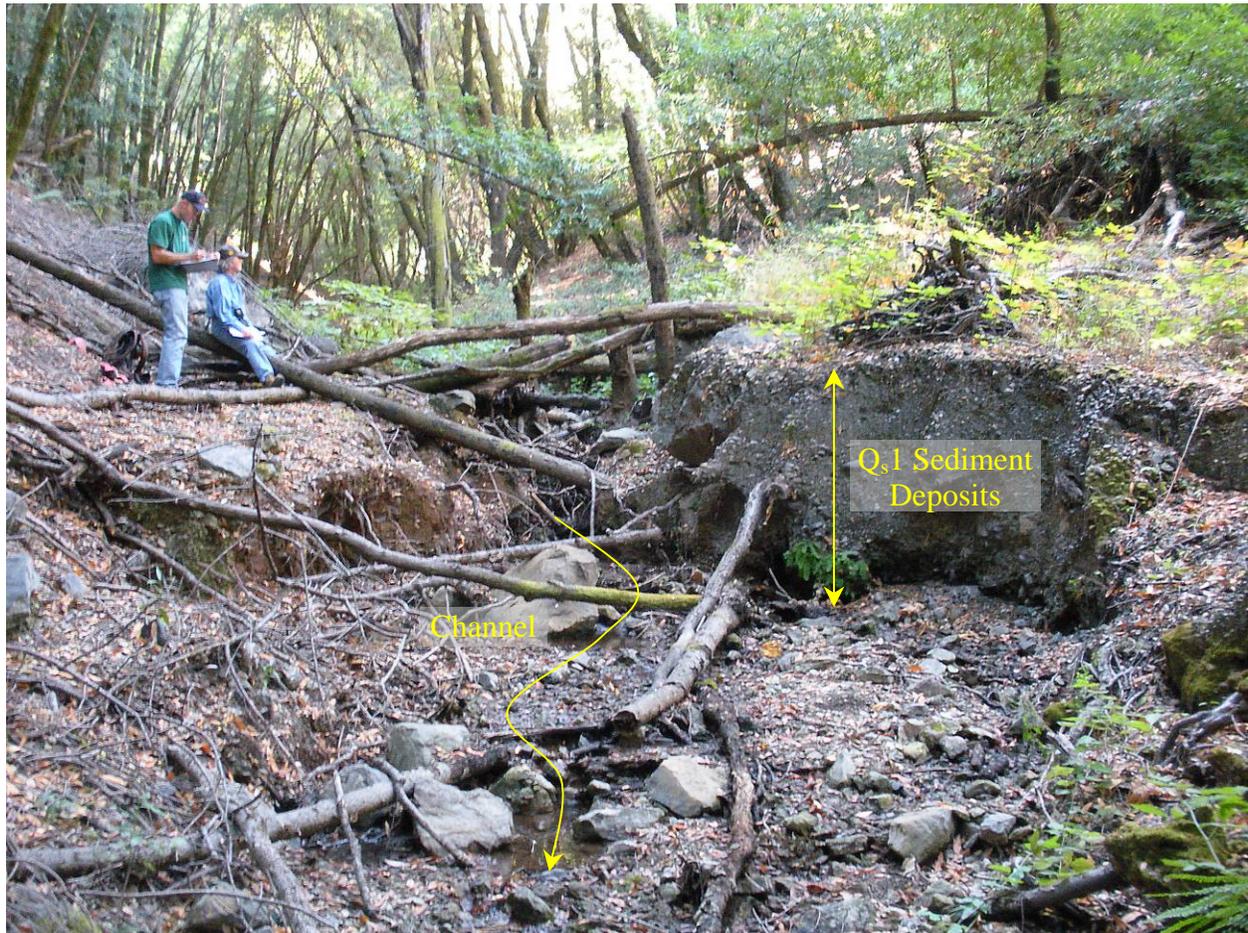
Figure 2-6 Channel cut through Q_s1 material

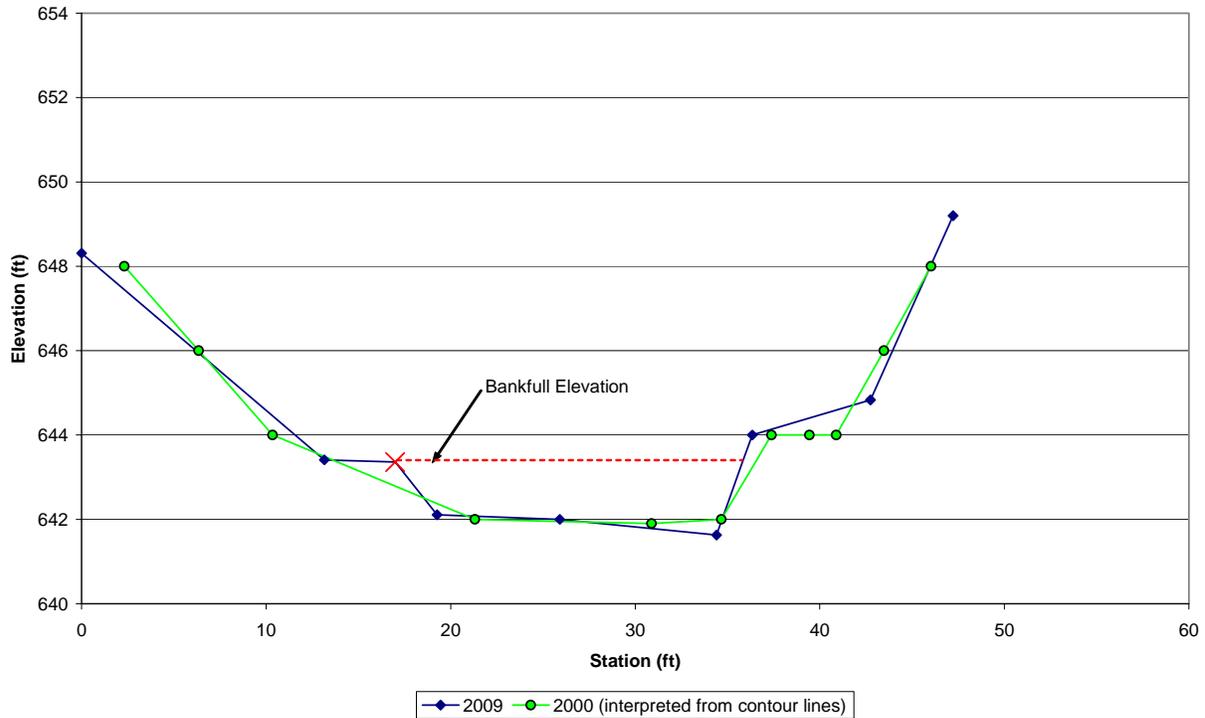
Figure 2-8 Station 62+92 (Reach 9) cross-section comparison

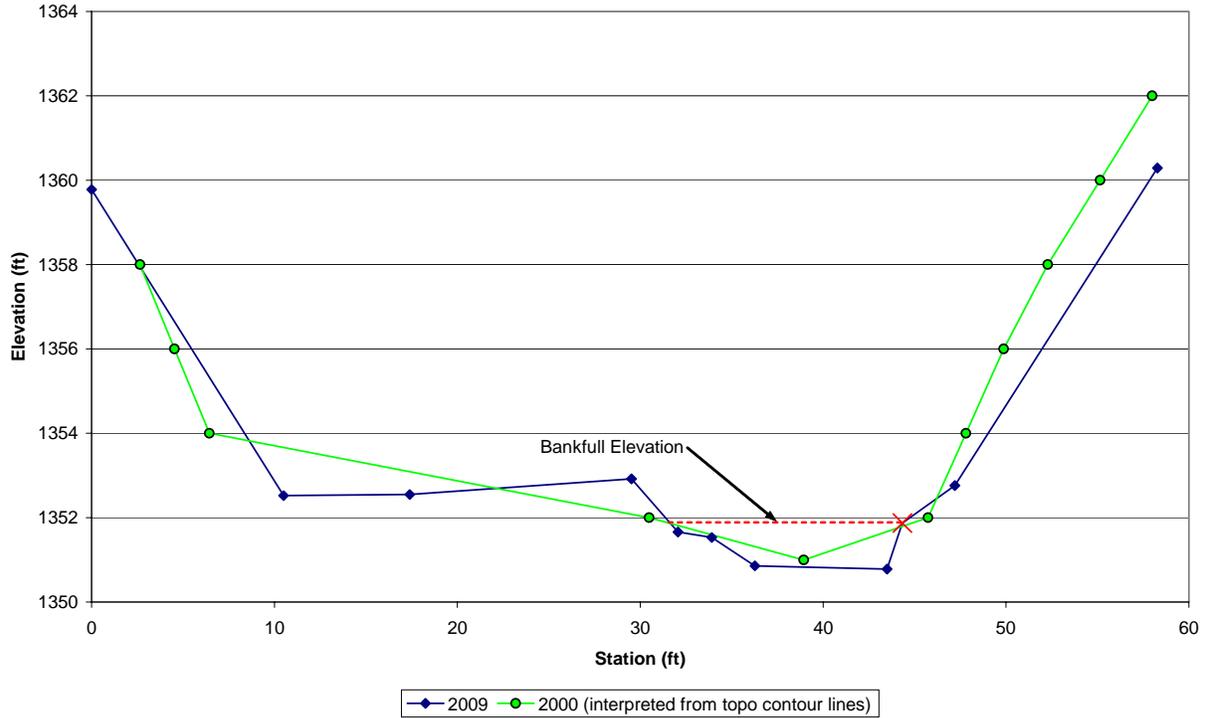
Figure 2-9 Station 169+03 (Reach 20) cross-section comparison

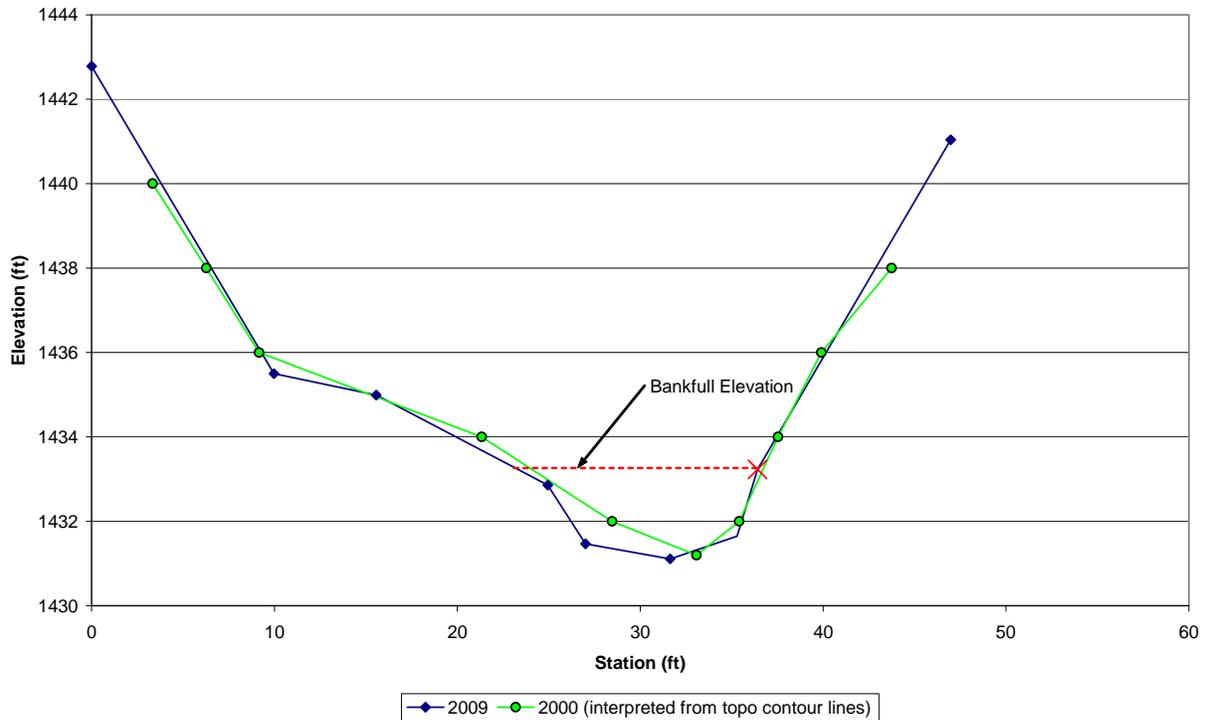
Figure 2-10 Station 185+95 (Reach 21) cross-section comparison

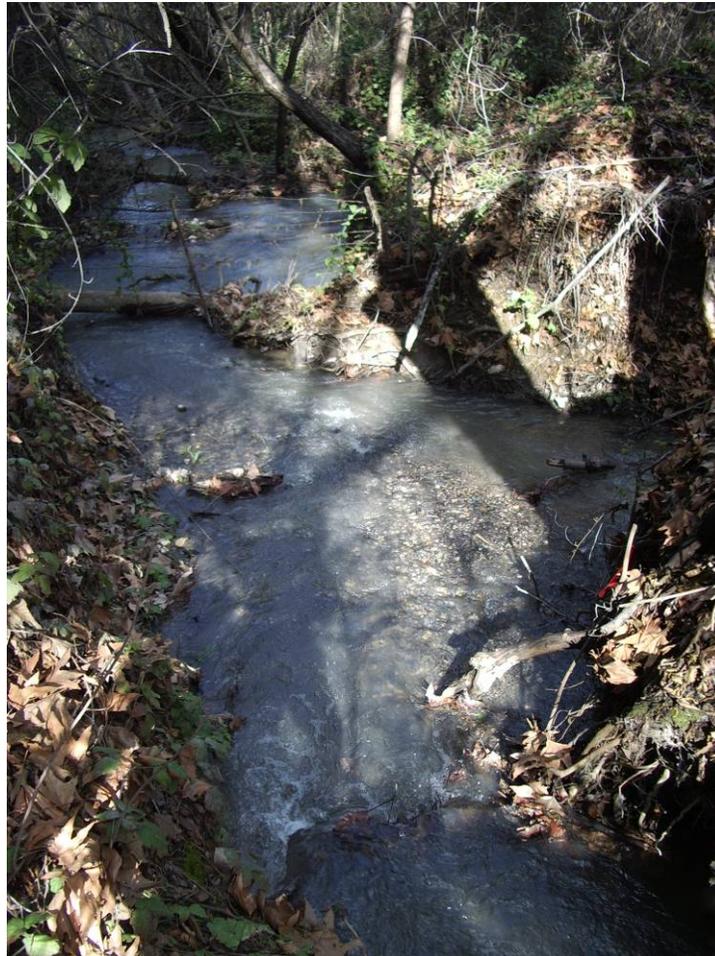
Figure 2-11 Looking downstream on Reach [1]

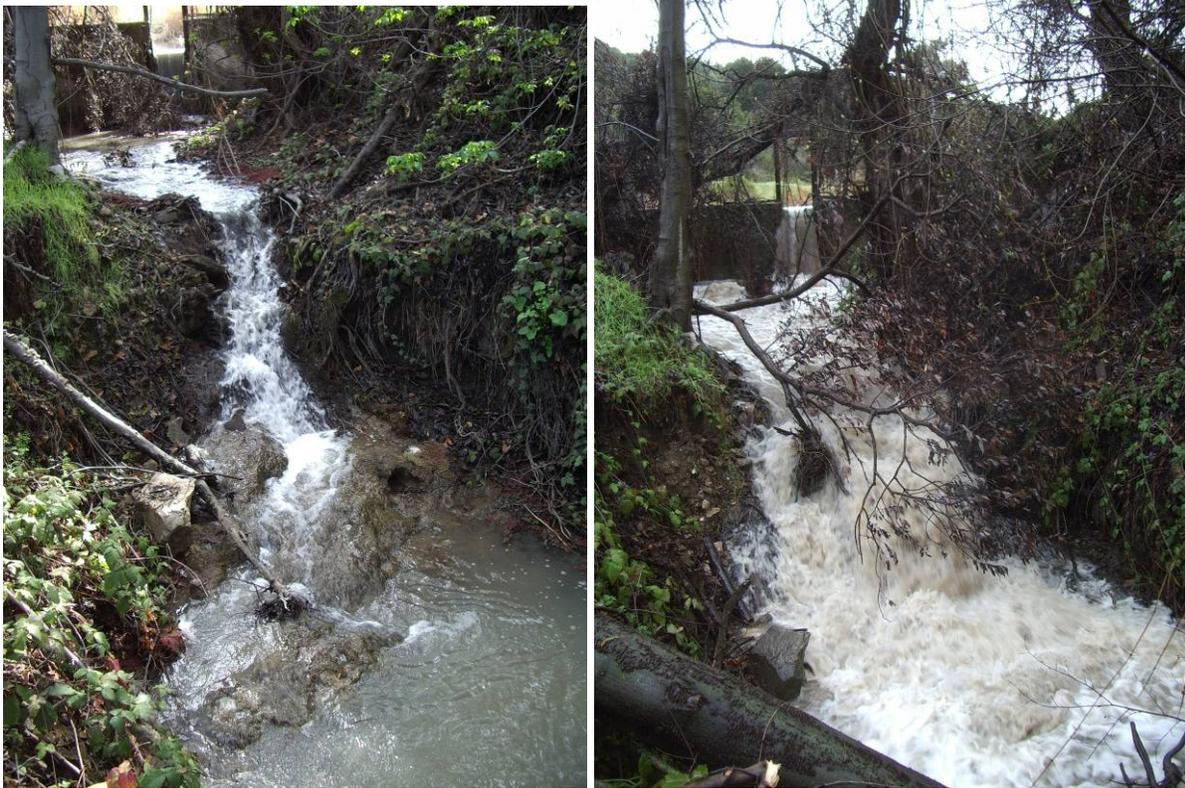
Comment Response			
<p>Insufficient documentation is present to determine whether or not the headcut was present below Pond 14 in 2000. This headcut could threaten the Pond 14 embankment and weir in the near future if four mature trees that support the channel bed and banks are eroded and fail into the channel. Two of the trees are currently being undermined by the headcut. The remaining two willow trees are approximately 15 feet away from the headcut close to the pond weir. The Long-Term Restoration Plan has been updated to further describe this</p>

location and recommends near term solutions to protect Pond 14 and stabilization of the downstream channel banks. See revised text in Section 4, Table 4-2.

Figure 2-12 Headcut downstream of the Pond 14 weir

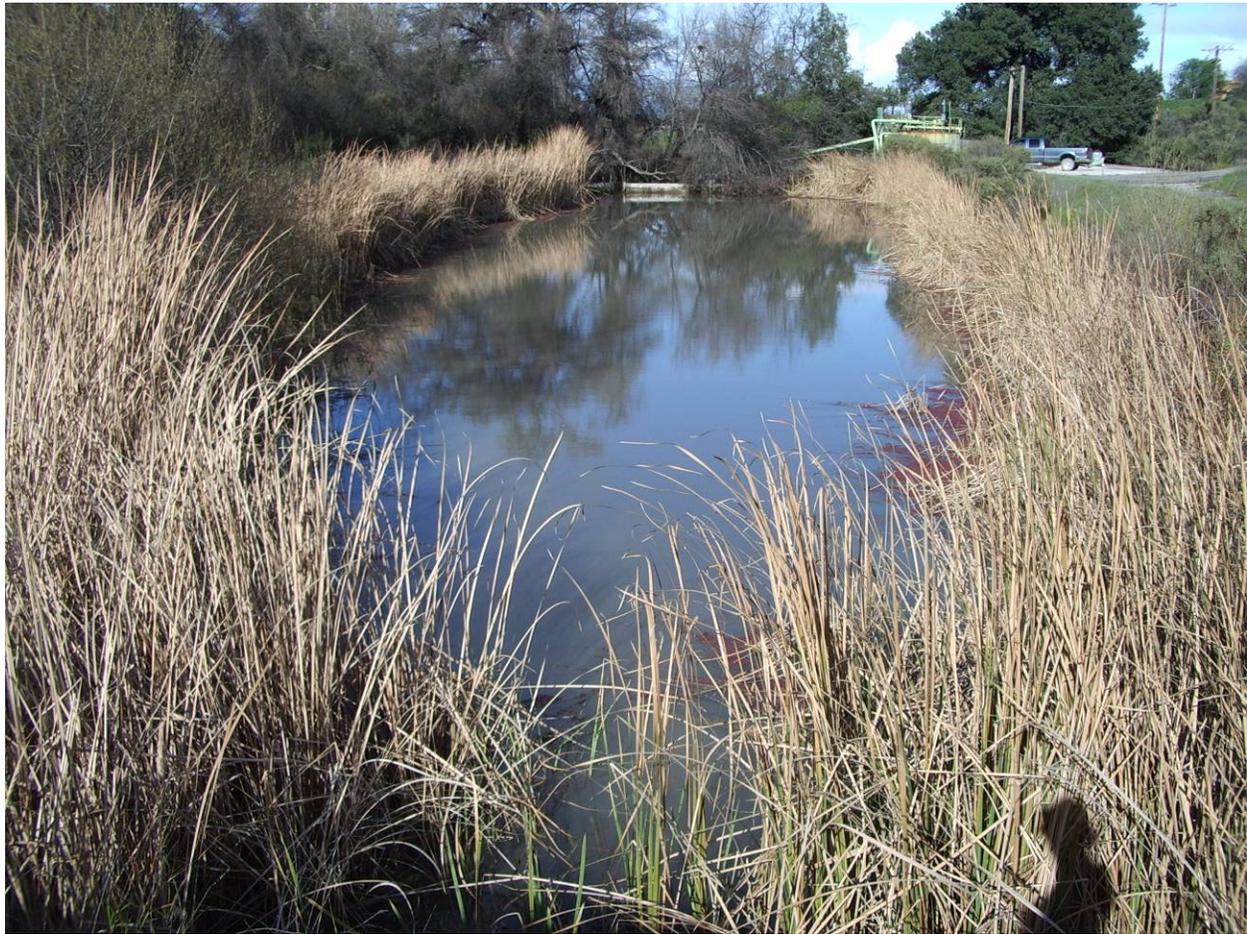
Figure 2-13 Looking downstream along Pond 14

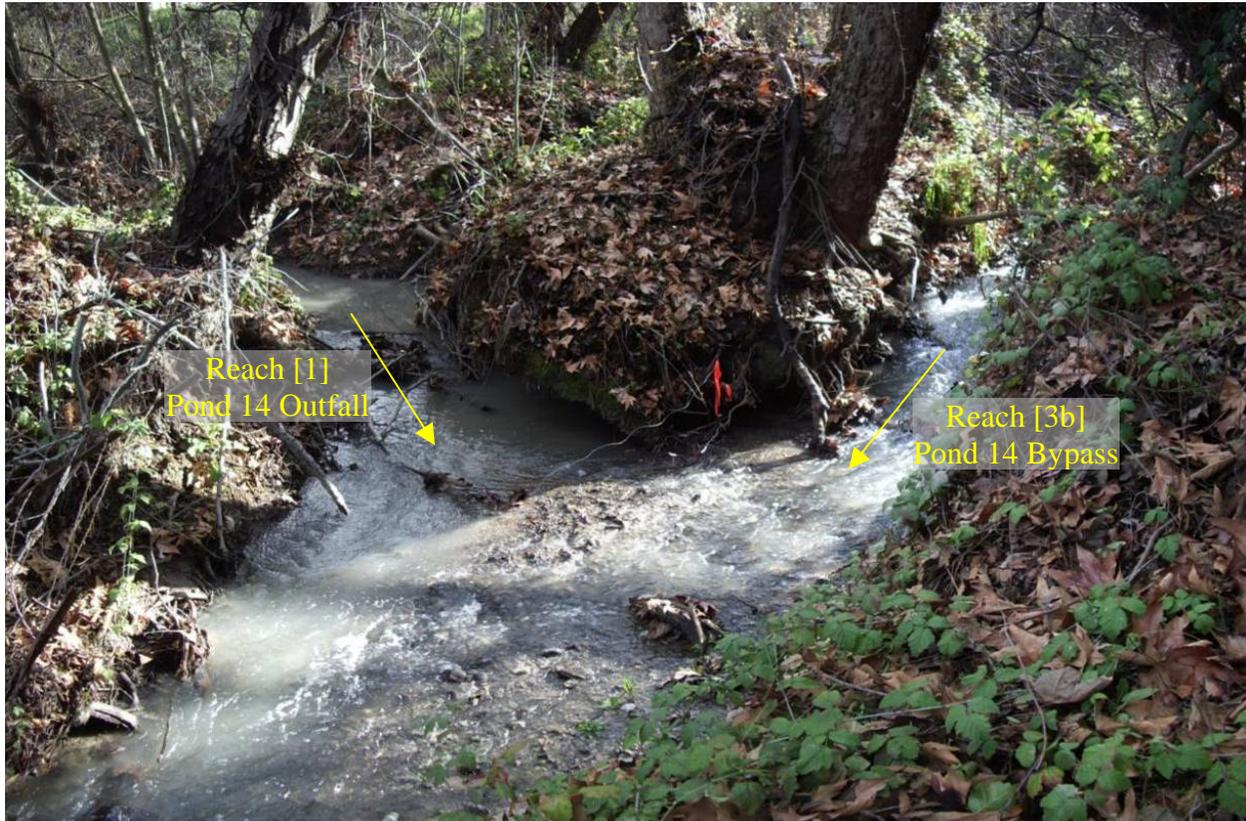
Figure 2-14 Looking upstream at the confluence of Reaches [1] and [3b]

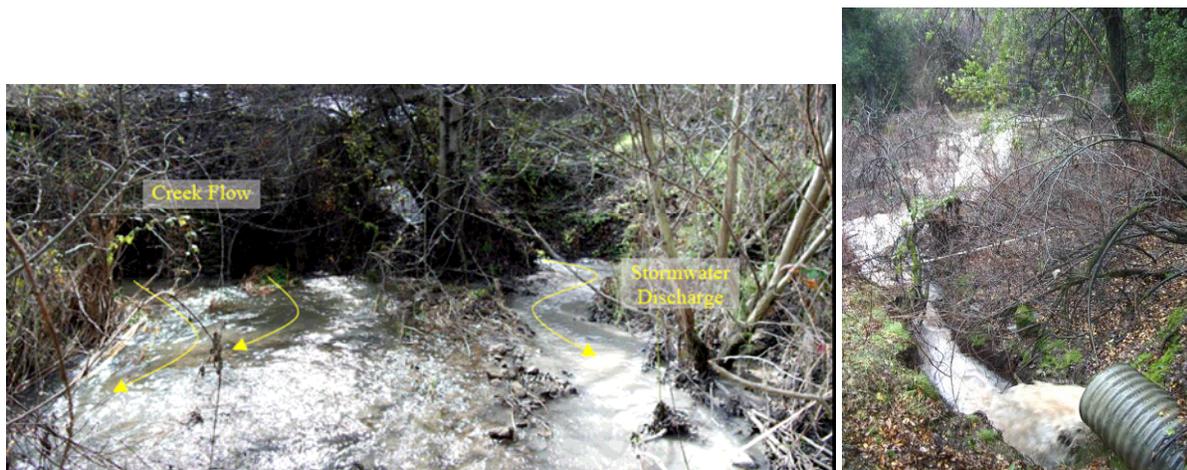
Figure 2-15 Reach [4] near Station 6+20

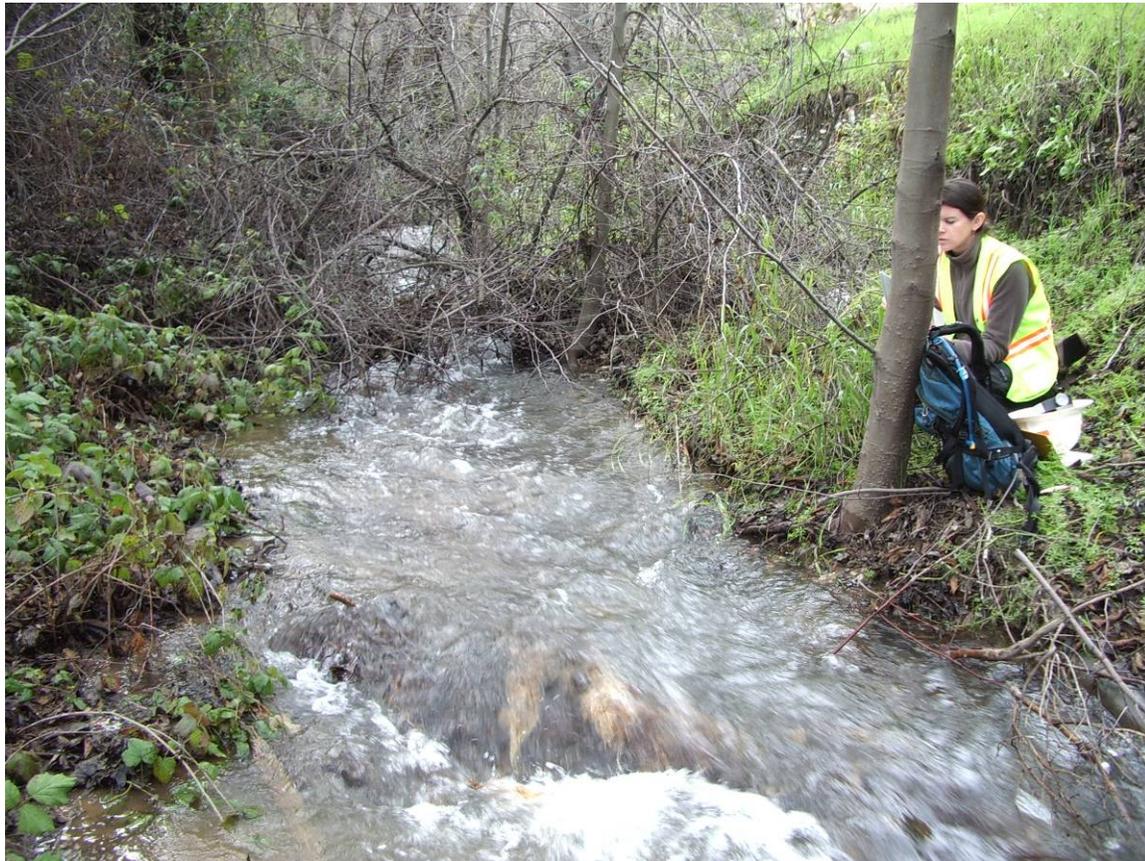
Figure 2-17 Looking upstream near Station 63+00

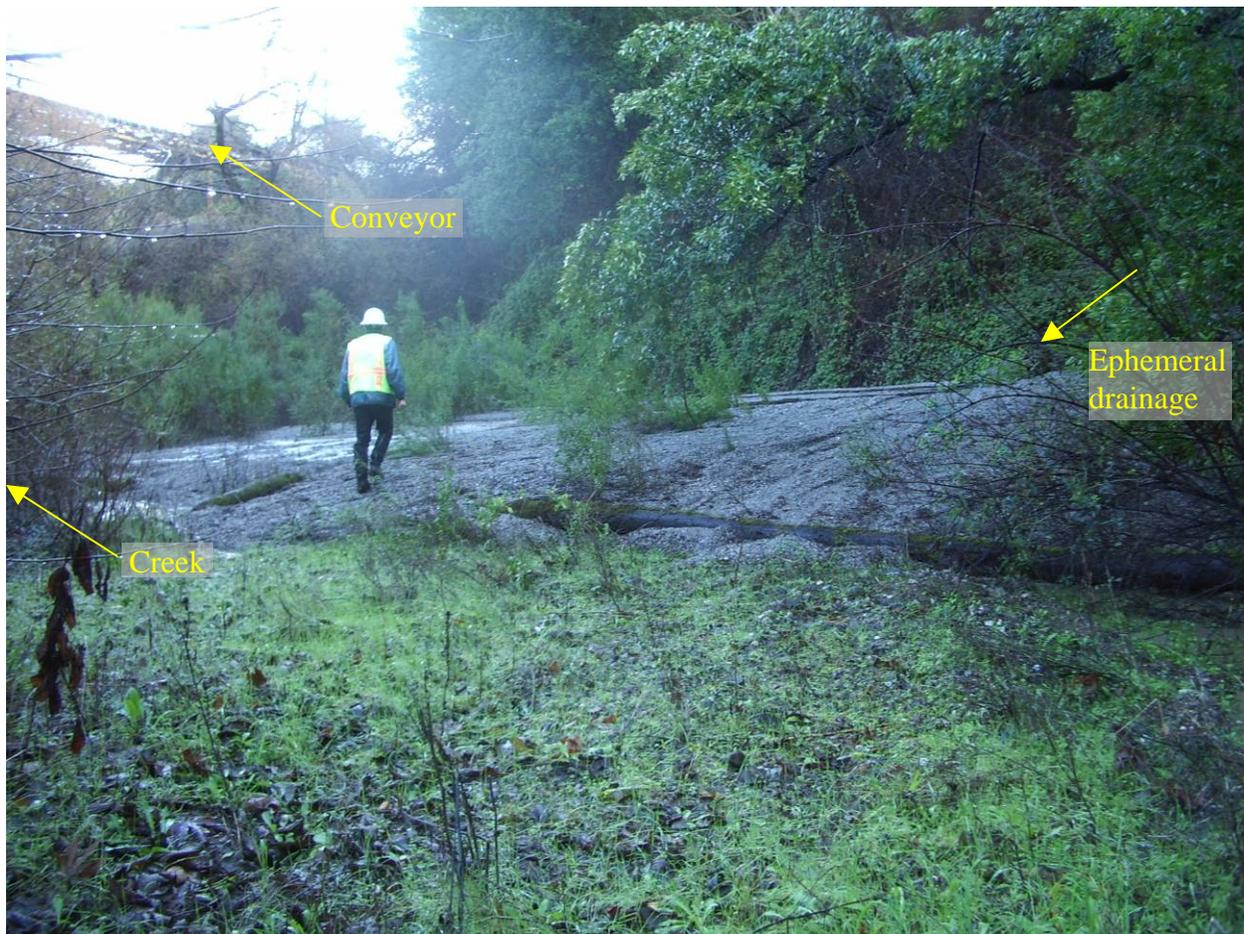
Figure 2-18 Looking downstream at an alluvial fan from an ephemeral drainage near Station 62+00

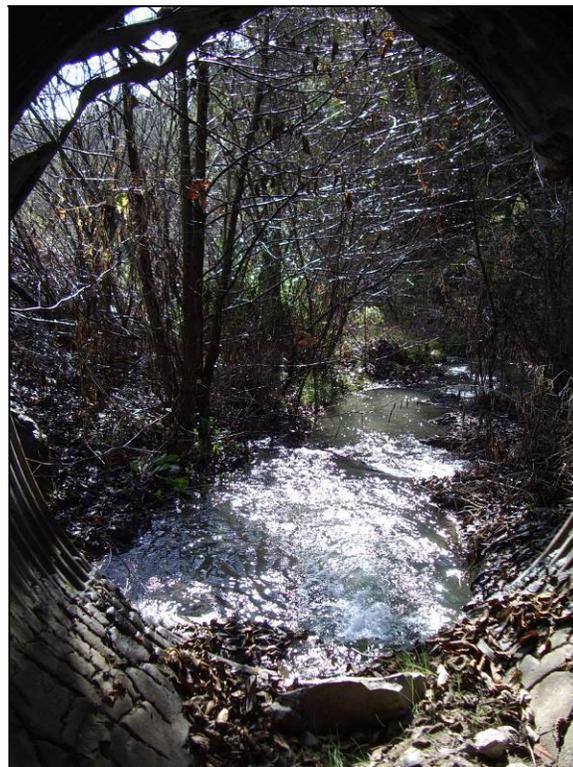
In the 2000 assessment, an eroded bank on the southern side of the Creek near Station 75+00 was identified. However, during the 2009 assessment, this bank was stable and vegetated. During a subsequent follow-up visit in January 2010, six small slumps (each less than 0.5 cubic yard) were observed on the steep bank on the southern side of the creek. Four of the slumps deposited directly into Permanente Creek, the other two slumped onto a bench above the channel. All of these slumps were natural in origin, not the result of the Facility operations (which occur on the northern side of the creek).

Figure 2-19 Looking downstream at Reach [9] from within the dry parallel culvert near Station 74+00

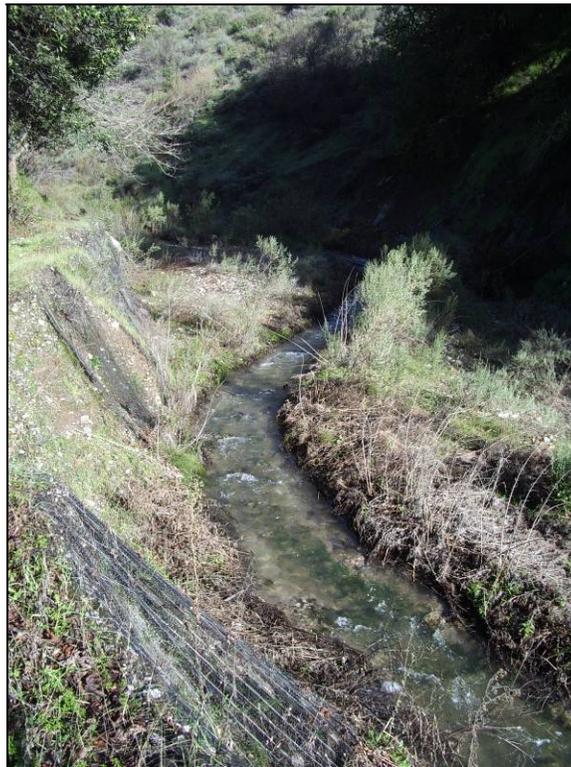
This reach is characterized by the full culvert, the half culvert, Pond 13, and the over-excavated portion of Pond 13 that is not inundated. No geomorphic assessment was performed in this reach due to its manipulated nature. However, it should be noted that the Creek within the non-inundated portion of Pond 13 has built a stable, meandering channel with a floodplain (see Figure 2-20). Excavated side slopes along the access road (former stagecoach road) on the southern side of the creek remain steep and mostly unvegetated, but the Creek appears to be mostly unaffected by these side slopes. The relatively short slope (less than 15 feet long) and rocky soil contribute little sediment to the creek. The rock pile extends over the full culvert and lies adjacent to the half culvert.

Figure 2-20 Looking upstream along non-inundated portion of Pond 13 near Station 90+00

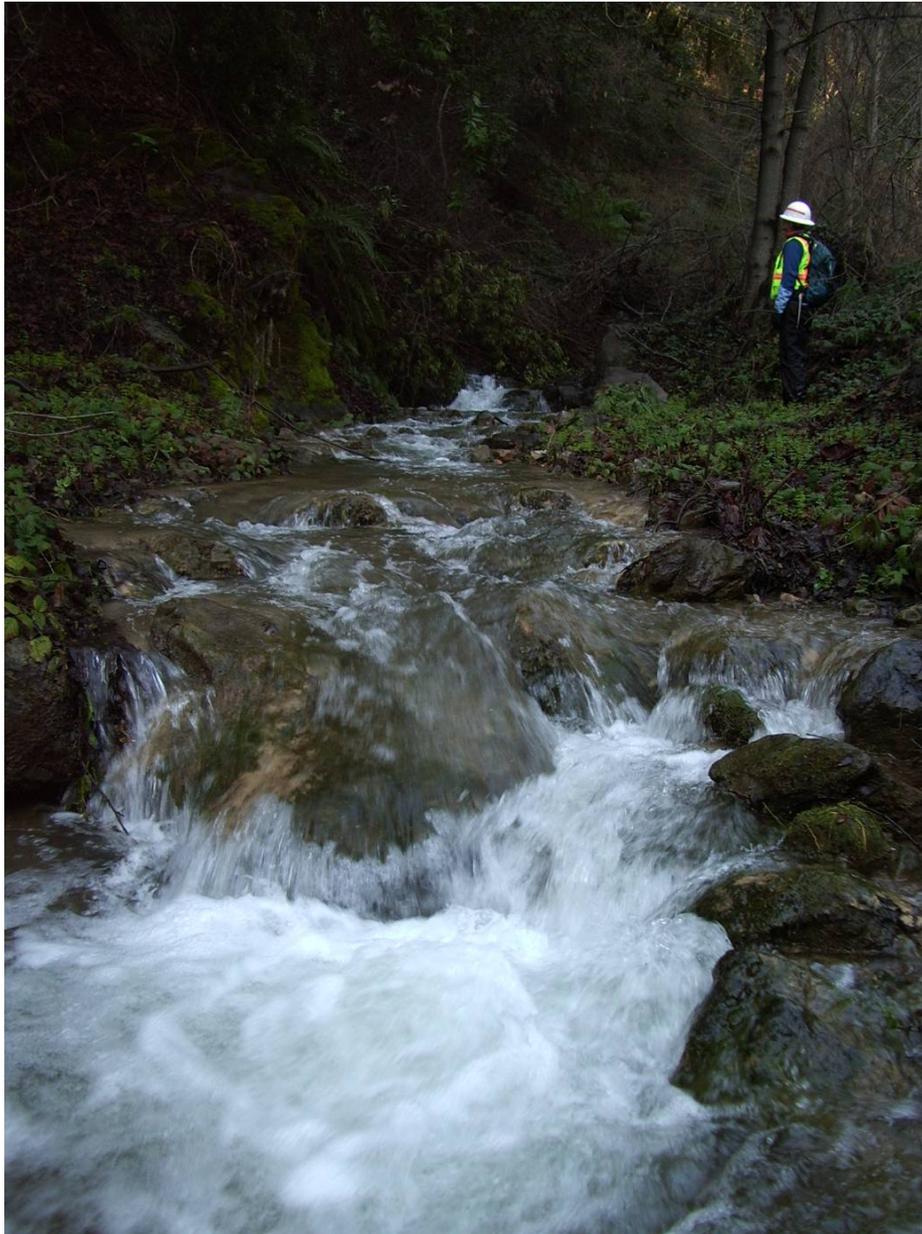
Figure 2-21 Stabilizing channel over old debris flow near Station 106+00

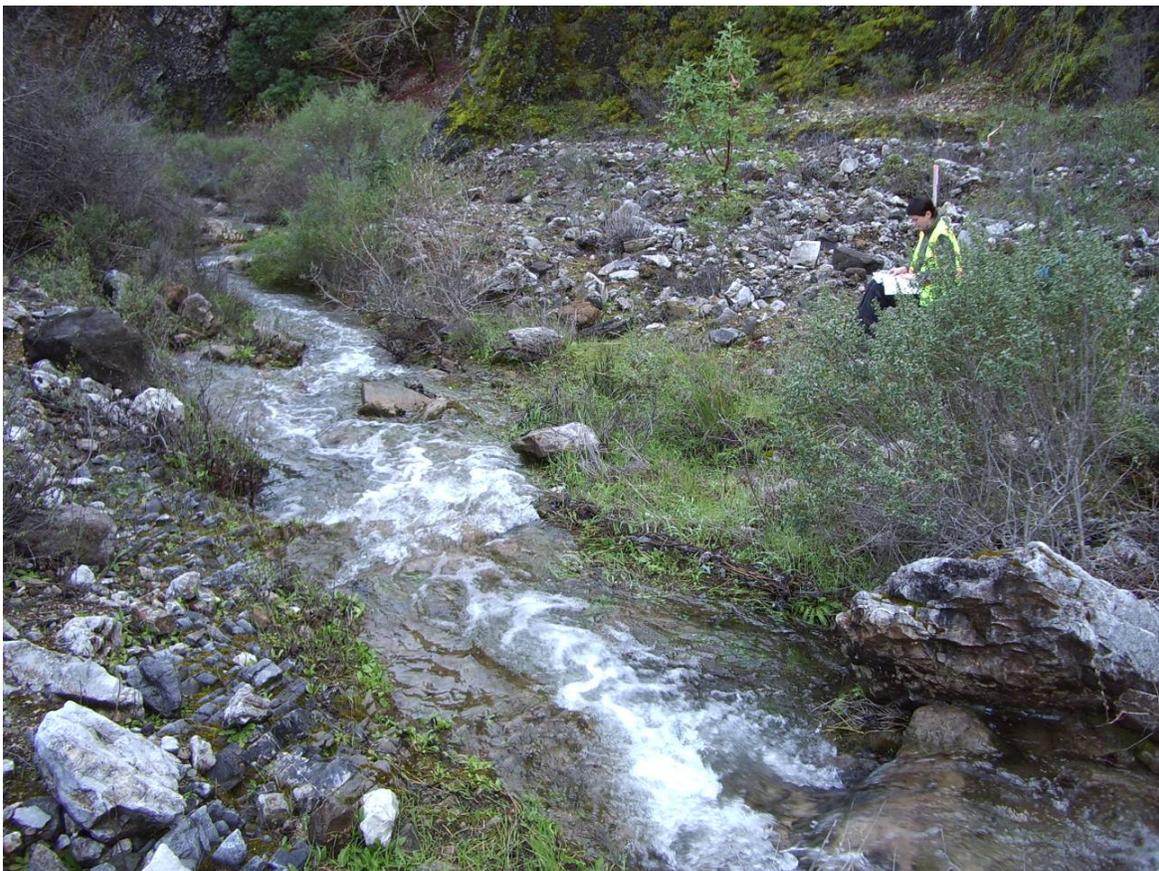
Creek flow is mainly subsurface through this reach. During the lower flows (approximately 10 percent of bankfull) observed in October 2008, the Creek had flow in the channel above and below this reach, but this reach was dry. However, after a 4-inch rain event on February 16, 2009, and with flows at approximately 50 percent of bankfull, this reach was flowing with approximately the same flow as the upper and lower reaches (see Figure 2-22).

Figure 2-22 Looking downstream along Reach [17] near Station 122+50

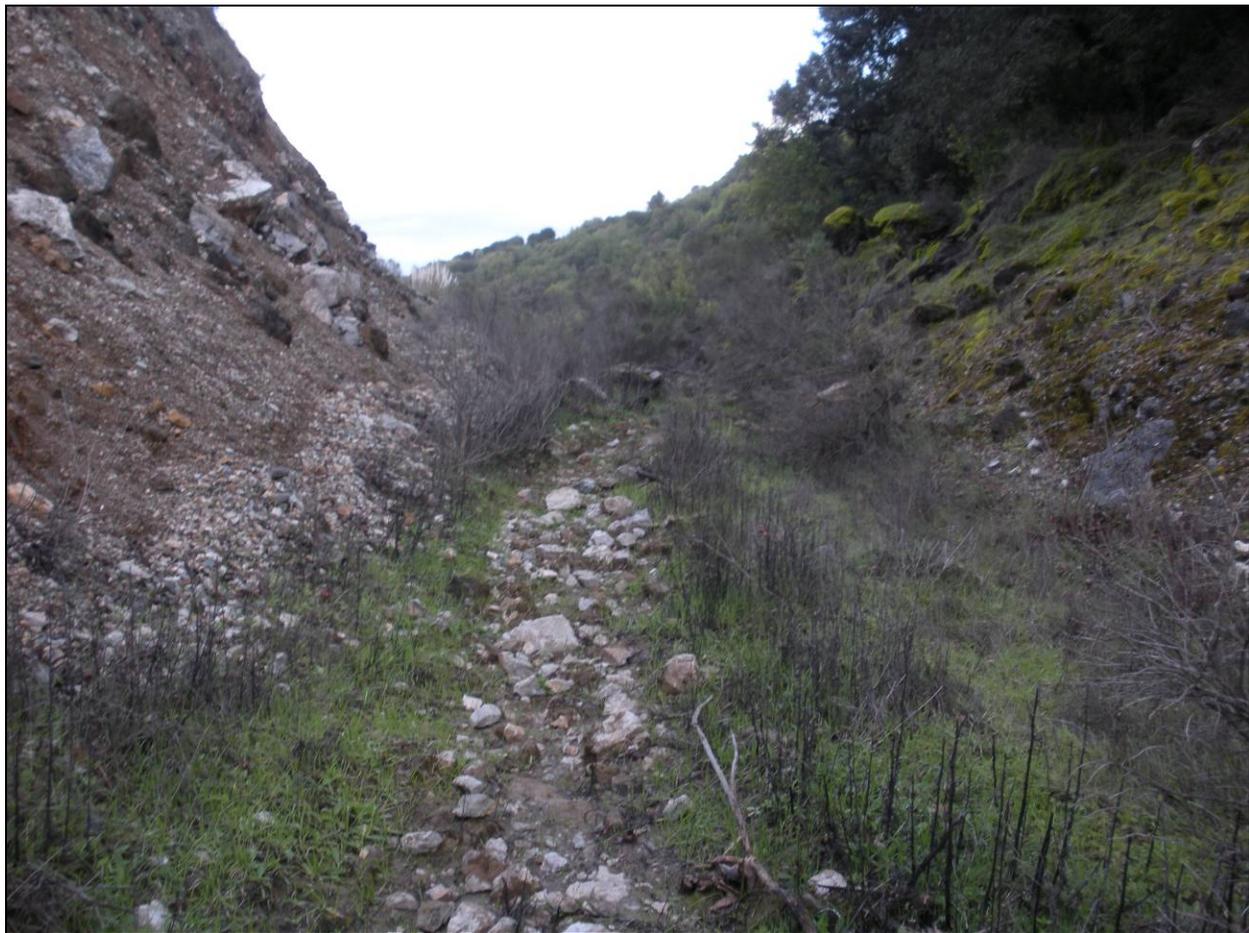
Figure 2-23 Looking downstream through Reach [18] near Station 135+00

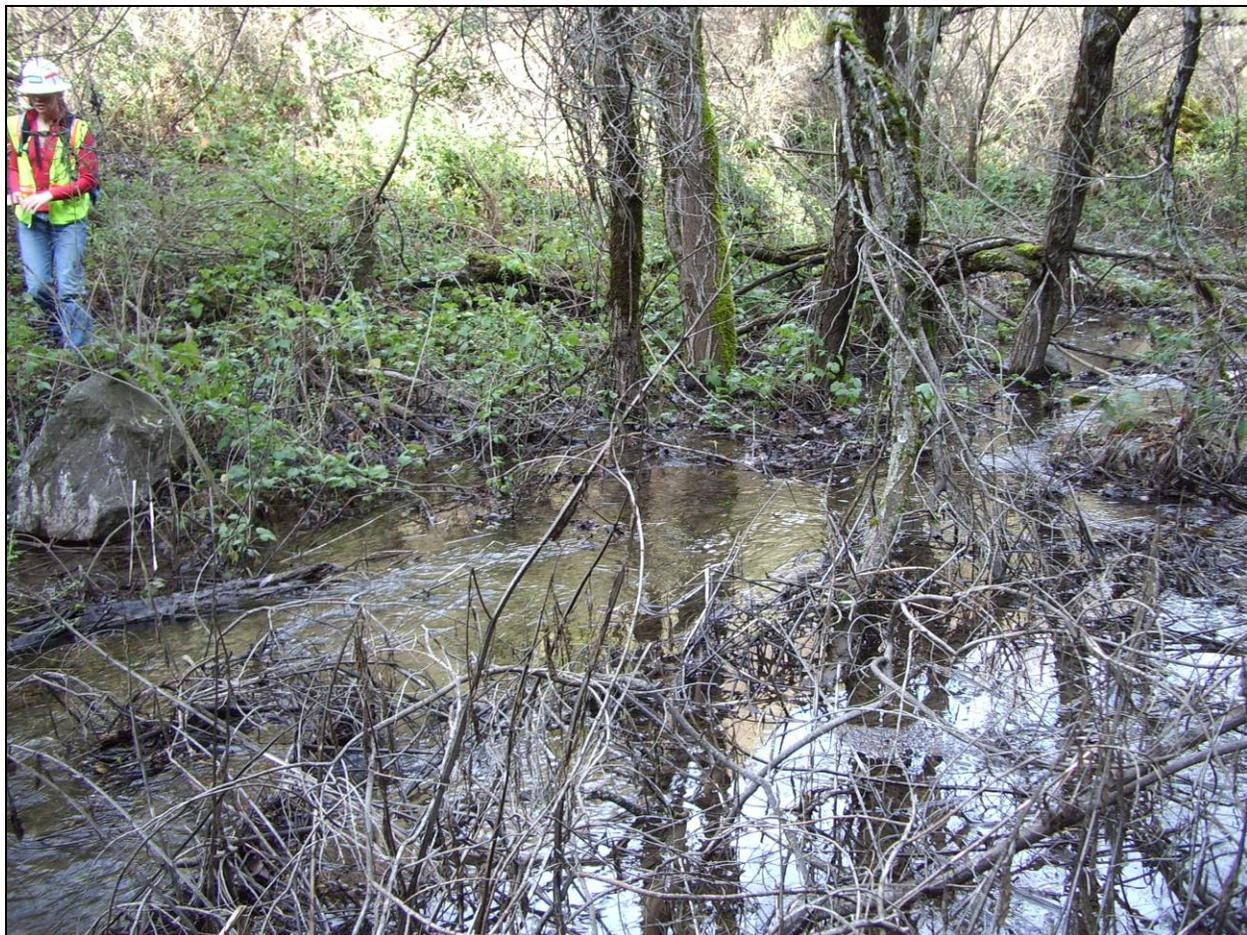
Figure 2-24 Reach [19] near Station 140+00

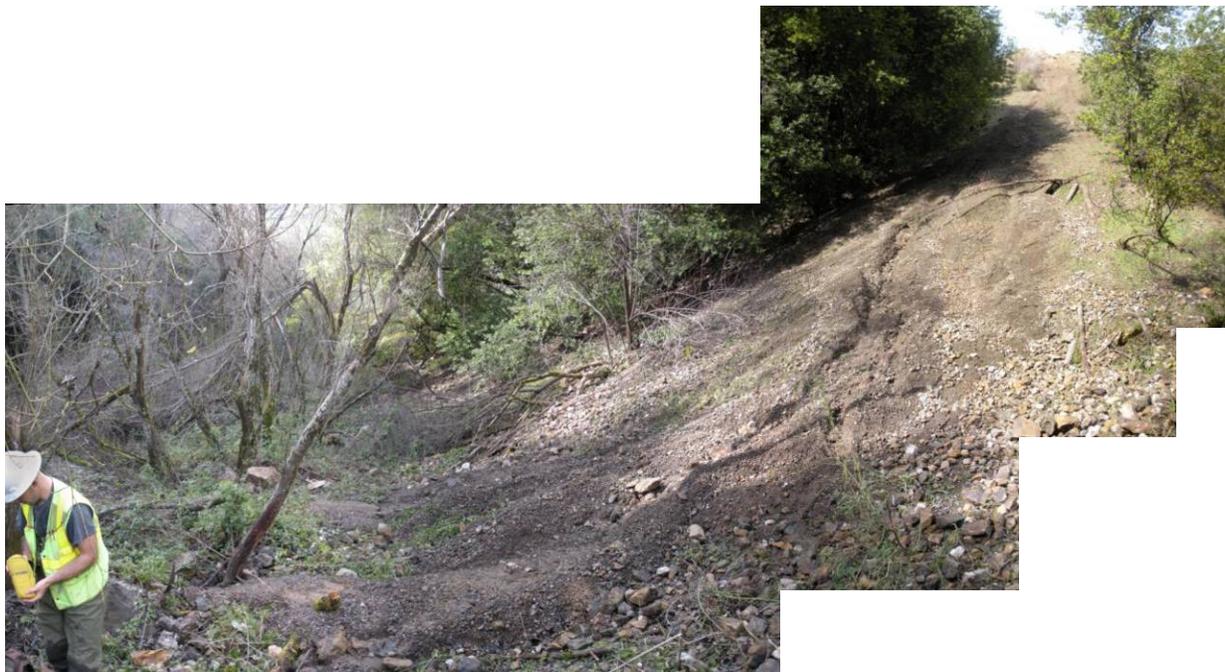
Figure 2-25 Sediment source near Station 141+20 (Q_s3)

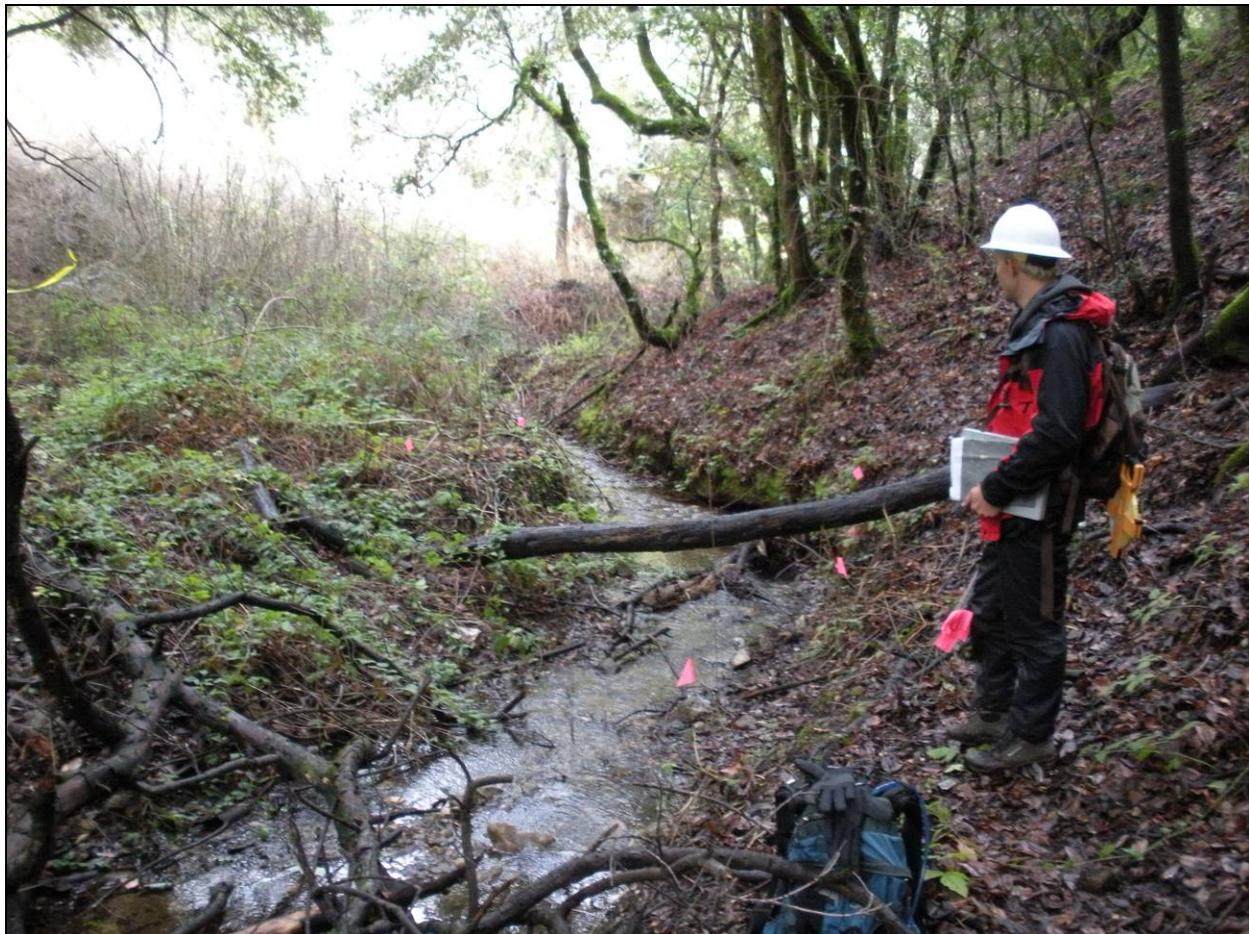
Figure 2-26 View near Station 169+00 on Reach [20]

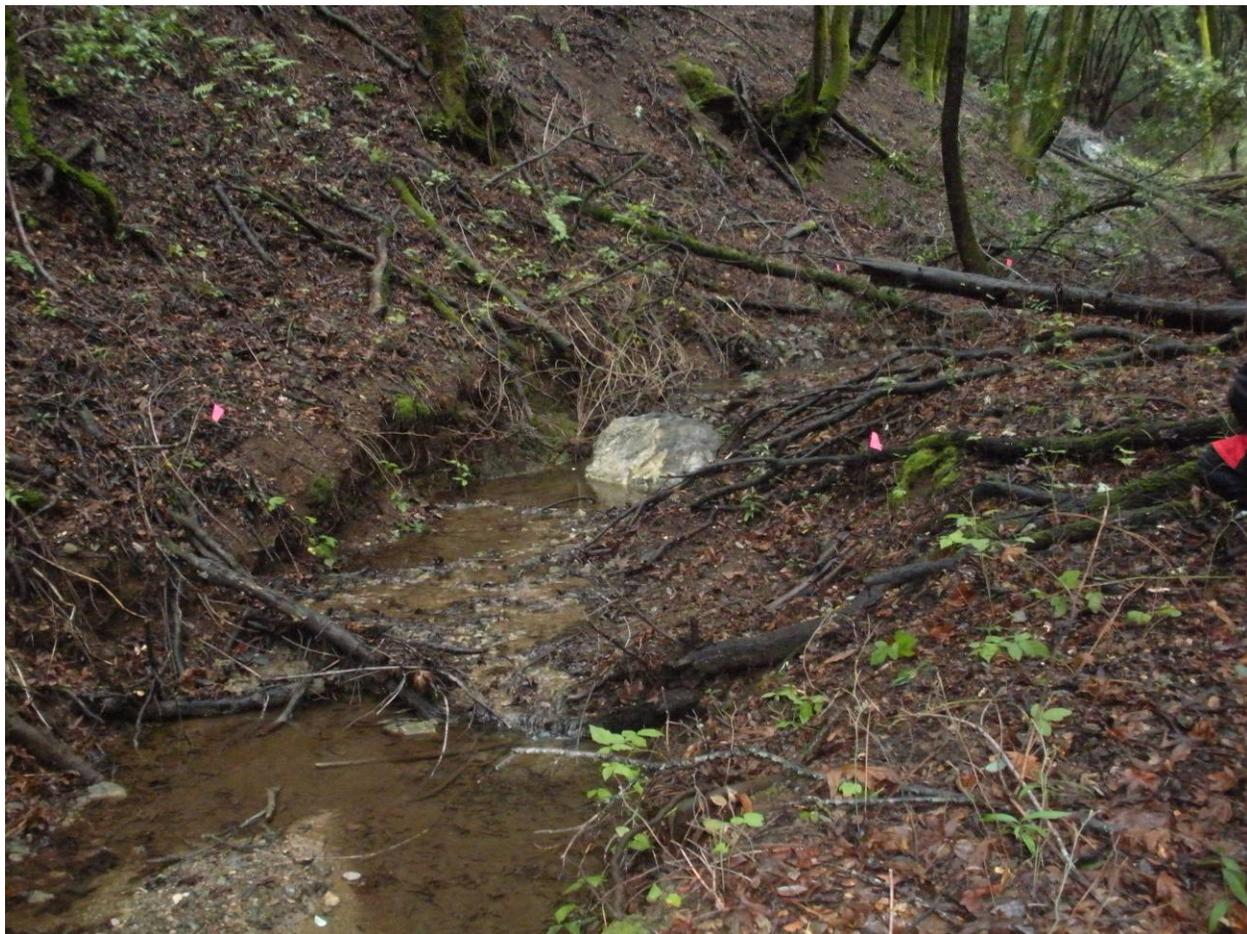
The exception is the area starting near the base of the debris slide at Station 187+50 (Q_s1) and continuing for approximately 355 feet downstream (Station: 185+15 to 188+70). As discussed in Section 2.3.2, the profile has downcut from 0.1 to 1.1 feet over the length of this reach, and the slope of the steepest portion at the base of Q_s1 has migrated approximately 12 feet upstream. The old debris slide at Station 178+50 (Q_s2) is still active along the upper slope, but it is no longer a significant source of sediment to the Creek, as most of the fines have already washed away and portions of the slope have begun to revegetate. The old debris slide at Station 187+50 (Q_s1) is no longer a significant source of sediment, as most of the fine-grained material has eroded away and vegetation has become established, stabilizing the slide. Small amounts of sediment may be dislodged as the stream continues to adjust its profile through the debris slide material in the streambed. Most of the down cutting has already occurred; however, the vertical banks will eventually erode to a more stable angle of repose.

Figure 2-27 View near Station 186+00 on Reach [21]

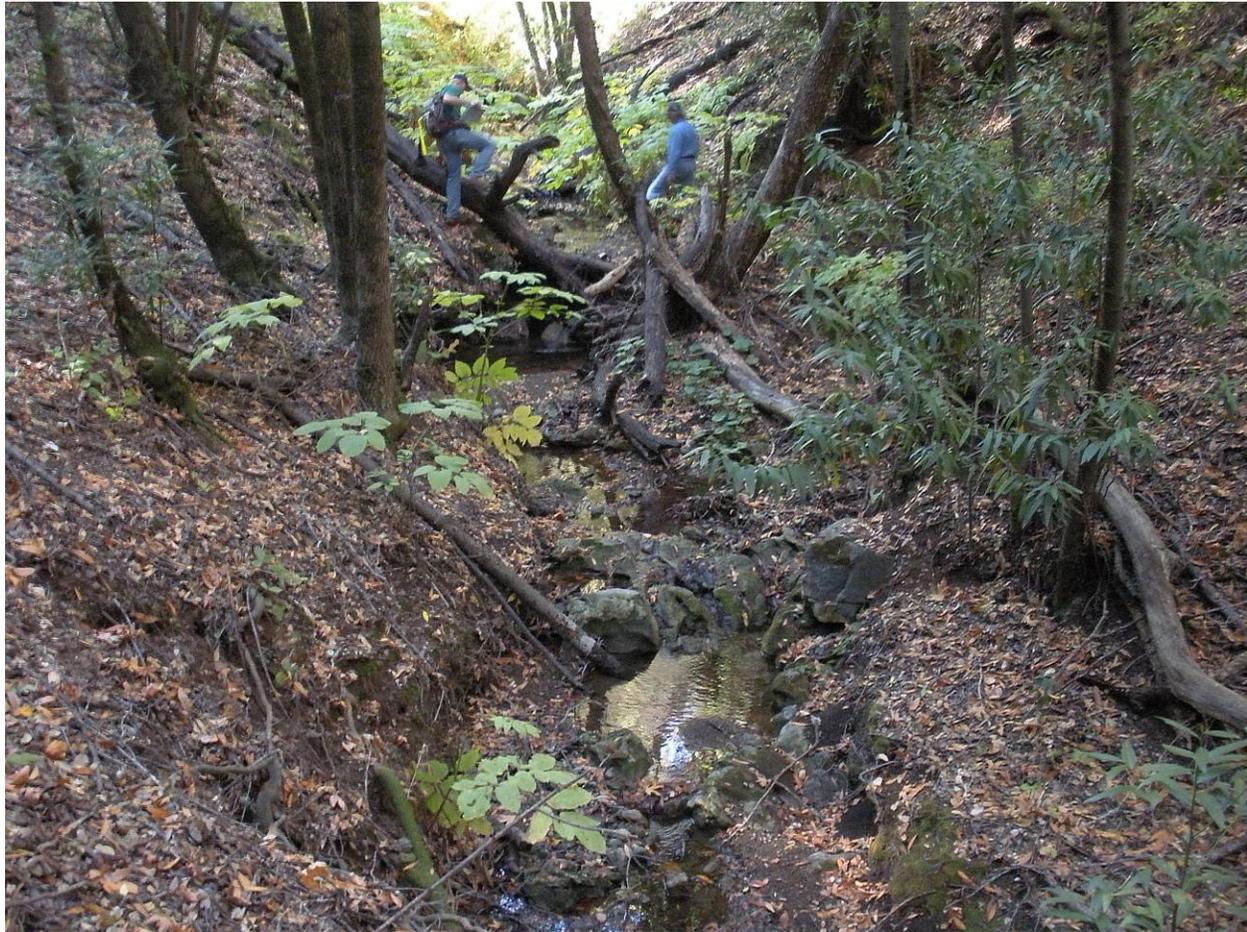
Figure 2-28 View on Reach [22] near Station 195+00
