PERMANENTE CREEK LONG-TERM RESTORATION PLAN

Prepared for
Lehigh Southwest Cement Company
24001 Stevens Creek Boulevard
Cupertino, CA 95014

March 10, 2010

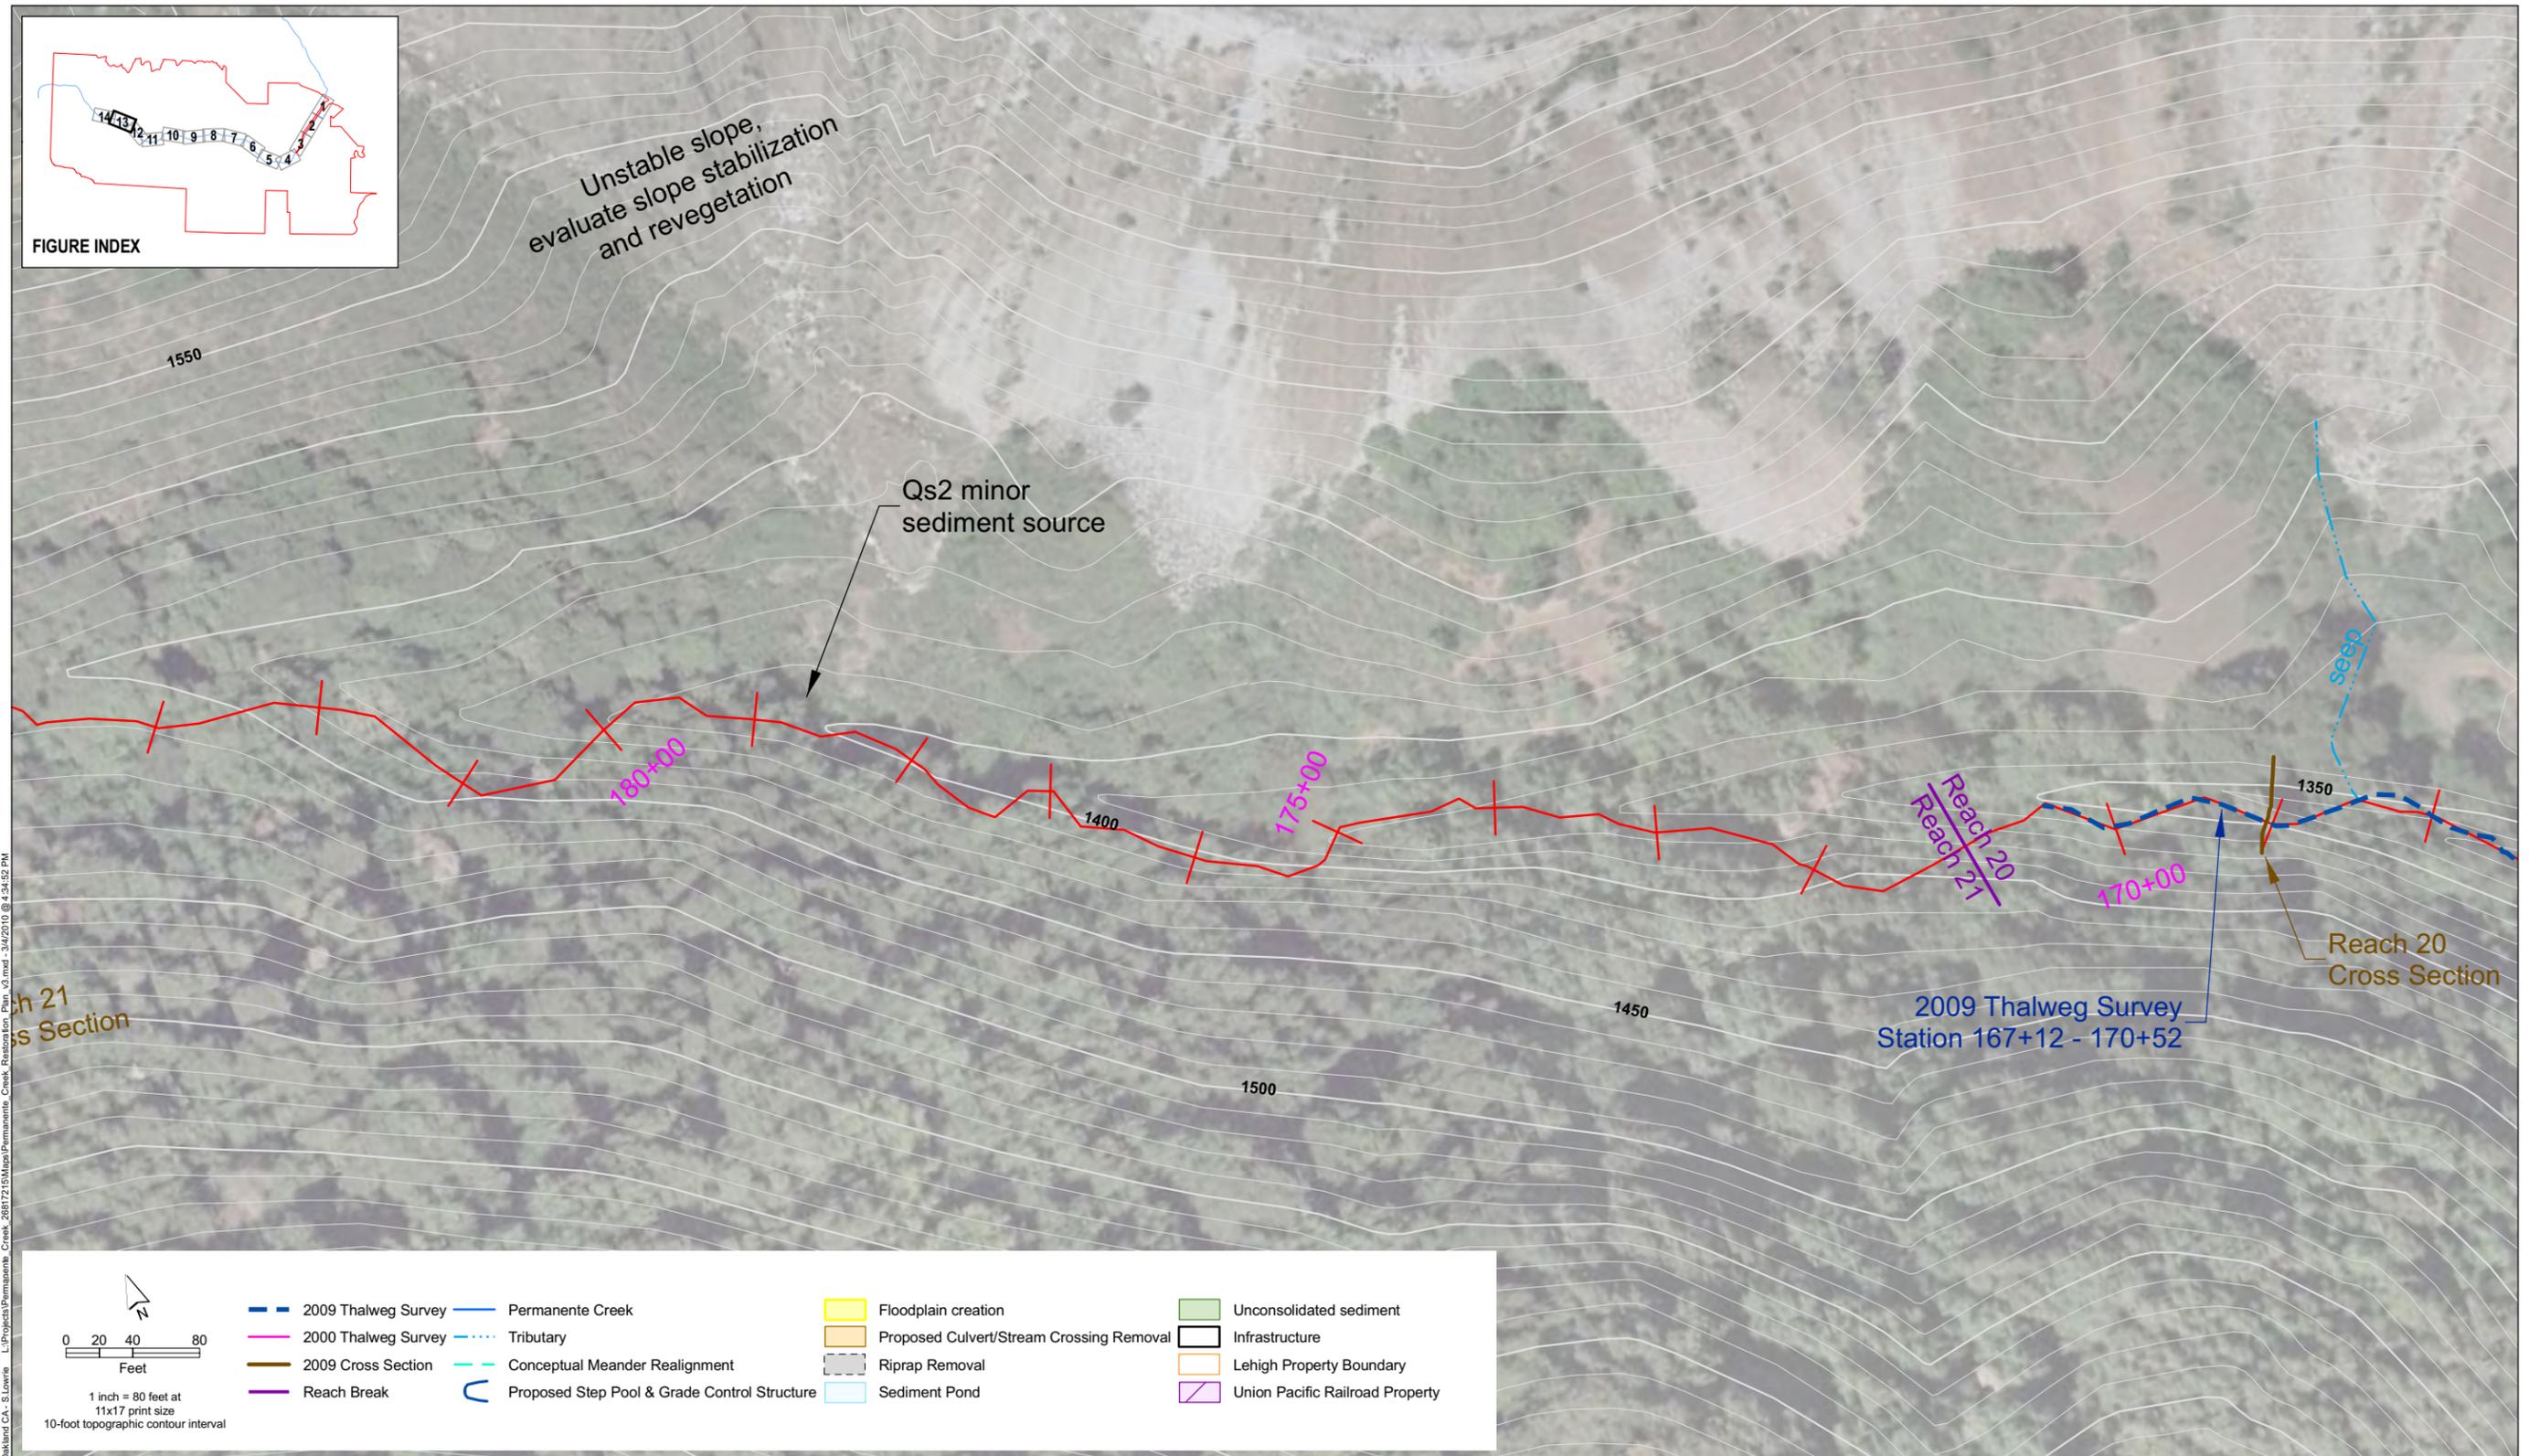
Unstable slope,
evaluate slope stabilization
and revegetation
