PERMANENTE CREEK LONG-TERM RESTORATION PLAN

Prepared for
Lehigh Southwest Cement Company
24001 Stevens Creek Boulevard
Cupertino, CA 95014

March 10, 2010

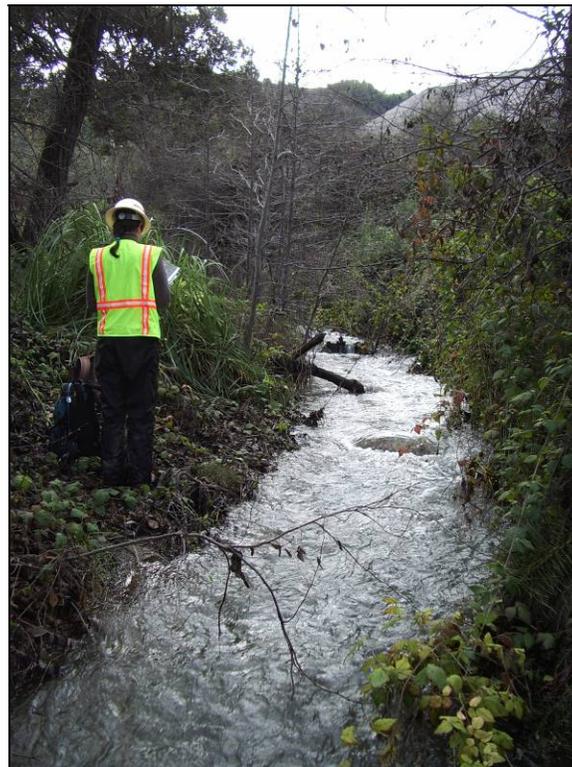
Figure 2-16 View of Reach [7] near Station 37+50

Due to its location at the Facility, directly adjacent to operations, this reach is channelized and does not have access to its original floodplain. This reach includes two culverted road crossings. However, the bed has stabilized in this position and the banks are stable and vegetated (see Figure 2-16). A short portion of this reach near the road crossing has widened and built a small, vegetated floodplain within the old channel.

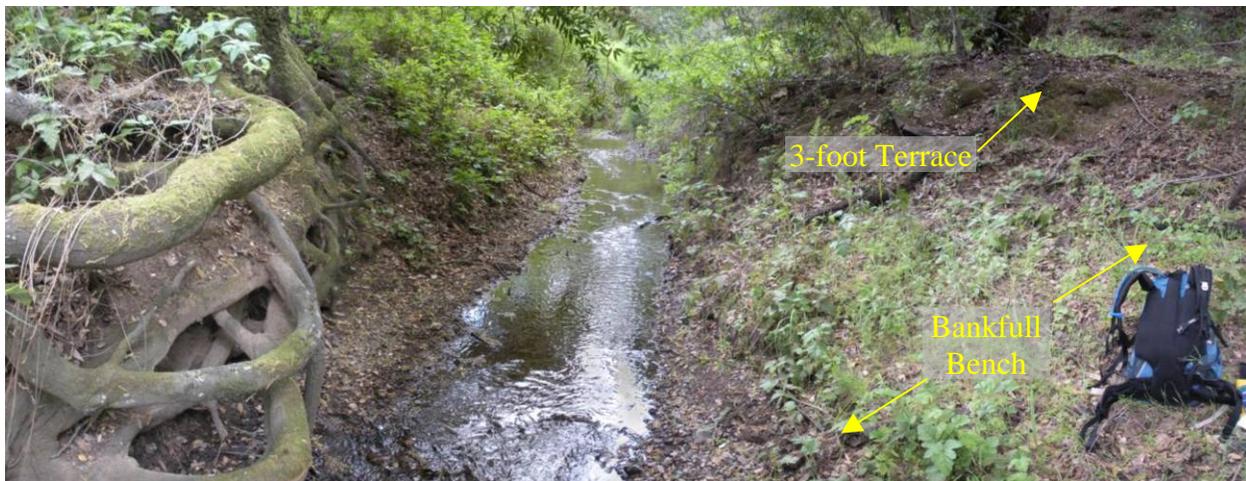
Figure 3-1 Looking upstream along West Fork Permanente Creek

During the observations, West Fork Permanente Creek appeared to be intermittent because it contained flow throughout the observed reach, yet no precipitation had occurred in the 2 weeks prior to the assessment. In comparison to Permanente Creek, West Fork Permanente Creek does not exhibit the calcium carbonate conglomerate, the gravel substrate is a much smaller size, it has a lower gradient and wider valley, and it has an abandoned floodplain terrace approximately 3 feet above bankfull (see Figure 3-1). The reach exhibited small and partially formed bankfull benches within the channel. Due to the variation from the nature of Permanente Creek, this reach is not recommended for use as a reference.

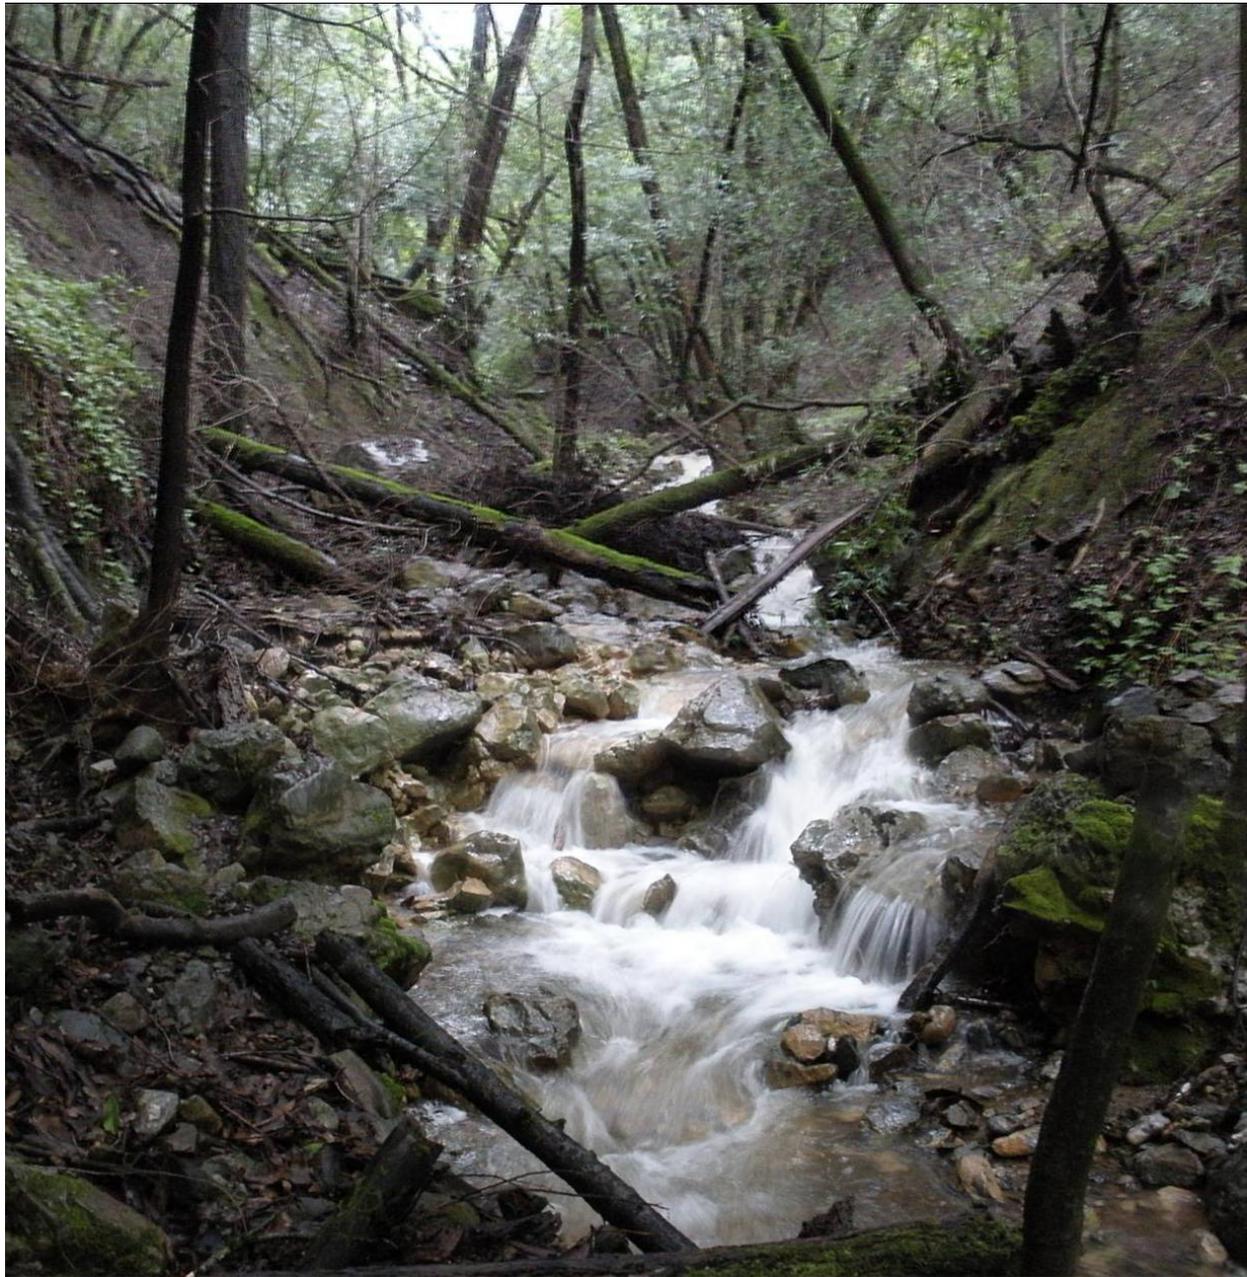
Figure 3-2 Looking upstream along Swiss Creek above Peacock Court

Swiss Creek was observed approximately 500 feet above the Peacock Court crossing because the channel was downcut at the crossing. In comparison to Permanente Creek, Swiss Creek also exhibited the calcium carbonate conglomerate, the channel was also shaped by debris flows and landslides from natural hillside processes, and the valley was similarly narrow and steep, but the sediment composition is somewhat coarser than that of Permanente Creek (see Figure 3-2). Due to the landslides and debris flows, this location of Swiss Creek is not in reference condition. However, it does demonstrate that landslides are characteristic of the area.

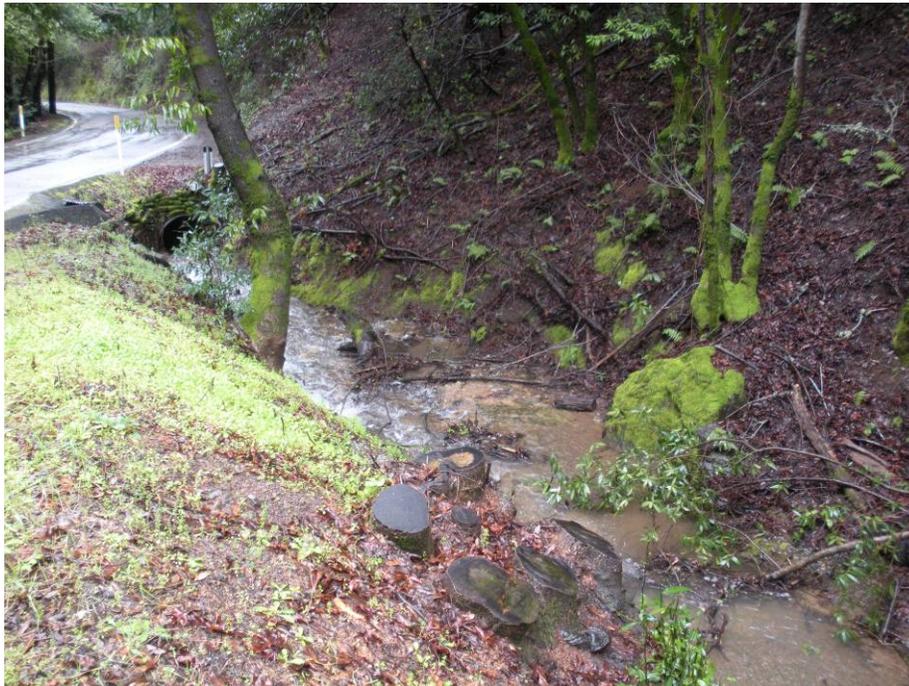
Figure 3-3 Looking downstream along Swiss Creek near Stevens Creek Road

Swiss Creek was also observed above and along Stevens Creek Road where the channel was found to be incised, have eroded banks and low bank vegetation, and be impacted by the close proximity of the road (see Figure 3-3).

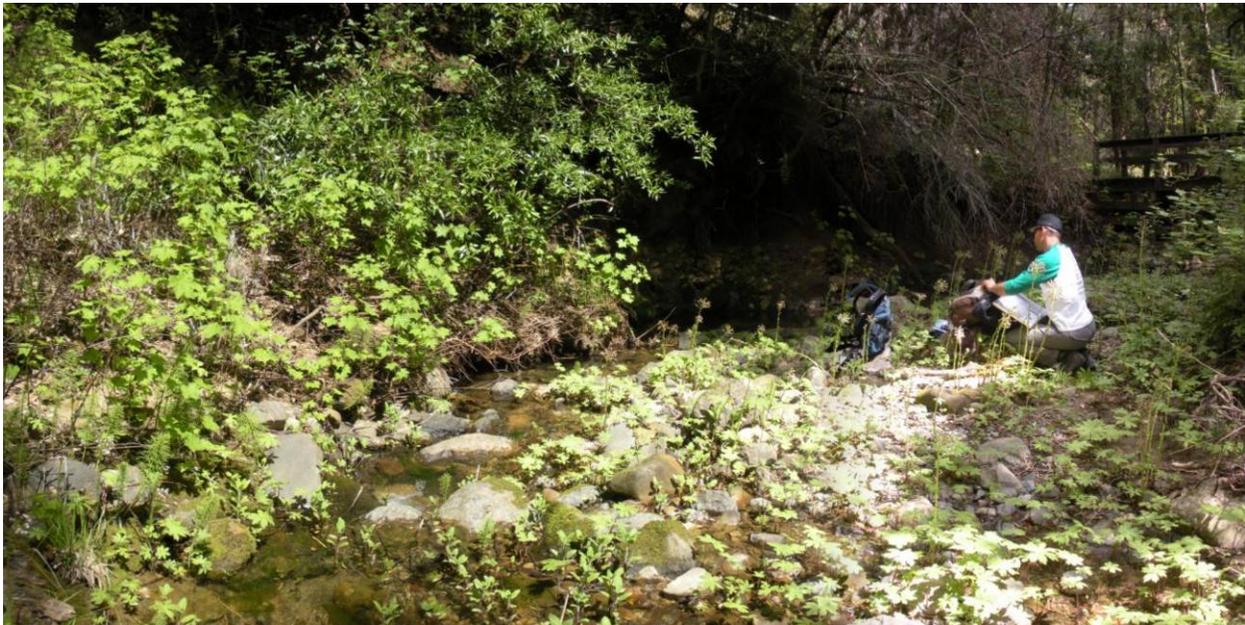
Figure 3-4 Looking downstream along Upper Stevens Creek

location was desired. Upper Stevens Creek, west of Permanente Creek, was observed in the Monte Bello Open Space Preserve near the junction of the Stevens Creek Nature Trail and the White Oak Trail. The assessed portion of Upper Stevens Creek, upstream of a bridge trail crossing, was in excellent condition with significant newt and aquatic vegetation populations in the channel. In comparison to Permanente Creek, Upper Stevens Creek exhibits similar hillslope and landslide processes, has similar bed material of cobbles and boulders interspersed with some small amounts of sand and silt, has similar riparian vegetation communities, and has steep canyon walls like Permanente Creek, but it does not contain the calcium carbonate conglomerate (see Figure 3-4 and Figure 3-5). Upper Stevens Creek, while being affected by landslides and debris flows, remains in dynamic equilibrium and has been able to accommodate or adjust to the sediment inputs quickly. The trail bridge limits lateral channel adjustment, which has caused some bank scouring both upstream and downstream of the crossing, but the erosion is localized.

The channel scores a ‘fair’ stability rating due to its steep upper slopes and landslide potential, but these features are necessary for a reference reach to be applicable to Permanente Creek.
